Profile/Photo Observation Report

Date:	03/29/2018	Weather:		Coding:	PACP 6.0
Pipe Length (ft):	340.2	Owner:	NA	Pre Clean:	Not Known
P.O.#:		Surveyor:	Jen Costello	PSR:	P-708-003-004
Customer:		Clean Date:	01/01/1900	Shape:	C

Street:	Lincoln	Flow Control:	Not Controlled
City:	Hobart, IN	Year Renewed:	
Location:	Light Highway	Tape/Media #:	
Purpose:	Maintenance Related	Dia/Height:	8"
Use:	Sanitary	Material:	PVC
Drain Area:	NA	Lining:	
Category:	NA		
Comment:	Flow direction wrong. Unknown reason for stop.		
Location Details:		Direction of Survey:	Downstream
US MH:	M-708-004	DS MH:	M-708-003
		Total Length Surveyed (ft):	202.7

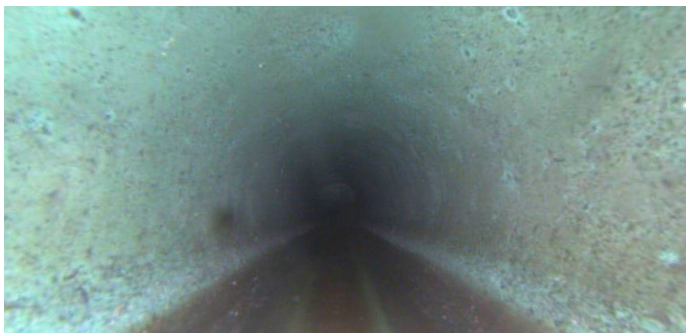
Code: **AMH**
Description: **Manhole**

Distance (ft): **.0**
Structural Grade: **0**
O&M Grade: **0**
Clock Start/From:
Clock To:
1st Value:
2nd Value:
Value Percent:
Continuous Index:
Within 8" of Joint: **NO**
Remarks: **M-708-004**

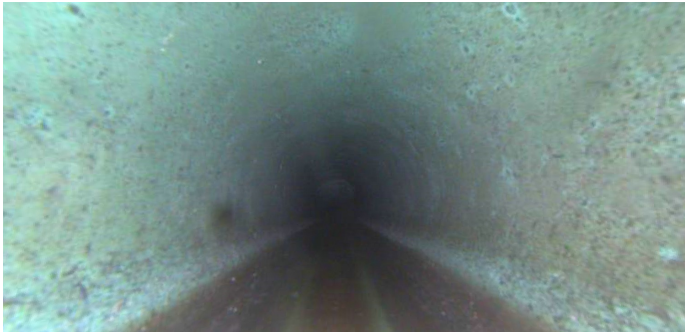
Code:	MWL
Description:	Water Level

Distance (ft):	.0
Structural Grade:	0
O&M Grade:	0
Clock Start/From:	
Clock To:	
1st Value:	
2nd Value:	
Value Percent:	5.000
Continuous Index:	
Within 8" of Joint:	NO
Remarks:

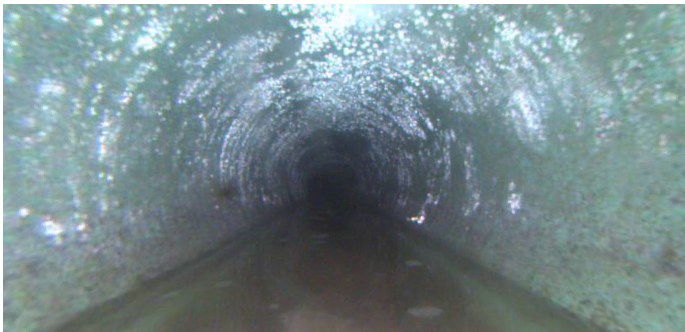
Code:	MWL
Description:	Water Level

Distance (ft):	19.6
Structural Grade:	0
O&M Grade:	0
Clock Start/From:	
Clock To:	
1st Value:	
2nd Value:	
Value Percent:	20.000
Continuous Index:	
Within 8" of Joint:	NO
Remarks:

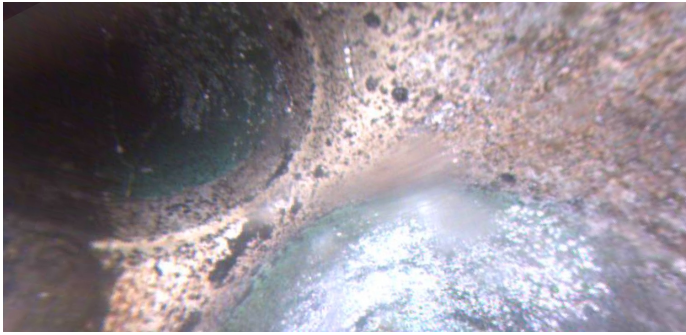
Code: **TF**
Description: **Tap Factory**

Distance (ft): **26.2**
Structural Grade: **0**
O&M Grade: **0**
Clock Start/From: **10**
Clock To:
1st Value: **4.000**
2nd Value:
Value Percent:
Continuous Index:
Within 8" of Joint:
Remarks:

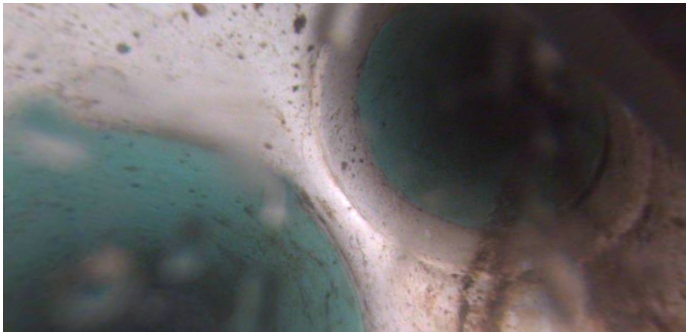
Code: **TF**
Description: **Tap Factory**

Distance (ft): **102.5**
Structural Grade: **0**
O&M Grade: **0**
Clock Start/From: **2**
Clock To:
1st Value: **4.000**
2nd Value:
Value Percent:
Continuous Index:
Within 8" of Joint:
Remarks:

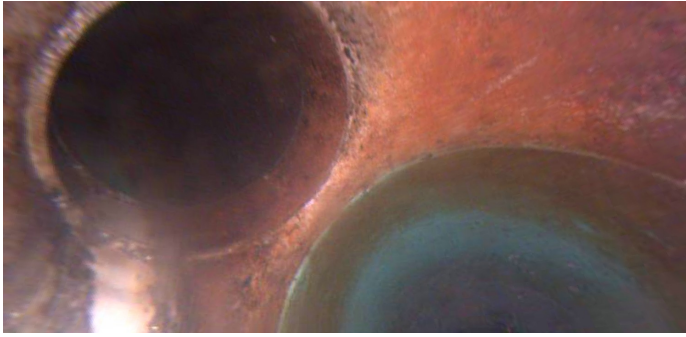
Code: **TF**
Description: **Tap Factory**

Distance (ft): **133.8**
Structural Grade: **0**
O&M Grade: **0**
Clock Start/From: **2**
Clock To:
1st Value: **4.000**
2nd Value:
Value Percent:
Continuous Index:
Within 8" of Joint:
Remarks:

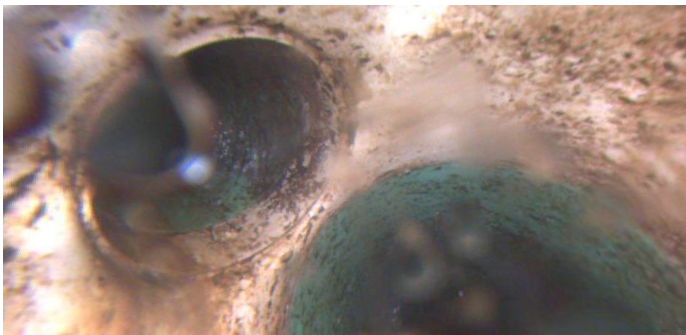
Code: **TF**
Description: **Tap Factory**

Distance (ft): **200.3**
Structural Grade: **0**
O&M Grade: **0**
Clock Start/From: **10**
Clock To:
1st Value: **4.000**
2nd Value:
Value Percent:
Continuous Index:
Within 8" of Joint:
Remarks:

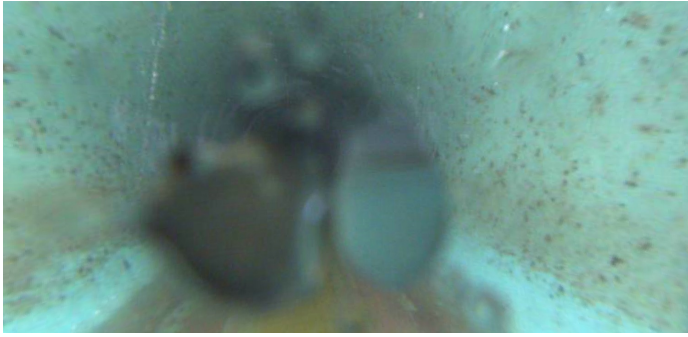
Code:	MSA
Description:	Abandoned Survey
Distance (ft):	202.7
Structural Grade:	0
O&M Grade:	0
Clock Start/From:	
Clock To:	
1st Value:	
2nd Value:	
Value Percent:	
Continuous Index:	
Within 8" of Joint:	NO
Remarks:	UNKNOWN
