Profile/Photo Observation Report

Date:	03/29/2018	Weather:		Coding:	PACP 6.0
Pipe Length (ft):	335.9	Owner:	NA	Pre Clean:	Not Known
P.O.#:		Surveyor:	Jen Costello	PSR:	P-708-005-006
Customer:		Clean Date:	01/01/1900	Shape:	C

Street:	STATE ST	Flow Control:	Not Controlled
City:	Hobart, IN	Year Renewed:	
Location:	Sidewalk	Tape/Media #:	
Purpose:	Maintenance Related	Dia/Height:	12"
Use:	Sanitary	Material:	PVC
Drain Area:	NA	Lining:	Cured in Place
Category:	NA		
Comment:	Underwater at 145'.		
Location Details:		Direction of Survey:	Downstream
US MH:	M-708-006	DS MH:	M-708-005
		Total Length Surveyed (ft):	146.2

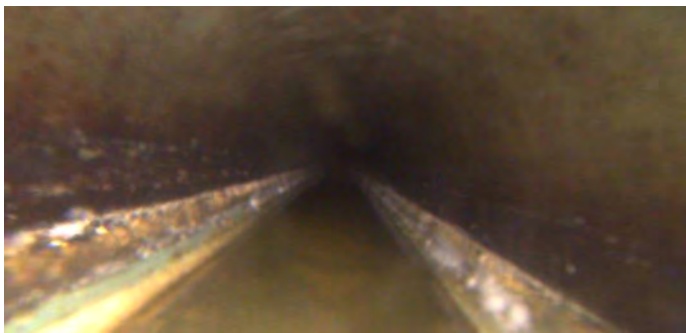
Code: **AMH**
Description: **Manhole**

Distance (ft): **.0**
Structural Grade: **0**
O&M Grade: **0**
Clock Start/From:
Clock To:
1st Value:
2nd Value:
Value Percent:
Continuous Index:
Within 8" of Joint: **NO**
Remarks: **M-708-006**

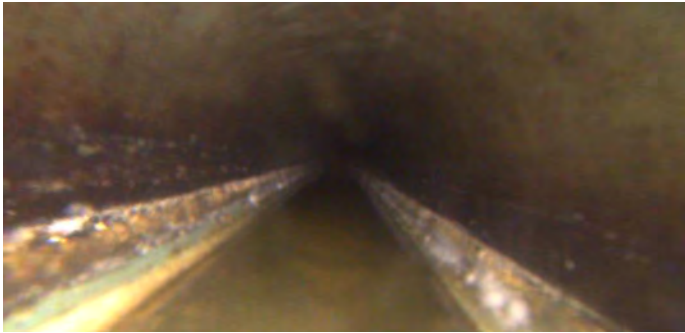
Code:	MWL
Description:	Water Level

Distance (ft):	.0
Structural Grade:	0
O&M Grade:	0
Clock Start/From:	
Clock To:	
1st Value:	
2nd Value:	
Value Percent:	10.000
Continuous Index:	
Within 8" of Joint:	NO
Remarks:

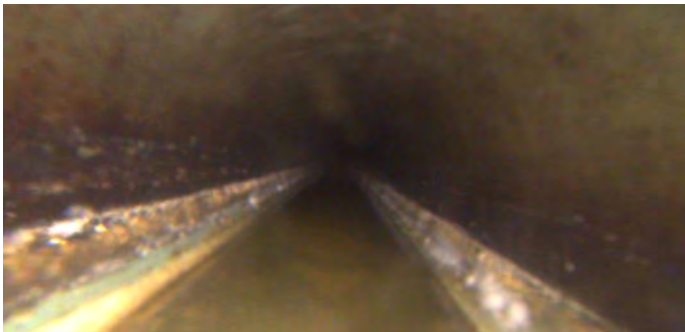
Code:	DAGS
Description:	Deposits Attached Grease

Distance (ft):	.0
Structural Grade:	0
O&M Grade:	2
Clock Start/From:	8
Clock To:	4
1st Value:	
2nd Value:	
Value Percent:	5.000
Continuous Index:	S01
Within 8" of Joint:	NO
Remarks:

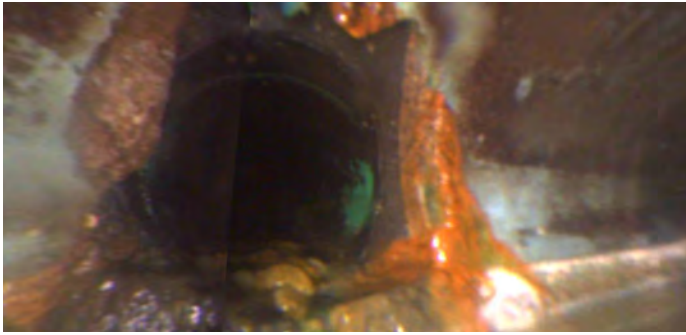
Code: **TBD**
Description: **Tap Break-in Defective**

Distance (ft): **34.2**
Structural Grade: **0**
O&M Grade: **3**
Clock Start/From: **9**
Clock To:
1st Value: **4.000**
2nd Value:
Value Percent:
Continuous Index:
Within 8" of Joint:
Remarks: **dae**

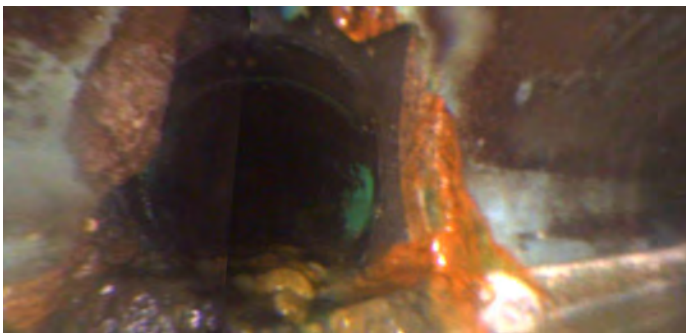
Code: **DAE**
Description: **Deposits Attached Encrustation**

Distance (ft): **34.2**
Structural Grade: **0**
O&M Grade: **2**
Clock Start/From: **9**
Clock To: **10**
1st Value:
2nd Value:
Value Percent: **5.000**
Continuous Index:
Within 8" of Joint: **NO**
Remarks:

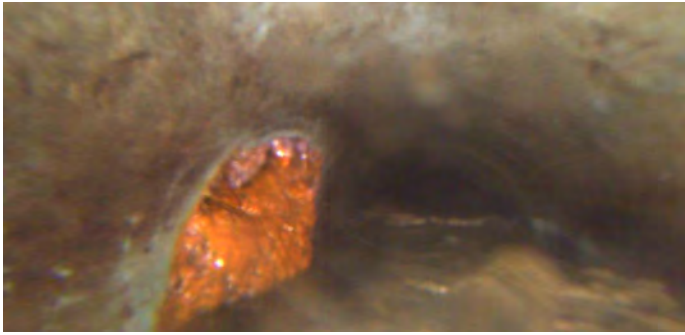
Code: **TFD**
Description: **Tap Factory Defective**

Distance (ft): **48.8**
Structural Grade: **0**
O&M Grade: **2**
Clock Start/From: **9**
Clock To:
1st Value: **4.000**
2nd Value:
Value Percent:
Continuous Index:
Within 8" of Joint:
Remarks: **blocked by DAE**

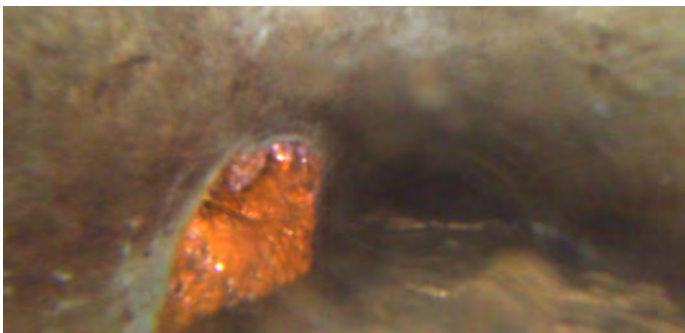
Code: **DAE**
Description: **Deposits Attached Encrustation**

Distance (ft): **48.8**
Structural Grade: **0**
O&M Grade: **2**
Clock Start/From: **9**
Clock To: **10**
1st Value:
2nd Value:
Value Percent: **5.000**
Continuous Index:
Within 8" of Joint: **NO**
Remarks:
