## Profile/Photo Observation Report

Date:	<b>03/29/2018</b>	Weather:		Coding:	<b>PACP 6.0</b>
Pipe Length (ft):	<b>335.9</b>	Owner:	<b>NA</b>	Pre Clean:	<b>Not Known</b>
P.O.#:		Surveyor:	<b>Jen Costello</b>	PSR:	<b>P-708-005-006</b>
Customer:		Clean Date:	<b>01/01/1900</b>	Shape:	<b>C</b>

Location Details:		Direction of Survey:	<b>Downstream</b>
US MH:	<b>M-708-006</b>	DS MH:	<b>M-708-005</b>
		Total Length Surveyed (ft):	<b>146.2</b>

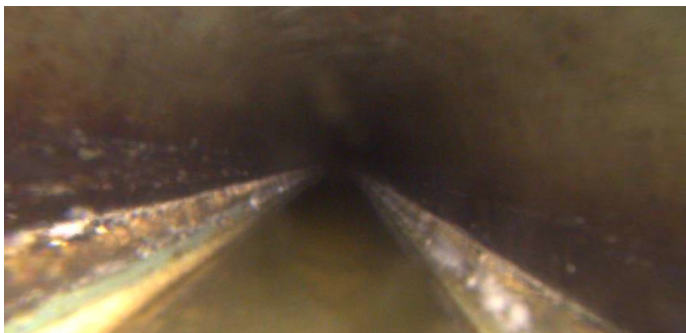
Code: **AMH**  
Description: **Manhole**

Distance (ft): **.0**  
Structural Grade: **0**  
O&M Grade: **0**  
Clock Start/From:  
Clock To:  
1st Value:  
2nd Value:  
Value Percent:  
Continuous Index:  
Within 8" of Joint: **NO**  
Remarks: **M-708-006**

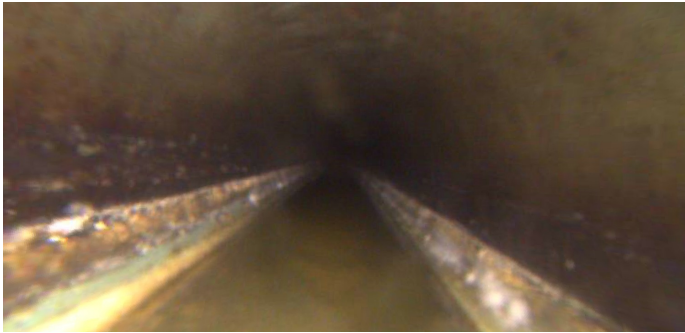
Code:	<b>MWL</b>
Description:	<b>Water Level</b>

Distance (ft):	<b>.0</b>
Structural Grade:	<b>0</b>
O&M Grade:	<b>0</b>
Clock Start/From:	
Clock To:	
1st Value:	
2nd Value:	
Value Percent:	<b>10.000</b>
Continuous Index:	
Within 8" of Joint:	<b>NO</b>
Remarks:

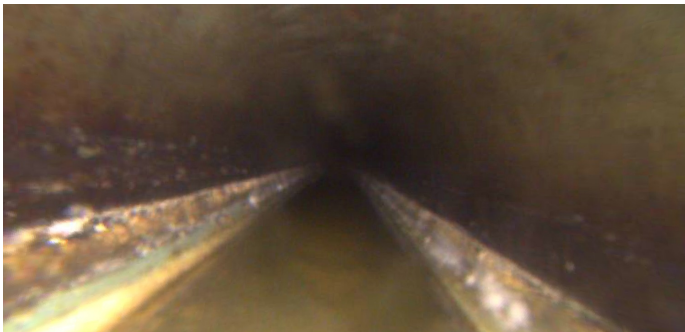
Code:	<b>DAGS</b>
Description:	<b>Deposits Attached Grease</b>

Distance (ft):	<b>.0</b>
Structural Grade:	<b>0</b>
O&M Grade:	<b>2</b>
Clock Start/From:	<b>8</b>
Clock To:	<b>4</b>
1st Value:	
2nd Value:	
Value Percent:	<b>5.000</b>
Continuous Index:	<b>S01</b>
Within 8" of Joint:	<b>NO</b>
Remarks:

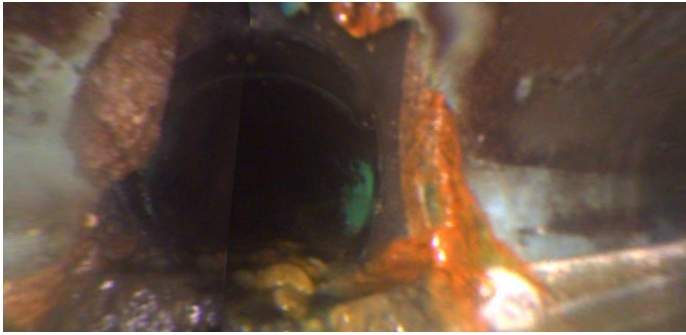
Code: **TBD**  
Description: **Tap Break-in Defective**

Distance (ft): **34.2**  
Structural Grade: **0**  
O&M Grade: **3**  
Clock Start/From: **9**  
Clock To:  
1st Value: **4.000**  
2nd Value:  
Value Percent:  
Continuous Index:  
Within 8" of Joint:  
Remarks: **dae**

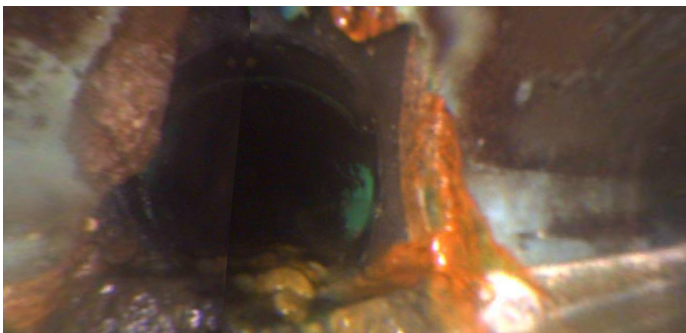
Code: **DAE**  
Description: **Deposits Attached Encrustation**

Distance (ft): **34.2**  
Structural Grade: **0**  
O&M Grade: **2**  
Clock Start/From: **9**  
Clock To: **10**  
1st Value:  
2nd Value:  
Value Percent: **5.000**  
Continuous Index:  
Within 8" of Joint: **NO**  
Remarks:

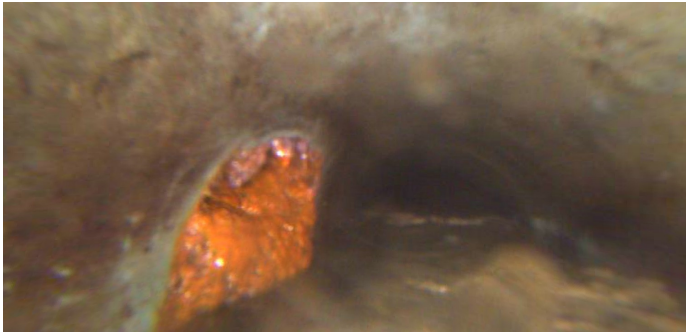
Code: **TFD**  
Description: **Tap Factory Defective**

Distance (ft): **48.8**  
Structural Grade: **0**  
O&M Grade: **2**  
Clock Start/From: **9**  
Clock To:  
1st Value: **4.000**  
2nd Value:  
Value Percent:  
Continuous Index:  
Within 8" of Joint:  
Remarks: **blocked by DAE**

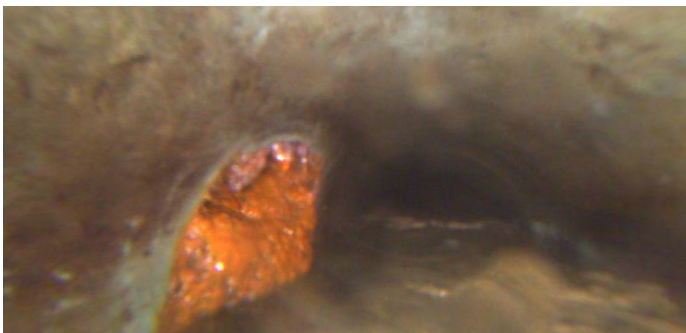
Code: **DAE**  
Description: **Deposits Attached Encrustation**

Distance (ft): **48.8**  
Structural Grade: **0**  
O&M Grade: **2**  
Clock Start/From: **9**  
Clock To: **10**  
1st Value:  
2nd Value:  
Value Percent: **5.000**  
Continuous Index:  
Within 8" of Joint: **NO**  
Remarks:

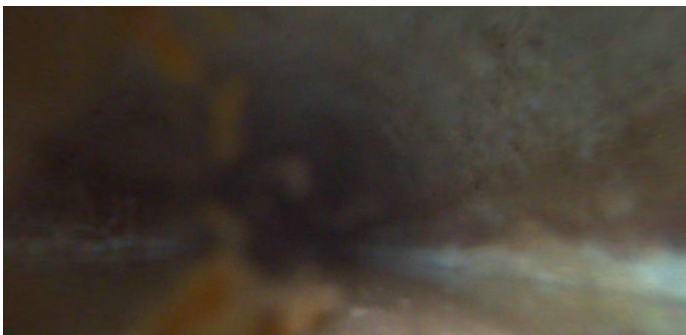
Code: **MWL**  
Description: **Water Level**

Distance (ft): **86.0**  
Structural Grade: **0**  
O&M Grade: **0**  
Clock Start/From:  
Clock To:  
1st Value:  
2nd Value:  
Value Percent: **40.000**  
Continuous Index:  
Within 8" of Joint: **NO**  
Remarks:

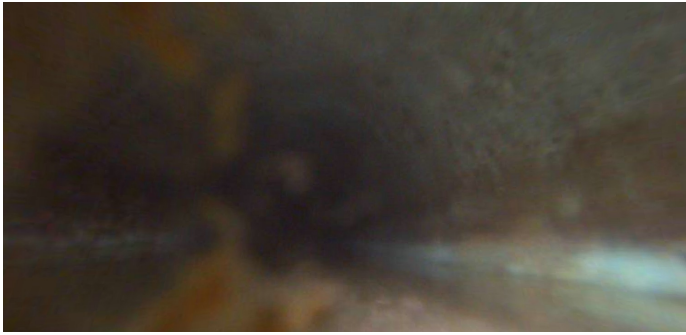
Code: **MCU**  
Description: **Camera Underwater**

Distance (ft): **86.0**  
Structural Grade: **0**  
O&M Grade: **4**  
Clock Start/From:  
Clock To:  
1st Value:  
2nd Value:  
Value Percent:  
Continuous Index: **F02**  
Within 8" of Joint: **NO**  
Remarks:

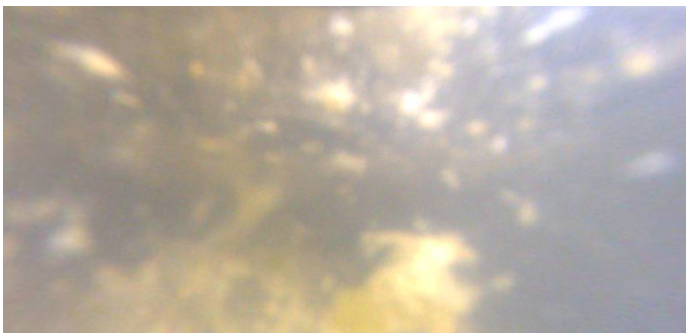
Code: **MWL**  
Description: **Water Level**

Distance (ft): **101.3**  
Structural Grade: **0**  
O&M Grade: **0**  
Clock Start/From:  
Clock To:  
1st Value:  
2nd Value:  
Value Percent: **60.000**  
Continuous Index:  
Within 8" of Joint: **NO**  
Remarks:

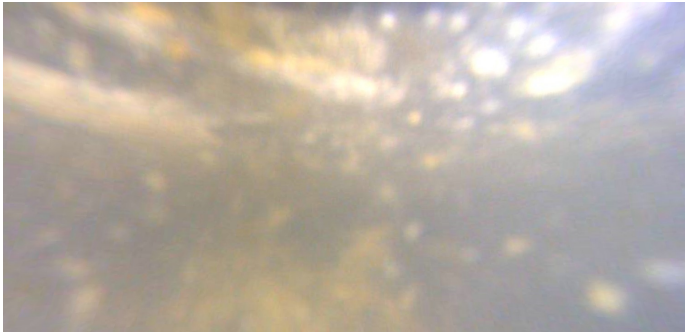
Code: **MCU**  
Description: **Camera Underwater**

Distance (ft): **101.3**  
Structural Grade: **0**  
O&M Grade: **4**  
Clock Start/From:  
Clock To:  
1st Value:  
2nd Value:  
Value Percent:  
Continuous Index: **S03**  
Within 8" of Joint: **NO**  
Remarks:
