Profile/Photo Observation Report

Street:	State	Flow Control:	Not Controlled
City:	Hobart, IN	Year Renewed:	
Location:	Sidewalk	Tape/Media #:	
Purpose:	Maintenance Related	Dia/Height:	8"
Use:	Sanitary	Material:	PVC
Drain Area:	NA	Lining:	
Category:	NA		
Comment:	Flow direction wrong. Reverse setup.		
Location Details:		Direction of Survey:	Upstream
US MH:	M-708-006	DS MH:	M-708-005
		Total Length Surveyed (ft):	8.5

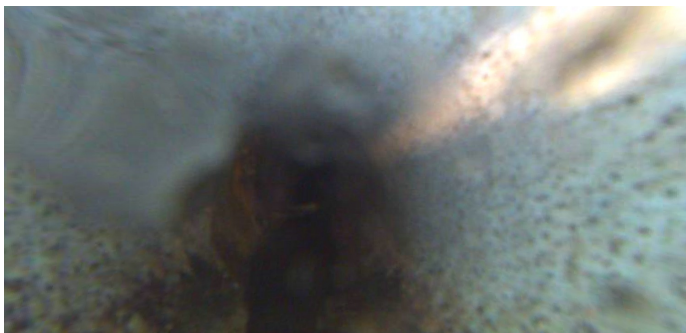
Code: **AMH**
Description: **Manhole**

Distance (ft): **.0**
Structural Grade: **0**
O&M Grade: **0**
Clock Start/From:
Clock To:
1st Value:
2nd Value:
Value Percent:
Continuous Index:
Within 8" of Joint: **NO**
Remarks: **M-708-005**

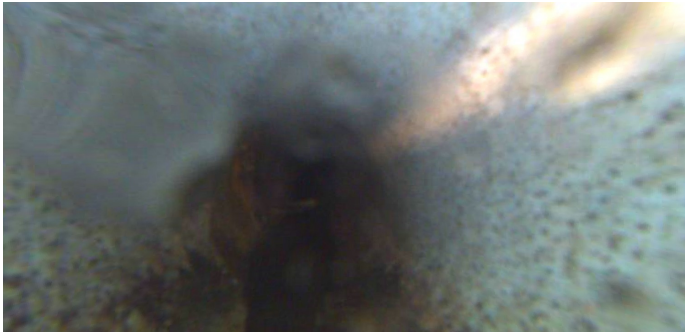
Code:	MWL
Description:	Water Level

Distance (ft):	.0
Structural Grade:	0
O&M Grade:	0
Clock Start/From:	
Clock To:	
1st Value:	
2nd Value:	
Value Percent:	5.000
Continuous Index:	
Within 8" of Joint:	NO
Remarks:

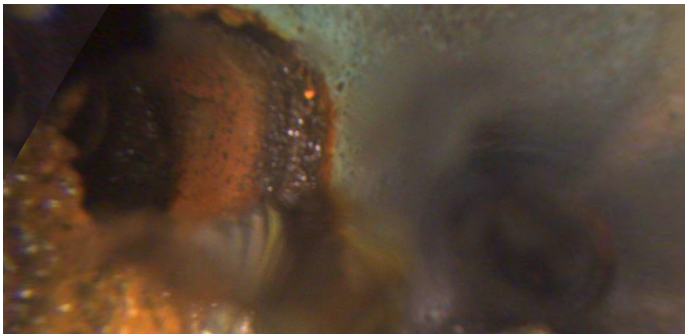
Code:	TBA
Description:	Tap Break-in Active

Distance (ft):	2.3
Structural Grade:	0
O&M Grade:	0
Clock Start/From:	10
Clock To:	
1st Value:	4.000
2nd Value:	
Value Percent:	
Continuous Index:	
Within 8" of Joint:	
Remarks:

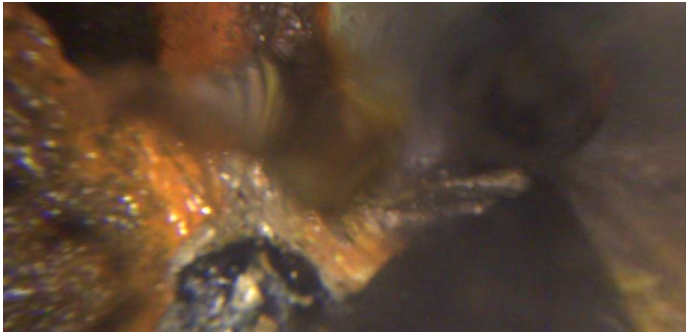
Code: **DAE**
Description: **Deposits Attached Encrustation**

Distance (ft): **2.3**
Structural Grade: **0**
O&M Grade: **2**
Clock Start/From: **7**
Clock To: **9**
1st Value:
2nd Value:
Value Percent: **5.000**
Continuous Index:
Within 8" of Joint: **NO**
Remarks:

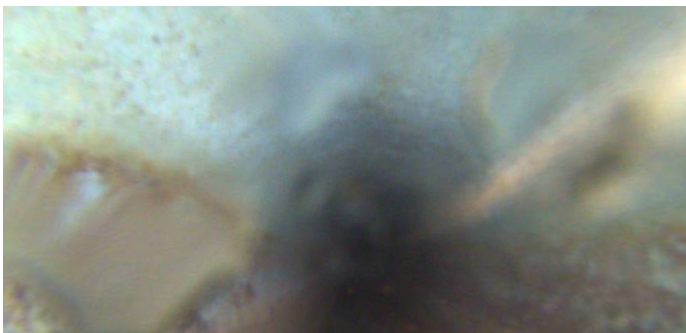
Code: **MSA**
Description: **Abandoned Survey**

Distance (ft): **8.5**
Structural Grade: **0**
O&M Grade: **0**
Clock Start/From:
Clock To:
1st Value:
2nd Value:
Value Percent:
Continuous Index:
Within 8" of Joint: **NO**
Remarks: **debris**
