## Profile/Photo Observation Report

Date:	<b>03/29/2018</b>	Weather:		Coding:	<b>PACP 6.0</b>
Pipe Length (ft):	<b>351.2</b>	Owner:	<b>NA</b>	Pre Clean:	<b>Not Known</b>
P.O.#:		Surveyor:	<b>Jen Costello</b>	PSR:	<b>P-708-006-007</b>
Customer:		Clean Date:	<b>01/01/1900</b>	Shape:	<b>C</b>

Street:	<b>STATE ST</b>	Flow Control:	<b>Not Controlled</b>
City:	<b>Hobart, IN</b>	Year Renewed:	
Location:	<b>Sidewalk</b>	Tape/Media #:	
Purpose:	<b>Maintenance Related</b>	Dia/Height:	<b>12"</b>
Use:	<b>Sanitary</b>	Material:	<b>PVC</b>
Drain Area:	<b>NA</b>	Lining:	<b>Cured in Place</b>
Category:	<b>NA</b>		
Comment:	<b>Redeployment. Flow direction wrong. Underwater at 329'.</b>		
Location Details:		Direction of Survey:	<b>Downstream</b>
US MH:	<b>M-708-007</b>	DS MH:	<b>M-708-006</b>
		Total Length Surveyed (ft):	<b>331.4</b>

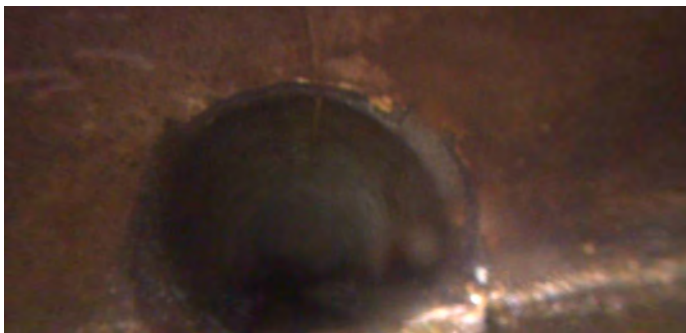
Code: **AMH**  
Description: **Manhole**

Distance (ft): **.0**  
Structural Grade: **0**  
O&M Grade: **0**  
Clock Start/From:  
Clock To:  
1st Value:  
2nd Value:  
Value Percent:  
Continuous Index:  
Within 8" of Joint: **NO**  
Remarks: **M-708-007**

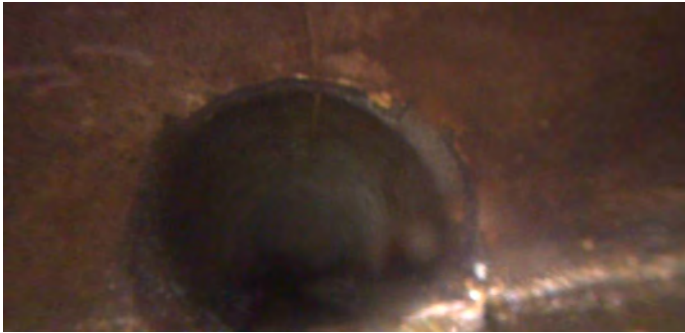
Code:	<b>MWL</b>
Description:	<b>Water Level</b>

Distance (ft):	<b>.0</b>
Structural Grade:	<b>0</b>
O&M Grade:	<b>0</b>
Clock Start/From:	
Clock To:	
1st Value:	
2nd Value:	
Value Percent:	<b>5.000</b>
Continuous Index:	
Within 8" of Joint:	<b>NO</b>
Remarks:

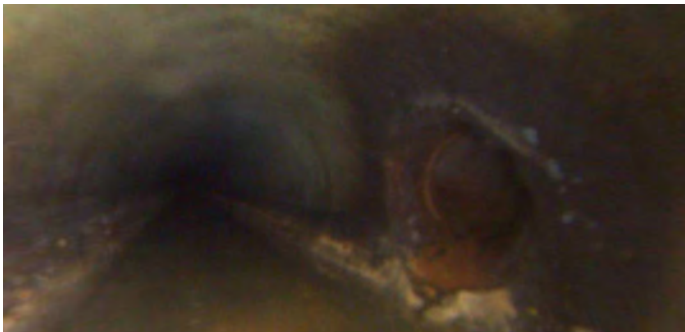
Code:	<b>TF</b>
Description:	<b>Tap Factory</b>

Distance (ft):	<b>7.0</b>
Structural Grade:	<b>0</b>
O&M Grade:	<b>0</b>
Clock Start/From:	<b>3</b>
Clock To:	
1st Value:	<b>4.000</b>
2nd Value:	
Value Percent:	
Continuous Index:	
Within 8" of Joint:	
Remarks:

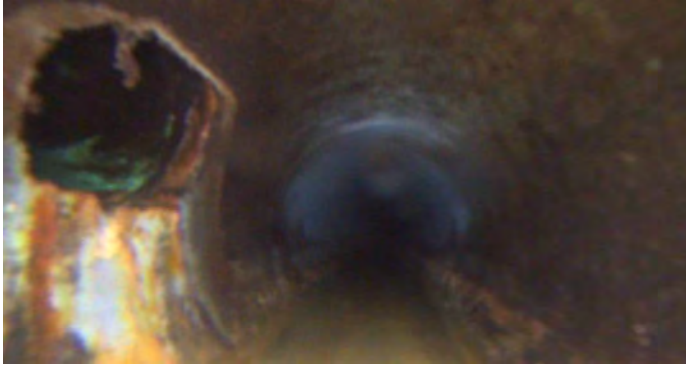
Code: **TF**  
Description: **Tap Factory**

Distance (ft): **30.6**  
Structural Grade: **0**  
O&M Grade: **0**  
Clock Start/From: **9**  
Clock To:  
1st Value: **4.000**  
2nd Value:  
Value Percent:  
Continuous Index:  
Within 8" of Joint:  
Remarks:

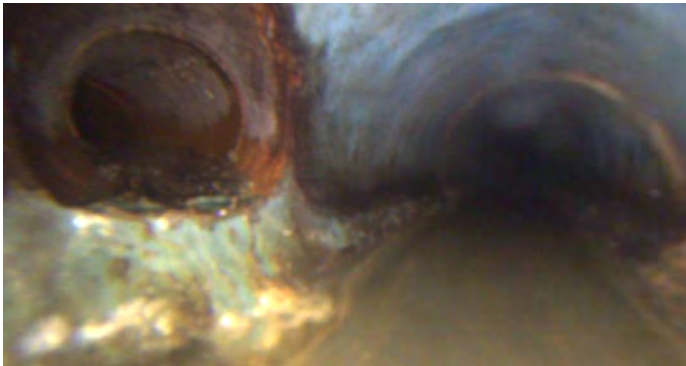
Code: **TF**  
Description: **Tap Factory**

Distance (ft): **56.9**  
Structural Grade: **0**  
O&M Grade: **0**  
Clock Start/From: **9**  
Clock To:  
1st Value: **4.000**  
2nd Value:  
Value Percent:  
Continuous Index:  
Within 8" of Joint:  
Remarks:

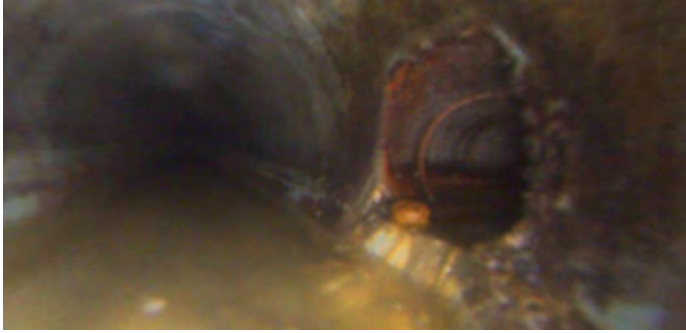
Code: **TF**  
Description: **Tap Factory**

Distance (ft): **64.9**  
Structural Grade: **0**  
O&M Grade: **0**  
Clock Start/From: **3**  
Clock To:  
1st Value: **4.000**  
2nd Value:  
Value Percent:  
Continuous Index:  
Within 8" of Joint:  
Remarks:

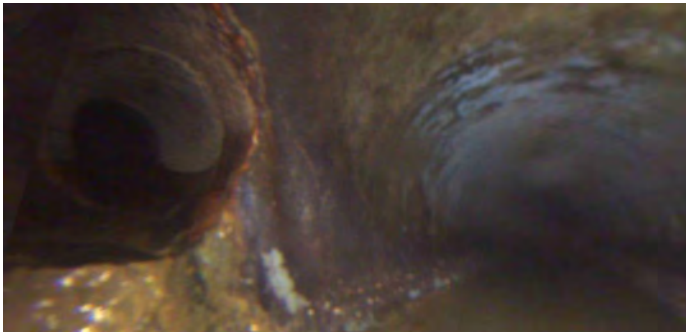
Code: **TFA**  
Description: **Tap Factory Active**

Distance (ft): **121.6**  
Structural Grade: **0**  
O&M Grade: **0**  
Clock Start/From: **9**  
Clock To:  
1st Value: **4.000**  
2nd Value:  
Value Percent:  
Continuous Index:  
Within 8" of Joint:  
Remarks:

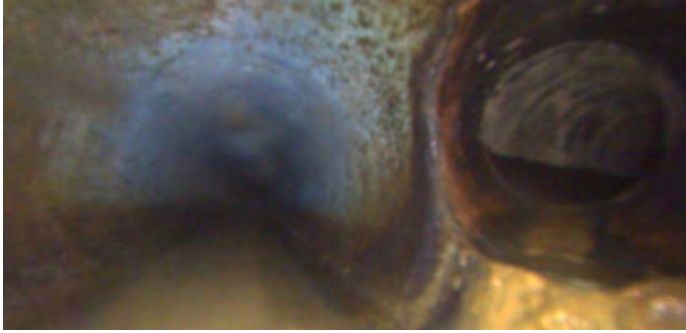
Code: **TF**  
Description: **Tap Factory**

Distance (ft): **129.4**  
Structural Grade: **0**  
O&M Grade: **0**  
Clock Start/From: **3**  
Clock To:  
1st Value: **4.000**  
2nd Value:  
Value Percent:  
Continuous Index:  
Within 8" of Joint:  
Remarks:

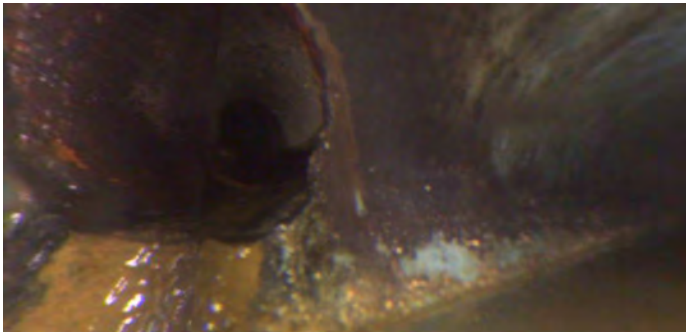
Code: **TFA**  
Description: **Tap Factory Active**

Distance (ft): **185.8**  
Structural Grade: **0**  
O&M Grade: **0**  
Clock Start/From: **9**  
Clock To:  
1st Value: **4.000**  
2nd Value:  
Value Percent:  
Continuous Index:  
Within 8" of Joint:  
Remarks:

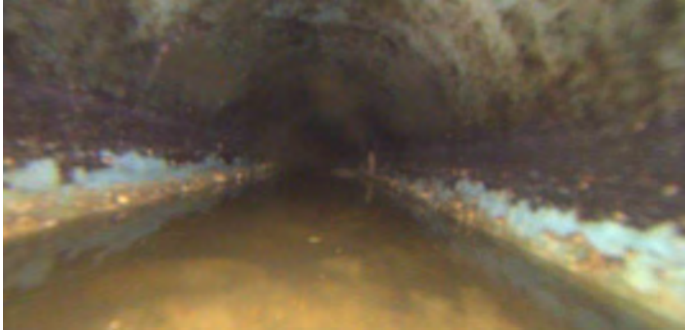
Code: **MWL**  
Description: **Water Level**

Distance (ft): **196.6**  
Structural Grade: **0**  
O&M Grade: **0**  
Clock Start/From:  
Clock To:  
1st Value:  
2nd Value:  
Value Percent: **20.000**  
Continuous Index:  
Within 8" of Joint: **NO**  
Remarks:

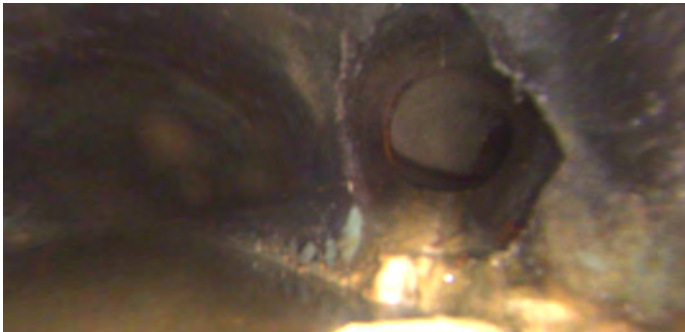
Code: **TFA**  
Description: **Tap Factory Active**

Distance (ft): **199.5**  
Structural Grade: **0**  
O&M Grade: **0**  
Clock Start/From: **3**  
Clock To:  
1st Value: **4.000**  
2nd Value:  
Value Percent:  
Continuous Index:  
Within 8" of Joint:  
Remarks:

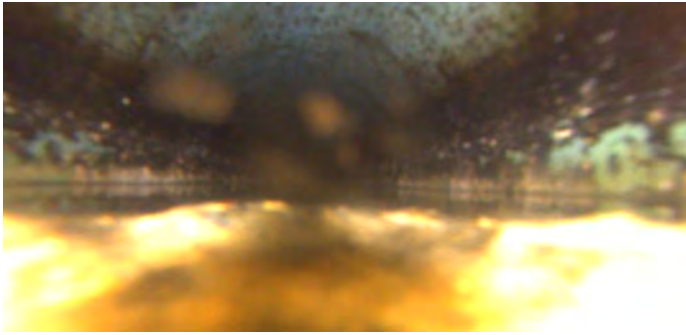
Code: **MWL**  
Description: **Water Level**

Distance (ft): **224.3**  
Structural Grade: **0**  
O&M Grade: **0**  
Clock Start/From:  
Clock To:  
1st Value:  
2nd Value:  
Value Percent: **40.000**  
Continuous Index:  
Within 8" of Joint: **NO**  
Remarks:

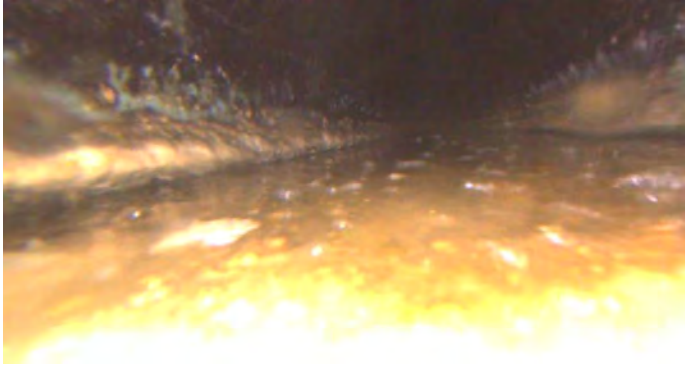
Code: **MCU**  
Description: **Camera Underwater**

Distance (ft): **268.0**  
Structural Grade: **0**  
O&M Grade: **4**  
Clock Start/From:  
Clock To:  
1st Value:  
2nd Value:  
Value Percent:  
Continuous Index: **F01**  
Within 8" of Joint: **NO**  
Remarks:

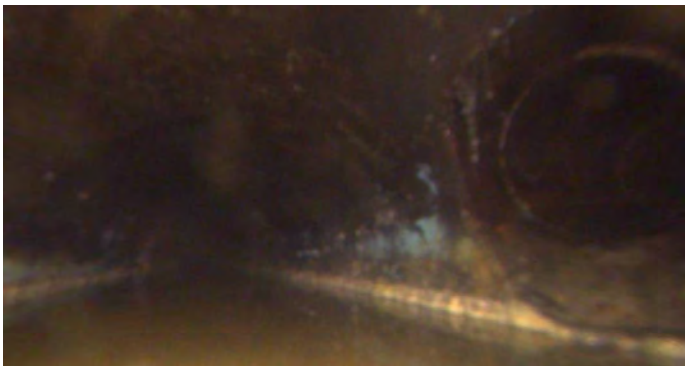
Code: **TF**  
Description: **Tap Factory**

Distance (ft): **270.1**  
Structural Grade: **0**  
O&M Grade: **0**  
Clock Start/From: **4**  
Clock To:  
1st Value: **4.000**  
2nd Value:  
Value Percent:  
Continuous Index:  
Within 8" of Joint:  
Remarks:

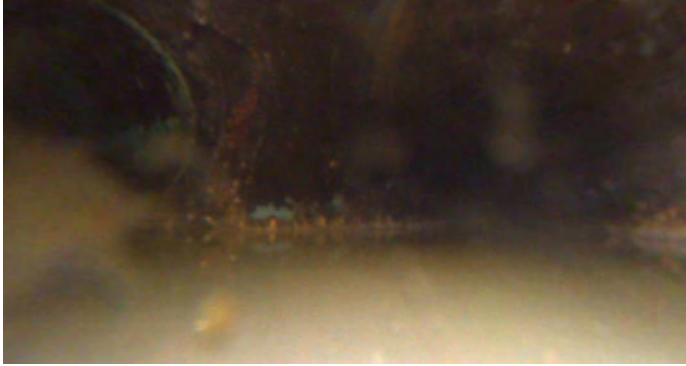
Code: **TF**  
Description: **Tap Factory**

Distance (ft): **272.8**  
Structural Grade: **0**  
O&M Grade: **0**  
Clock Start/From: **8**  
Clock To:  
1st Value: **4.000**  
2nd Value:  
Value Percent:  
Continuous Index:  
Within 8" of Joint:  
Remarks:
