Profile/Photo Observation Report

Date:	03/29/2018	Weather:		Coding:	PACP 6.0
Pipe Length (ft):	351.2	Owner:	NA	Pre Clean:	Not Known
P.O.#:		Surveyor:	Jen Costello	PSR:	P-708-006-007
Customer:		Clean Date:	01/01/1900	Shape:	C

Street:	STATE ST	Flow Control:	Not Controlled
City:	Hobart, IN	Year Renewed:	
Location:	Sidewalk	Tape/Media #:	
Purpose:	Maintenance Related	Dia/Height:	12"
Use:	Sanitary	Material:	PVC
Drain Area:	NA	Lining:	
Category:	NA		
Comment:	Underwater at 10'.

Location Details:		Direction of Survey:	Upstream
US MH:	M-708-007	DS MH:	M-708-006
		Total Length Surveyed (ft):	11.6

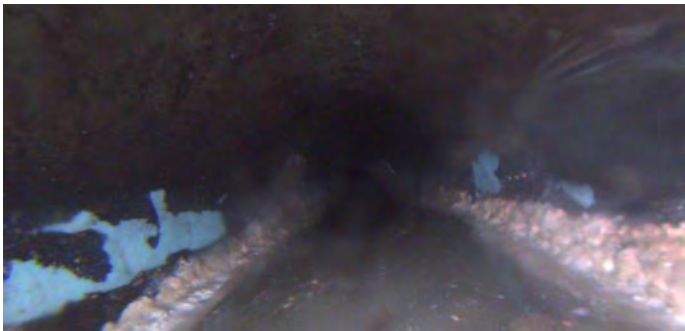
Code: **AMH**
Description: **Manhole**

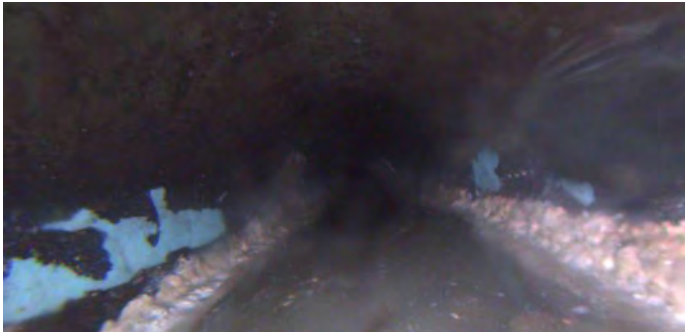
Code:	MWL
Description:	Water Level

Distance (ft):	.0
Structural Grade:	0
O&M Grade:	0
Clock Start/From:	
Clock To:	
1st Value:	
2nd Value:	
Value Percent:	10.000
Continuous Index:	
Within 8" of Joint:	NO
Remarks:

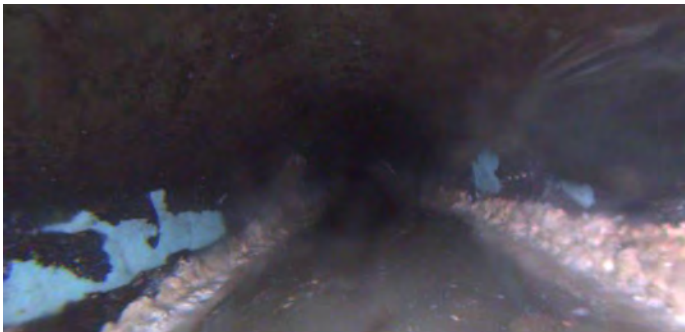
Code:	DAGS
Description:	Deposits Attached Grease

Distance (ft):	.0
Structural Grade:	0
O&M Grade:	2
Clock Start/From:	8
Clock To:	4
1st Value:	
2nd Value:	
Value Percent:	5.000
Continuous Index:	S01
Within 8" of Joint:	NO
Remarks:
