Profile/Photo Observation Report

Date:	03/29/2018	Weather:		Coding:	PACP 6.0
Pipe Length (ft):	351.2	Owner:	NA	Pre Clean:	Not Known
P.O.#:		Surveyor:	Jen Costello	PSR:	P-708-006-007
Customer:		Clean Date:	01/01/1900	Shape:	C

Street:	State	Flow Control:	Not Controlled
City:	Hobart, IN	Year Renewed:	
Location:	Sidewalk	Tape/Media #:	
Purpose:	Maintenance Related	Dia/Height:	12"
Use:	Sanitary	Material:	PVC
Drain Area:	NA	Lining:	
Category:	NA		
Comment:	Underwater at 10'.

Location Details:		Direction of Survey:	Upstream
US MH:	M-708-007	DS MH:	M-708-006
		Total Length Surveyed (ft):	11.6

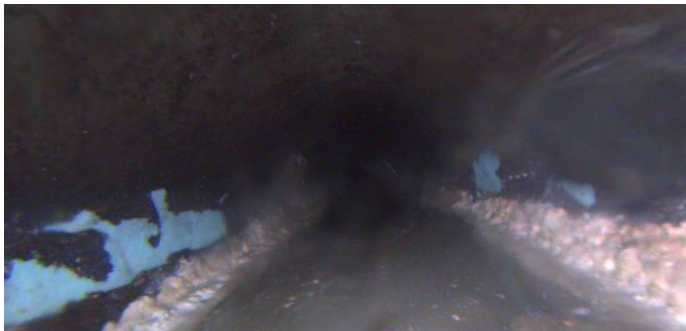
Code: **AMH**
Description: **Manhole**

Distance (ft): **.0**
Structural Grade: **0**
O&M Grade: **0**
Clock Start/From:
Clock To:
1st Value:
2nd Value:
Value Percent:
Continuous Index:
Within 8" of Joint: **NO**
Remarks: **M-708-006**

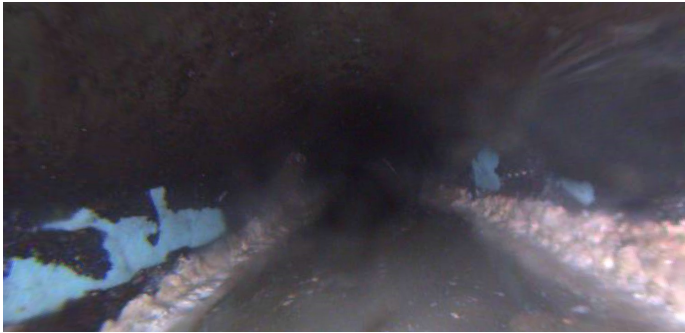
Code:	MWL
Description:	Water Level

Distance (ft):	.0
Structural Grade:	0
O&M Grade:	0
Clock Start/From:	
Clock To:	
1st Value:	
2nd Value:	
Value Percent:	10.000
Continuous Index:	
Within 8" of Joint:	NO
Remarks:

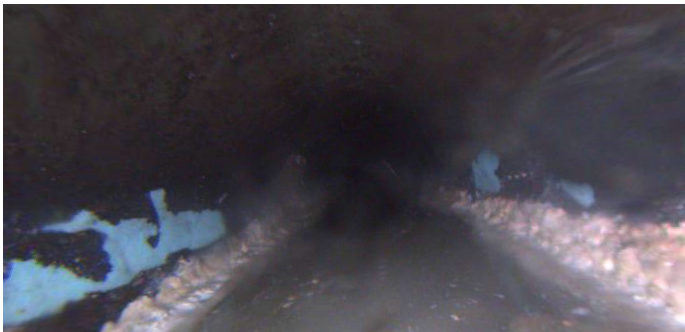
Code:	DAGS
Description:	Deposits Attached Grease

Distance (ft):	.0
Structural Grade:	0
O&M Grade:	2
Clock Start/From:	8
Clock To:	4
1st Value:	
2nd Value:	
Value Percent:	5.000
Continuous Index:	S01
Within 8" of Joint:	NO
Remarks:

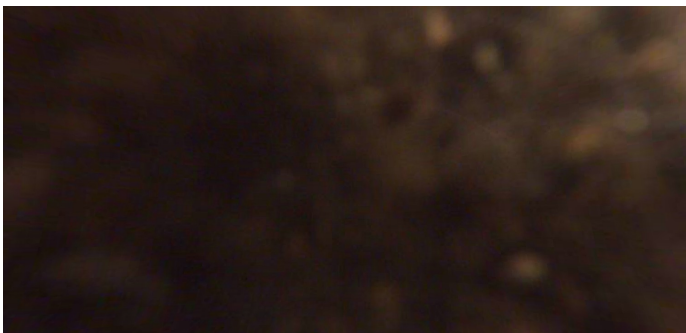
Code: **MSA**
Description: **Abandoned Survey**

Distance (ft): **11.6**
Structural Grade: **0**
O&M Grade: **0**
Clock Start/From:
Clock To:
1st Value:
2nd Value:
Value Percent:
Continuous Index:
Within 8" of Joint: **NO**
Remarks: **MCU**
