Profile/Photo Observation Report

Date:	03/29/2018	Weather:		Coding:	PACP 6.0
Pipe Length (ft):	351.2	Owner:	NA	Pre Clean:	Not Known
P.O.#:		Surveyor:	Jen Costello	PSR:	P-708-006-007
Customer:		Clean Date:	01/01/1900	Shape:	C

Street:	STATE ST	Flow Control:	Not Controlled
City:	Hobart, IN	Year Renewed:	
Location:	Sidewalk	Tape/Media #:	
Purpose:	Maintenance Related	Dia/Height:	12"
Use:	Sanitary	Material:	PVC
Drain Area:	NA	Lining:	Cured in Place
Category:	NA		
Comment:	Robot issue.

Location Details:		Direction of Survey:	Downstream
US MH:	M-708-007	DS MH:	M-708-006
		Total Length Surveyed (ft):	4.2

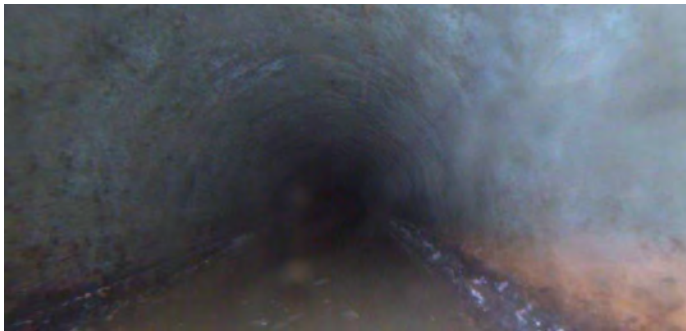
Code: **AMH**
Description: **Manhole**

Distance (ft): **.0**
Structural Grade: **0**
O&M Grade: **0**
Clock Start/From:
Clock To:
1st Value:
2nd Value:
Value Percent:
Continuous Index:
Within 8" of Joint: **NO**
Remarks: **M-708-007**

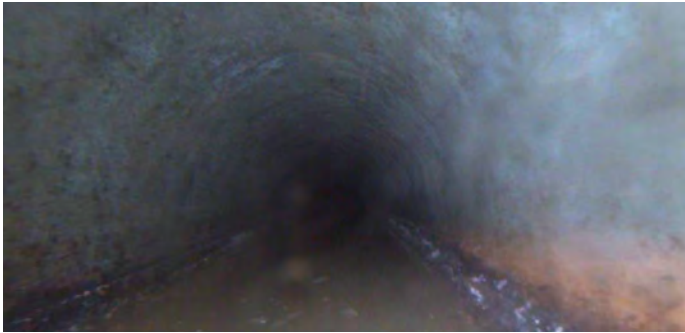
Code:	MWL
Description:	Water Level

Distance (ft):	.0
Structural Grade:	0
O&M Grade:	0
Clock Start/From:	
Clock To:	
1st Value:	
2nd Value:	
Value Percent:	10.000
Continuous Index:	
Within 8" of Joint:	NO
Remarks:

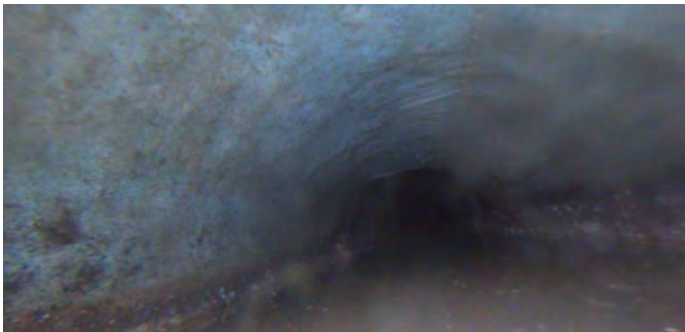
Code:	MSA
Description:	Abandoned Survey

Distance (ft):	4.2
Structural Grade:	0
O&M Grade:	0
Clock Start/From:	
Clock To:	
1st Value:	
2nd Value:	
Value Percent:	
Continuous Index:	
Within 8" of Joint:	NO
Remarks:	DEBRIS UNDER WATER
