Profile/Photo Observation Report

Date:	03/29/2018	Weather:		Coding:	PACP 6.0
Pipe Length (ft):	351.2	Owner:	NA	Pre Clean:	Not Known
P.O.#:		Surveyor:	Jen Costello	PSR:	P-708-006-007
Customer:		Clean Date:	01/01/1900	Shape:	C

Street:	State	Flow Control:	Not Controlled
City:	Hobart, IN	Year Renewed:	
Location:	Sidewalk	Tape/Media #:	
Purpose:	Maintenance Related	Dia/Height:	12"
Use:	Sanitary	Material:	PVC
Drain Area:	NA	Lining:	Cured in Place
Category:	NA		
Comment:	Robot issue.

Location Details:		Direction of Survey:	Downstream
US MH:	M-708-007	DS MH:	M-708-006
		Total Length Surveyed (ft):	4.2

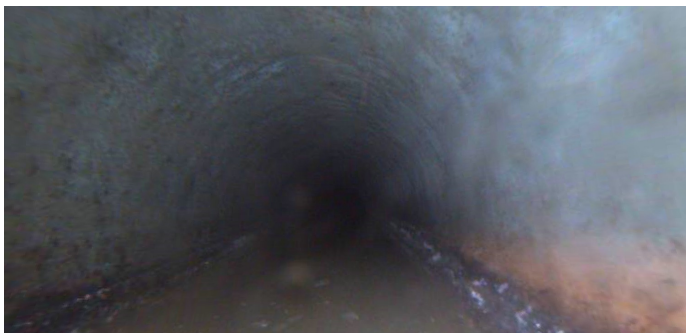
Code: **AMH**
Description: **Manhole**

Distance (ft): **.0**
Structural Grade: **0**
O&M Grade: **0**
Clock Start/From:
Clock To:
1st Value:
2nd Value:
Value Percent:
Continuous Index:
Within 8" of Joint: **NO**
Remarks: **M-708-007**

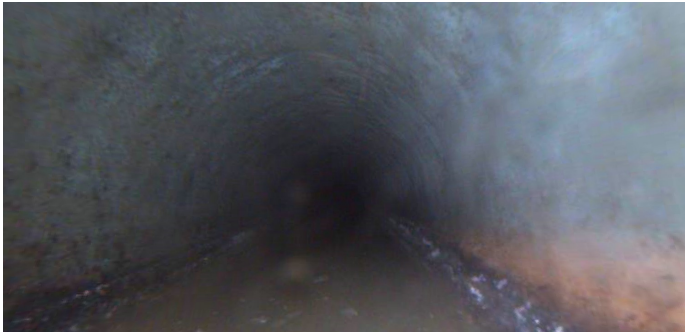
Code:	MWL
Description:	Water Level

Distance (ft):	.0
Structural Grade:	0
O&M Grade:	0
Clock Start/From:	
Clock To:	
1st Value:	
2nd Value:	
Value Percent:	10.000
Continuous Index:	
Within 8" of Joint:	NO
Remarks:

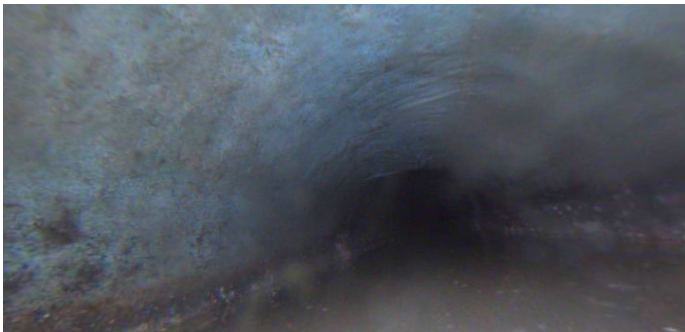
Code:	MSA
Description:	Abandoned Survey

Distance (ft):	4.2
Structural Grade:	0
O&M Grade:	0
Clock Start/From:	
Clock To:	
1st Value:	
2nd Value:	
Value Percent:	
Continuous Index:	
Within 8" of Joint:	NO
Remarks:	DEBRIS UNDER WATER
