## Profile/Photo Observation Report

Street:	<b>STATE ST</b>	Flow Control:	<b>Not Controlled</b>
City:	<b>Hobart, IN</b>	Year Renewed:	
Location:	<b>Sidewalk</b>	Tape/Media #:	
Purpose:	<b>Maintenance Related</b>	Dia/Height:	<b>8"</b>
Use:	<b>Sanitary</b>	Material:	<b>VCP</b>
Drain Area:	<b>NA</b>	Lining:	<b>Cured in Place</b>
Category:	<b>NA</b>		
Comment:	<b>Flow direction wrong. Reverse setup.</b>		
Location Details:		Direction of Survey:	<b>Downstream</b>
US MH:	<b>M-708-008</b>	DS MH:	<b>M-708-007</b>
		Total Length Surveyed (ft):	<b>1.8</b>

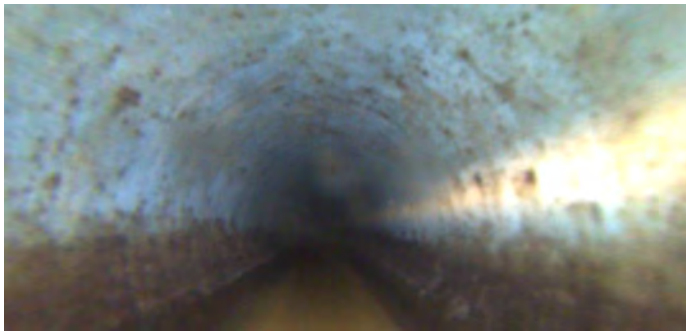
Code: **AMH**  
Description: **Manhole**

Distance (ft): **.0**  
Structural Grade: **0**  
O&M Grade: **0**  
Clock Start/From:  
Clock To:  
1st Value:  
2nd Value:  
Value Percent:  
Continuous Index:  
Within 8" of Joint: **NO**  
Remarks: **M-708-008**

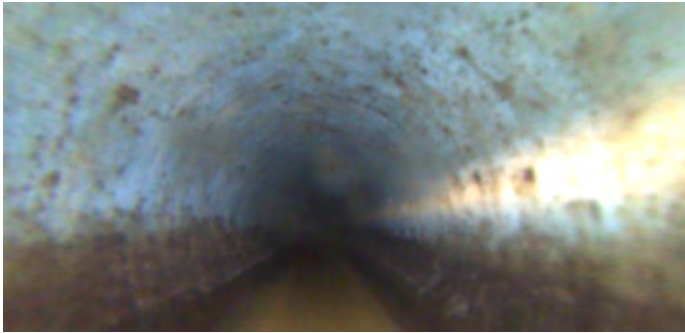
Code:	<b>MWL</b>
Description:	<b>Water Level</b>

Distance (ft):	<b>.0</b>
Structural Grade:	<b>0</b>
O&M Grade:	<b>0</b>
Clock Start/From:	
Clock To:	
1st Value:	
2nd Value:	
Value Percent:	<b>5.000</b>
Continuous Index:	
Within 8" of Joint:	<b>NO</b>
Remarks:

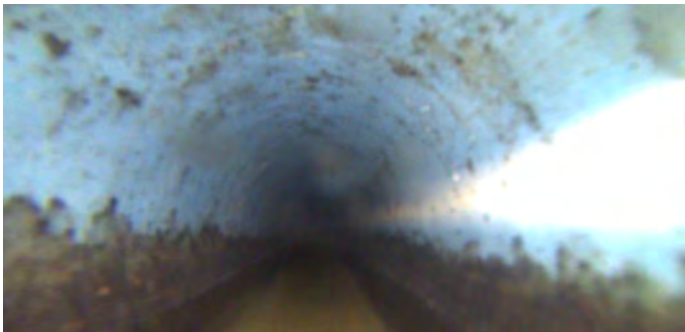
Code:	<b>MSA</b>
Description:	<b>Abandoned Survey</b>

Distance (ft):	<b>1.8</b>
Structural Grade:	<b>0</b>
O&M Grade:	<b>0</b>
Clock Start/From:	
Clock To:	
1st Value:	
2nd Value:	
Value Percent:	
Continuous Index:	
Within 8" of Joint:	<b>NO</b>
Remarks:	<b>UNKNOWN</b>
