Profile/Photo Observation Report

| Date: | 03/29/2018 | Weather: | | Coding: | PACP 6.0 |

| US MH: | M-708-008 | DS MH: | M-708-007 |

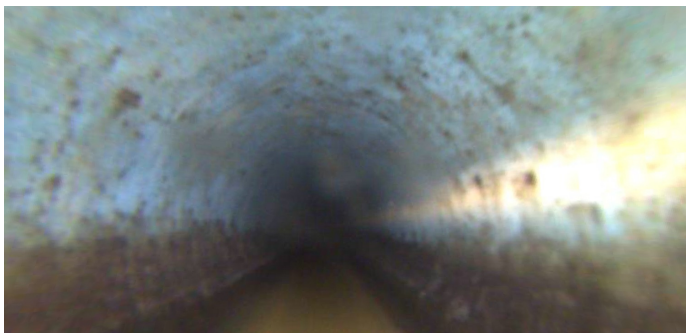
Code: **AMH**
Description: **Manhole**

Distance (ft): **.0**
Structural Grade: **0**
O&M Grade: **0**
Clock Start/From:
Clock To:
1st Value:
2nd Value:
Value Percent:
Continuous Index:
Within 8" of Joint: **NO**
Remarks: **M-708-008**

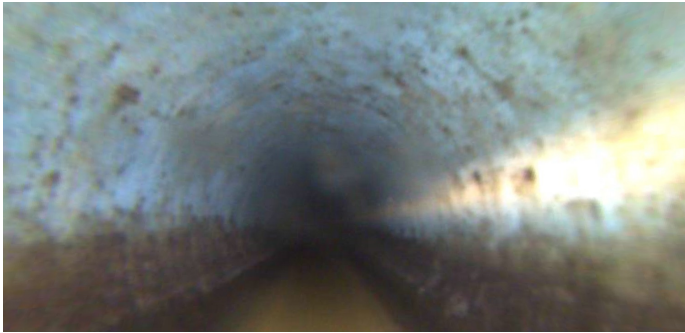
| Code: | MWL |
| Description: | Water Level |

| Value Percent: | 5.000 |

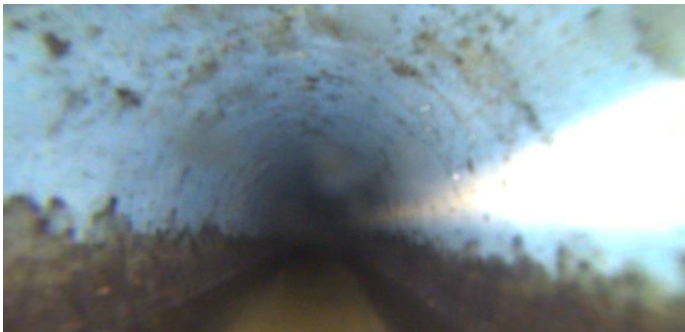
| Comment: | Flow direction wrong. Reverse setup. | | |

| Code: | MSA |
| Description: | Abandoned Survey |

| Distance (ft): | 1.8 |
