## Profile/Photo Observation Report

Date:	<b>03/29/2018</b>	Weather:		Coding:	<b>PACP 6.0</b>
Pipe Length (ft):	<b>321.7</b>	Owner:	<b>NA</b>	Pre Clean:	<b>Not Known</b>
P.O.#:		Surveyor:	<b>Jen Costello</b>	PSR:	<b>P-708-007-008</b>
Customer:		Clean Date:	<b>01/01/1900</b>	Shape:	<b>C</b>

Street:	<b>STATE ST</b>	Flow Control:	<b>Not Controlled</b>
City:	<b>Hobart, IN</b>	Year Renewed:	
Location:	<b>Sidewalk</b>	Tape/Media #:	
Purpose:	<b>Maintenance Related</b>	Dia/Height:	<b>8"</b>
Use:	<b>Sanitary</b>	Material:	<b>VCP</b>
Drain Area:	<b>NA</b>	Lining:	<b>Cured in Place</b>
Category:	<b>NA</b>		
Comment:	<b>Flow direction wrong. Reverse setup. Underwater at 195'.</b>		
Location Details:		Direction of Survey:	<b>Downstream</b>
US MH:	<b>M-708-008</b>	DS MH:	<b>M-708-007</b>
		Total Length Surveyed (ft):	<b>194.6</b>

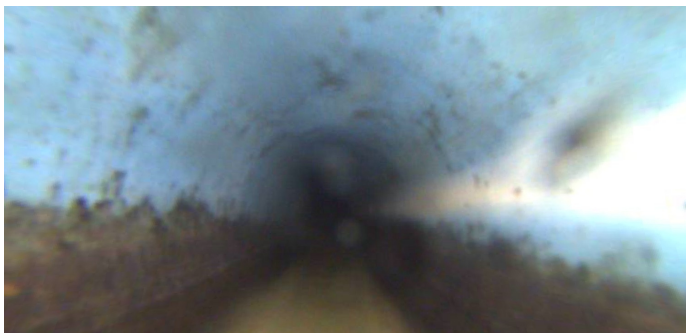
Code: **AMH**  
Description: **Manhole**

Distance (ft): **.0**  
Structural Grade: **0**  
O&M Grade: **0**  
Clock Start/From:  
Clock To:  
1st Value:  
2nd Value:  
Value Percent:  
Continuous Index:  
Within 8" of Joint: **NO**  
Remarks: **M-708-008**

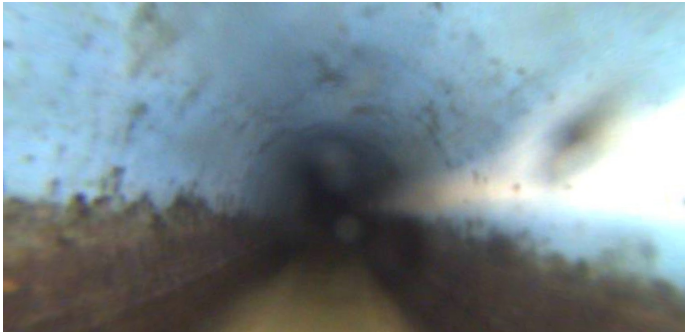
Code:	<b>MWL</b>
Description:	<b>Water Level</b>

Distance (ft):	<b>.0</b>
Structural Grade:	<b>0</b>
O&M Grade:	<b>0</b>
Clock Start/From:	
Clock To:	
1st Value:	
2nd Value:	
Value Percent:	<b>5.000</b>
Continuous Index:	
Within 8" of Joint:	<b>NO</b>
Remarks:

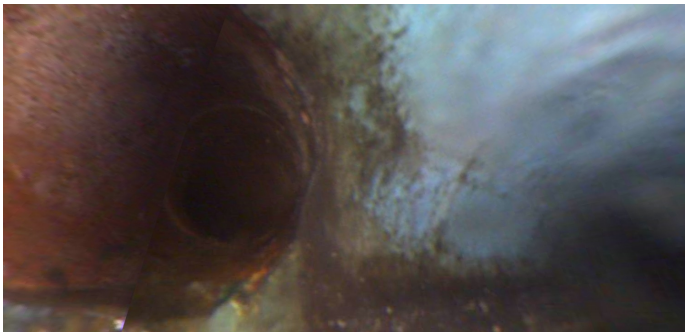
Code:	<b>TB</b>
Description:	<b>Tap Break-in</b>

Distance (ft):	<b>48.6</b>
Structural Grade:	<b>0</b>
O&M Grade:	<b>0</b>
Clock Start/From:	<b>9</b>
Clock To:	
1st Value:	<b>4.000</b>
2nd Value:	
Value Percent:	
Continuous Index:	
Within 8" of Joint:	
Remarks:

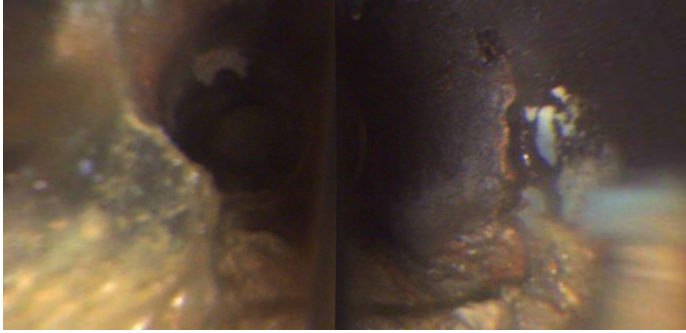
Code: **TBA**  
Description: **Tap Break-in Active**

Distance (ft): **56.8**  
Structural Grade: **0**  
O&M Grade: **0**  
Clock Start/From: **3**  
Clock To:  
1st Value: **4.000**  
2nd Value:  
Value Percent:  
Continuous Index:  
Within 8" of Joint:  
Remarks:

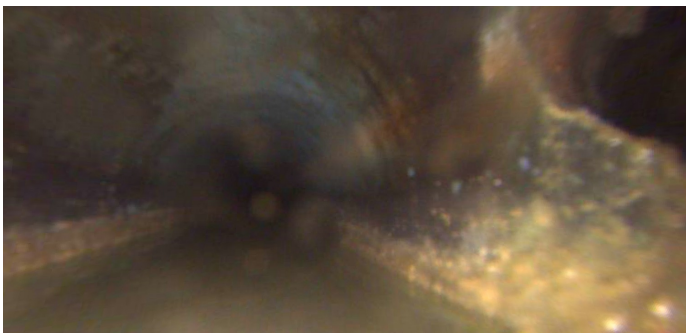
Code: **DAGS**  
Description: **Deposits Attached Grease**

Distance (ft): **56.8**  
Structural Grade: **0**  
O&M Grade: **2**  
Clock Start/From: **8**  
Clock To: **4**  
1st Value:  
2nd Value:  
Value Percent: **5.000**  
Continuous Index: **S01**  
Within 8" of Joint: **NO**  
Remarks:

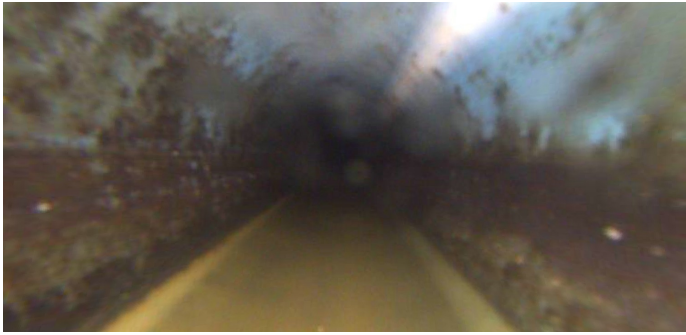
Code: **MWL**  
Description: **Water Level**

Distance (ft): **101.6**  
Structural Grade: **0**  
O&M Grade: **0**  
Clock Start/From:  
Clock To:  
1st Value:  
2nd Value:  
Value Percent: **5.000**  
Continuous Index:  
Within 8" of Joint: **NO**  
Remarks:

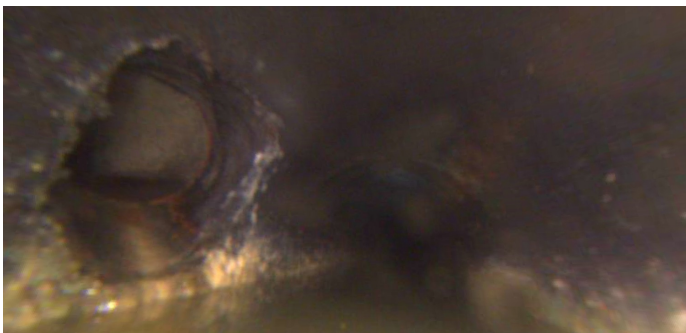
Code: **TBA**  
Description: **Tap Break-in Active**

Distance (ft): **106.5**  
Structural Grade: **0**  
O&M Grade: **0**  
Clock Start/From: **9**  
Clock To:  
1st Value: **4.000**  
2nd Value:  
Value Percent:  
Continuous Index:  
Within 8" of Joint:  
Remarks:

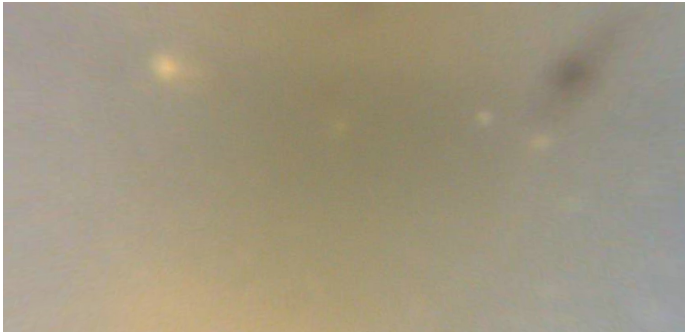
Code: **MWL**  
Description: **Water Level**

Distance (ft): **116.6**  
Structural Grade: **0**  
O&M Grade: **0**  
Clock Start/From:  
Clock To:  
1st Value:  
2nd Value:  
Value Percent: **100.000**  
Continuous Index:  
Within 8" of Joint: **NO**  
Remarks:

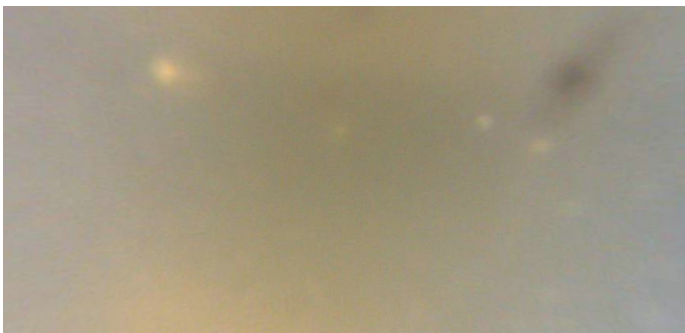
Code: **DAGS**  
Description: **Deposits Attached Grease**

Distance (ft): **116.6**  
Structural Grade: **0**  
O&M Grade: **2**  
Clock Start/From: **8**  
Clock To: **4**  
1st Value:  
2nd Value:  
Value Percent: **5.000**  
Continuous Index: **F01**  
Within 8" of Joint: **NO**  
Remarks:

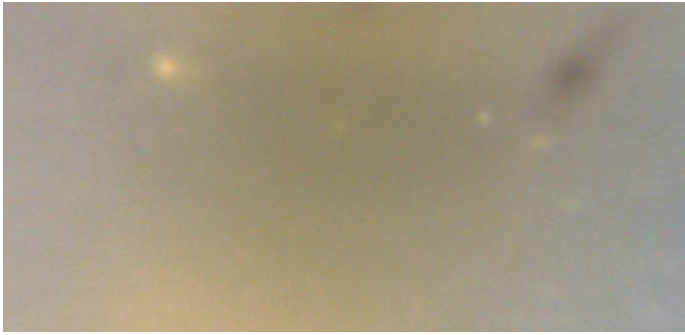
Code: **MCU**  
Description: **Camera Underwater**

Distance (ft): **116.6**  
Structural Grade: **0**  
O&M Grade: **4**  
Clock Start/From:  
Clock To:  
1st Value:  
2nd Value:  
Value Percent:  
Continuous Index: **S02**  
Within 8" of Joint: **NO**  
Remarks:
