## Profile/Photo Observation Report

Date:	<b>03/29/2018</b>	Weather:		Coding:	<b>PACP 6.0</b>
Pipe Length (ft):	<b>321.7</b>	Owner:	<b>NA</b>	Pre Clean:	<b>Not Known</b>
P.O.#:		Surveyor:	<b>Jen Costello</b>	PSR:	<b>P-708-007-008</b>
Customer:		Clean Date:	<b>01/01/1900</b>	Shape:	<b>C</b>

Street:	<b>State</b>	Flow Control:	<b>Not Controlled</b>
City:	<b>Hobart, IN</b>	Year Renewed:	
Location:	<b>Sidewalk</b>	Tape/Media #:	
Purpose:	<b>Maintenance Related</b>	Dia/Height:	<b>8"</b>
Use:	<b>Sanitary</b>	Material:	<b>VCP</b>
Drain Area:	<b>NA</b>	Lining:	<b>Cured in Place</b>
Category:	<b>NA</b>		
Comment:	<b>Flow direction wrong. Reverse setup. Underwater at 195'.</b>		
Location Details:		Direction of Survey:	<b>Downstream</b>
US MH:	<b>M-708-008</b>	DS MH:	<b>M-708-007</b>
		Total Length Surveyed (ft):	<b>194.6</b>

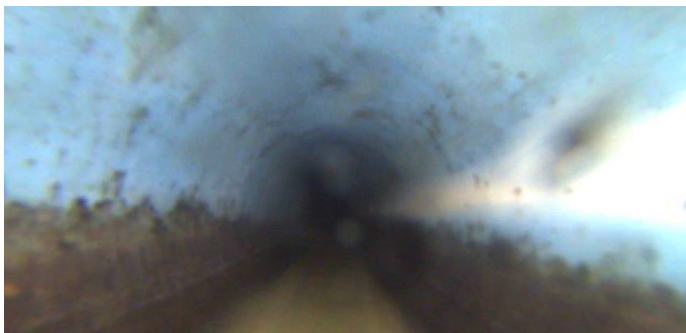
Code: **AMH**  
Description: **Manhole**

Distance (ft): **.0**  
Structural Grade: **0**  
O&M Grade: **0**  
Clock Start/From:  
Clock To:  
1st Value:  
2nd Value:  
Value Percent:  
Continuous Index:  
Within 8" of Joint: **NO**  
Remarks: **M-708-008**

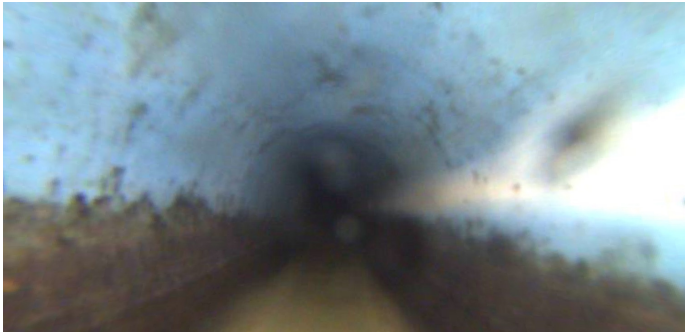
Code:	<b>MWL</b>
Description:	<b>Water Level</b>

Distance (ft):	<b>.0</b>
Structural Grade:	<b>0</b>
O&M Grade:	<b>0</b>
Clock Start/From:	
Clock To:	
1st Value:	
2nd Value:	
Value Percent:	<b>5.000</b>
Continuous Index:	
Within 8" of Joint:	<b>NO</b>
Remarks:

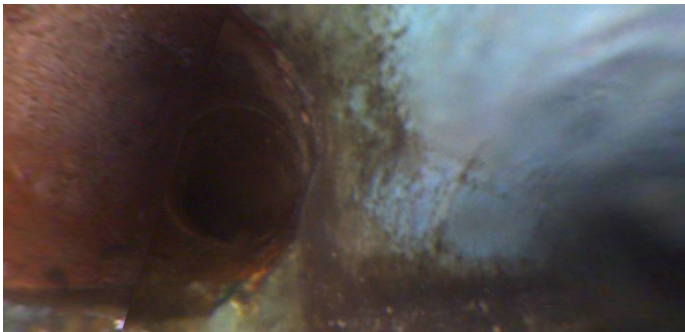
Code:	<b>TB</b>
Description:	<b>Tap Break-in</b>

Distance (ft):	<b>48.6</b>
Structural Grade:	<b>0</b>
O&M Grade:	<b>0</b>
Clock Start/From:	<b>9</b>
Clock To:	
1st Value:	<b>4.000</b>
2nd Value:	
Value Percent:	
Continuous Index:	
Within 8" of Joint:	
Remarks:

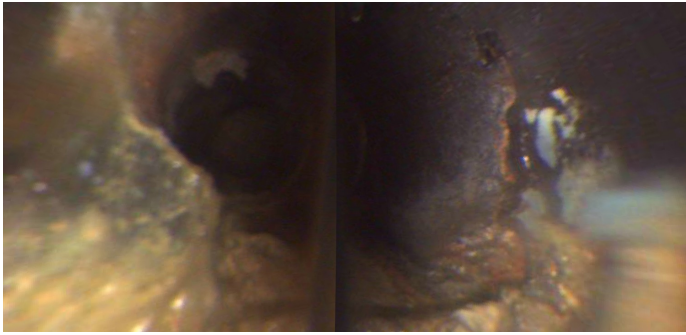
Code: **TBA**  
Description: **Tap Break-in Active**

Distance (ft): **56.8**  
Structural Grade: **0**  
O&M Grade: **0**  
Clock Start/From: **3**  
Clock To:  
1st Value: **4.000**  
2nd Value:  
Value Percent:  
Continuous Index:  
Within 8" of Joint:  
Remarks:

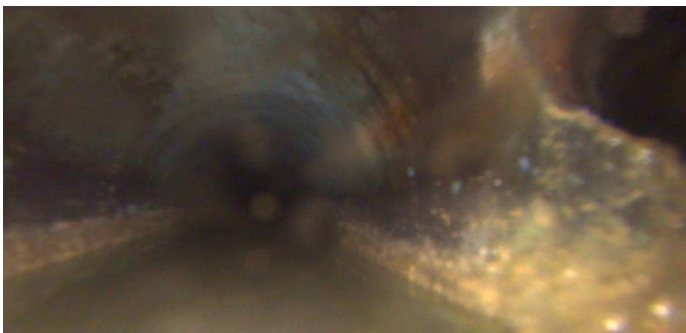
Code: **DAGS**  
Description: **Deposits Attached Grease**

Distance (ft): **56.8**  
Structural Grade: **0**  
O&M Grade: **2**  
Clock Start/From: **8**  
Clock To: **4**  
1st Value:  
2nd Value:  
Value Percent: **5.000**  
Continuous Index: **S01**  
Within 8" of Joint: **NO**  
Remarks:

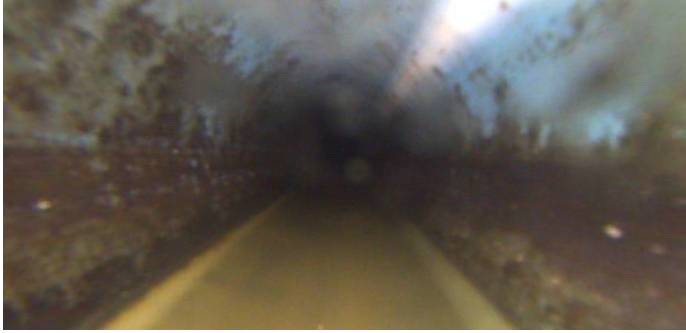
Code: **MWL**  
Description: **Water Level**

Distance (ft): **101.6**  
Structural Grade: **0**  
O&M Grade: **0**  
Clock Start/From:  
Clock To:  
1st Value:  
2nd Value:  
Value Percent: **5.000**  
Continuous Index:  
Within 8" of Joint: **NO**  
Remarks:

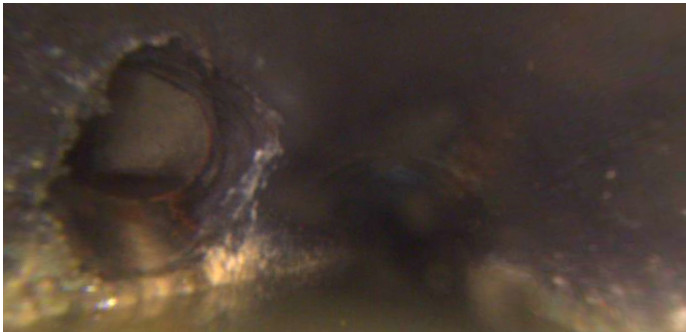
Code: **TBA**  
Description: **Tap Break-in Active**

Distance (ft): **106.5**  
Structural Grade: **0**  
O&M Grade: **0**  
Clock Start/From: **9**  
Clock To:  
1st Value: **4.000**  
2nd Value:  
Value Percent:  
Continuous Index:  
Within 8" of Joint:  
Remarks:

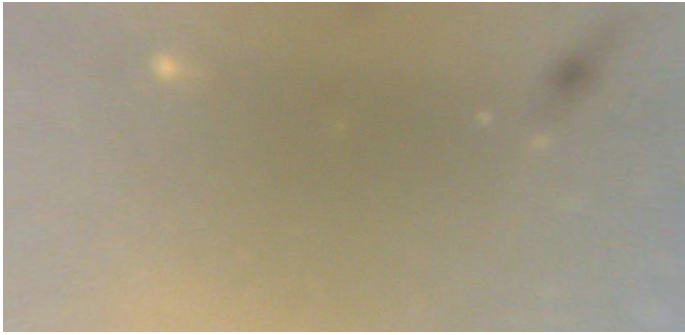
Code: **MWL**  
Description: **Water Level**

Distance (ft): **116.6**  
Structural Grade: **0**  
O&M Grade: **0**  
Clock Start/From:  
Clock To:  
1st Value:  
2nd Value:  
Value Percent: **100.000**  
Continuous Index:  
Within 8" of Joint: **NO**  
Remarks:

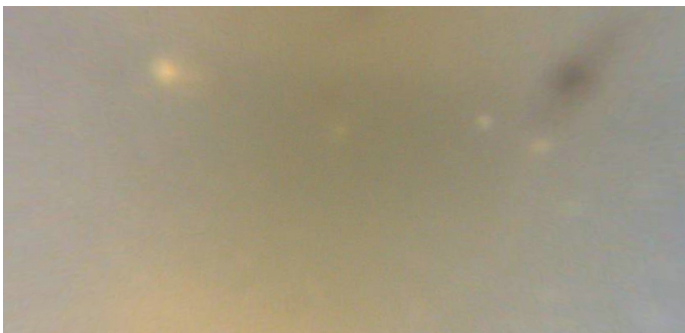
Code: **DAGS**  
Description: **Deposits Attached Grease**

Distance (ft): **116.6**  
Structural Grade: **0**  
O&M Grade: **2**  
Clock Start/From: **8**  
Clock To: **4**  
1st Value:  
2nd Value:  
Value Percent: **5.000**  
Continuous Index: **F01**  
Within 8" of Joint: **NO**  
Remarks:

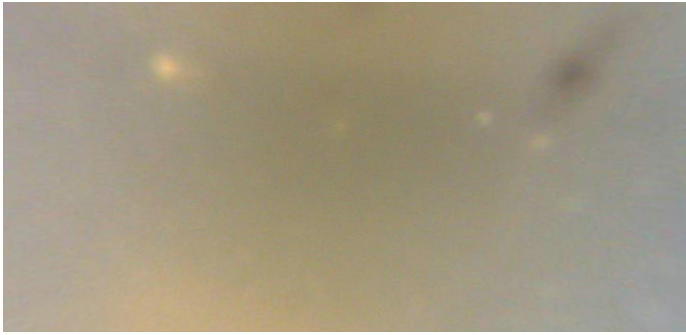
Code: **MCU**  
Description: **Camera Underwater**

Distance (ft): **116.6**  
Structural Grade: **0**  
O&M Grade: **4**  
Clock Start/From:  
Clock To:  
1st Value:  
2nd Value:  
Value Percent:  
Continuous Index: **S02**  
Within 8" of Joint: **NO**  
Remarks:
