Profile/Photo Observation Report

Date:	03/29/2018	Weather:		Coding:	PACP 6.0
Pipe Length (ft):	321.7	Owner:	NA	Pre Clean:	Not Known
P.O.#:		Surveyor:	Jen Costello	PSR:	P-708-007-008
Customer:		Clean Date:	01/01/1900	Shape:	C

Street:	State	Flow Control:	Not Controlled
City:	Hobart, IN	Year Renewed:	
Location:	Sidewalk	Tape/Media #:	
Purpose:	Maintenance Related	Dia/Height:	12"
Use:	Sanitary	Material:	PVC
Drain Area:	NA	Lining:	Cured in Place
Category:	NA		
Comment:	Flow direction wrong.

Location Details:		Direction of Survey:	Upstream
US MH:	M-708-008	DS MH:	M-708-007
		Total Length Surveyed (ft):	23.5

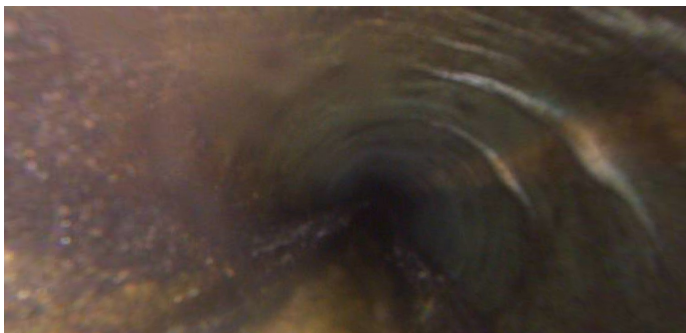
Code: **AMH**
Description: **Manhole**

Distance (ft): **.0**
Structural Grade: **0**
O&M Grade: **0**
Clock Start/From:
Clock To:
1st Value:
2nd Value:
Value Percent:
Continuous Index:
Within 8" of Joint: **NO**
Remarks: **M-708-007**

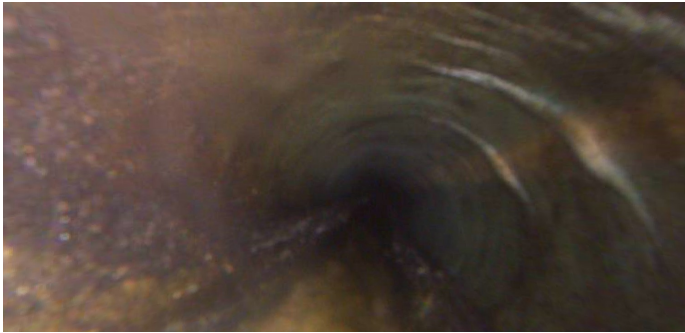
Code:	MWL
Description:	Water Level

Distance (ft):	.0
Structural Grade:	0
O&M Grade:	0
Clock Start/From:	
Clock To:	
1st Value:	
2nd Value:	
Value Percent:	5.000
Continuous Index:	
Within 8" of Joint:	NO
Remarks:

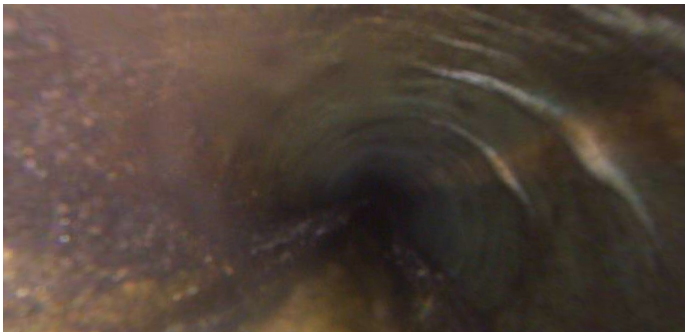
Code:	LFW
Description:	Lining Failure Wrinkled

Distance (ft):	.0
Structural Grade:	3
O&M Grade:	0
Clock Start/From:	12
Clock To:	4
1st Value:	
2nd Value:	
Value Percent:	
Continuous Index:	
Within 8" of Joint:	NO
Remarks:

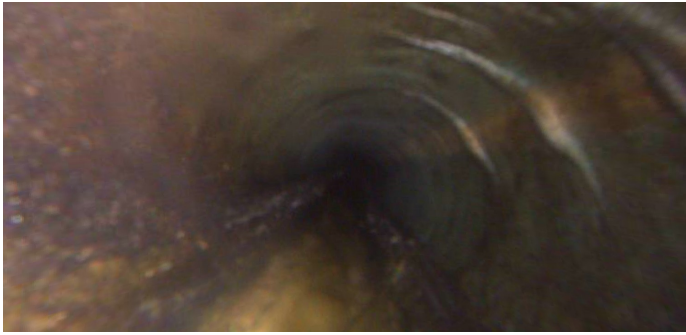
Code: **DAGS**
Description: **Deposits Attached Grease**

Distance (ft): **.0**
Structural Grade: **0**
O&M Grade: **2**
Clock Start/From: **8**
Clock To: **4**
1st Value:
2nd Value:
Value Percent: **5.000**
Continuous Index: **S01**
Within 8" of Joint: **NO**
Remarks:

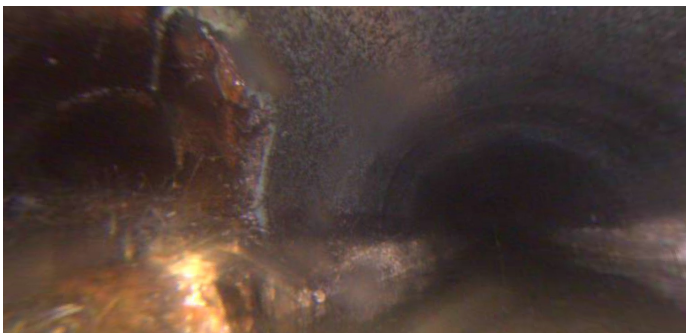
Code: **TBA**
Description: **Tap Break-in Active**

Distance (ft): **8.8**
Structural Grade: **0**
O&M Grade: **0**
Clock Start/From: **3**
Clock To:
1st Value: **4.000**
2nd Value:
Value Percent:
Continuous Index:
Within 8" of Joint:
Remarks:

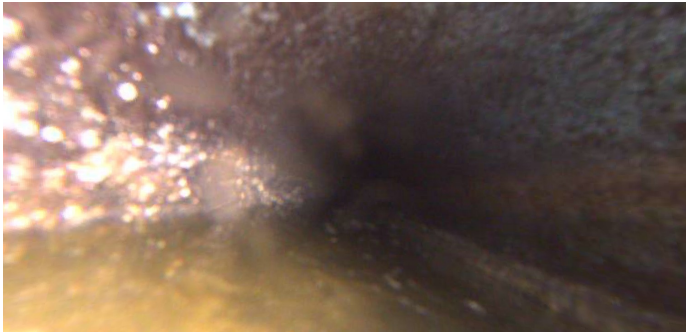
Code: **MSA**
Description: **Abandoned Survey**

Distance (ft): **23.5**
Structural Grade: **0**
O&M Grade: **0**
Clock Start/From:
Clock To:
1st Value:
2nd Value:
Value Percent:
Continuous Index:
Within 8" of Joint: **NO**
Remarks: **OVERTURNED**

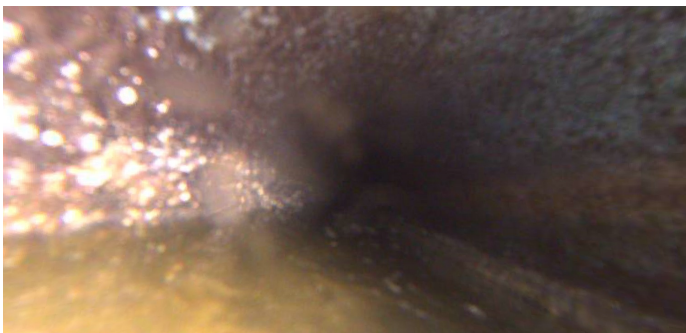
Code: **DAGS**
Description: **Deposits Attached Grease**

Distance (ft): **23.5**
Structural Grade: **0**
O&M Grade: **2**
Clock Start/From: **8**
Clock To: **4**
1st Value:
2nd Value:
Value Percent: **5.000**
Continuous Index: **F01**
Within 8" of Joint: **NO**
Remarks: **debris under water**
