Profile/Photo Observation Report

Date:	10/11/2018	Weather:		Coding:	PACP 6.0
Pipe Length (ft):	321.7	Owner:	NA	Pre Clean:	Not Known
P.O.#:		Surveyor:	Selasie Honu	PSR:	P-708-007-008
Customer:		Clean Date:	01/01/1900	Shape:	C

Street:	STATE ST	Flow Control:	Not Controlled
City:	Hobart, IN	Year Renewed:	
Location:	Light Highway	Tape/Media #:	
Purpose:	Routine Assessment	Dia/Height:	12"
Use:	Sanitary	Material:	PVC
Drain Area:	NA	Lining:	
Category:	NA		
Comment:

Location Details:		Direction of Survey:	Upstream
US MH:	M-708-008	DS MH:	M-708-007
		Total Length Surveyed (ft):	319.8

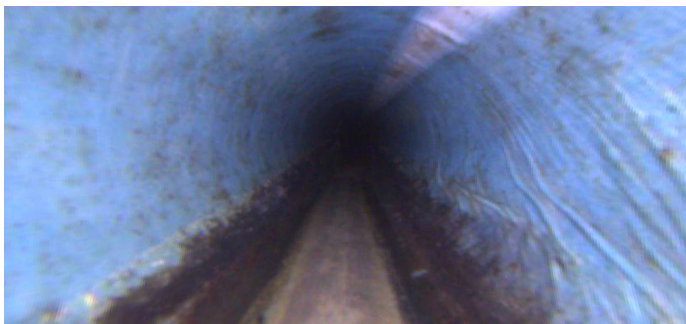
Code: **AMH**
Description: **Manhole**

Distance (ft): **.0**
Structural Grade: **0**
O&M Grade: **0**
Clock Start/From:
Clock To:
1st Value:
2nd Value:
Value Percent:
Continuous Index:
Within 8" of Joint: **NO**
Remarks: **M-708-007**

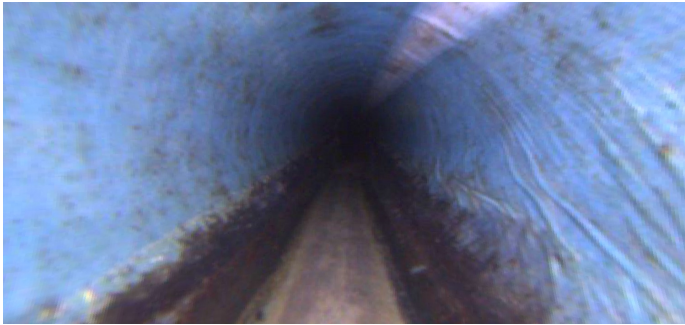
Code:	MWL
Description:	Water Level

Distance (ft):	.0
Structural Grade:	0
O&M Grade:	0
Clock Start/From:	
Clock To:	
1st Value:	
2nd Value:	
Value Percent:	5.000
Continuous Index:	
Within 8" of Joint:	NO
Remarks:

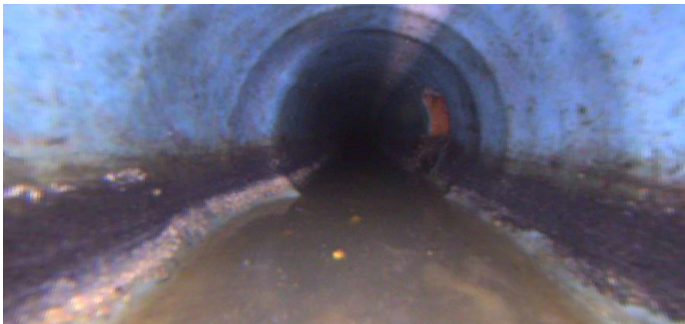
Code:	TFD
Description:	Tap Factory Defective

Distance (ft):	6.6
Structural Grade:	0
O&M Grade:	2
Clock Start/From:	3
Clock To:	
1st Value:	4.000
2nd Value:	
Value Percent:	
Continuous Index:	
Within 8" of Joint:	
Remarks:	root infiltration

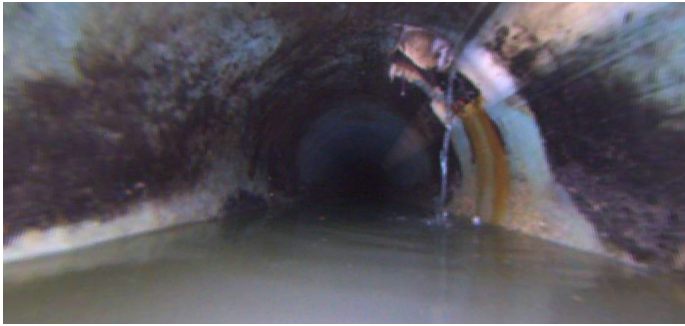
Code: **TFA**
Description: **Tap Factory Active**

Distance (ft): **26.7**
Structural Grade: **0**
O&M Grade: **0**
Clock Start/From: **1**
Clock To:
1st Value: **3.000**
2nd Value:
Value Percent:
Continuous Index:
Within 8" of Joint:
Remarks:

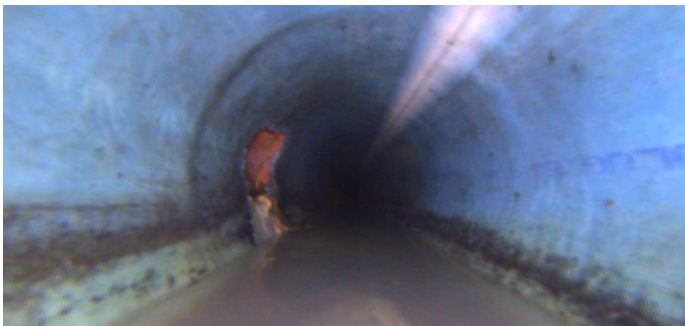
Code: **TF**
Description: **Tap Factory**

Distance (ft): **55.1**
Structural Grade: **0**
O&M Grade: **0**
Clock Start/From: **9**
Clock To:
1st Value: **4.000**
2nd Value:
Value Percent:
Continuous Index:
Within 8" of Joint:
Remarks:

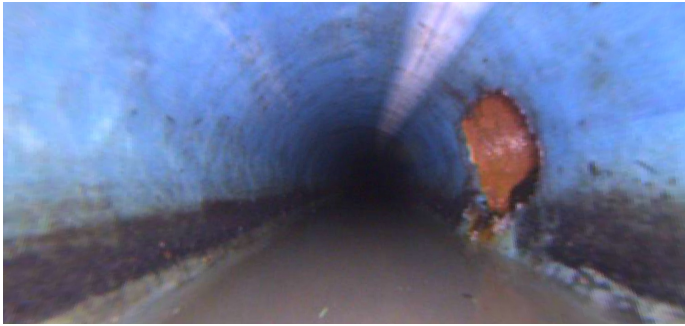
Code: **TF**
Description: **Tap Factory**

Distance (ft): **63.7**
Structural Grade: **0**
O&M Grade: **0**
Clock Start/From: **3**
Clock To:
1st Value: **4.000**
2nd Value:
Value Percent:
Continuous Index:
Within 8" of Joint:
Remarks:

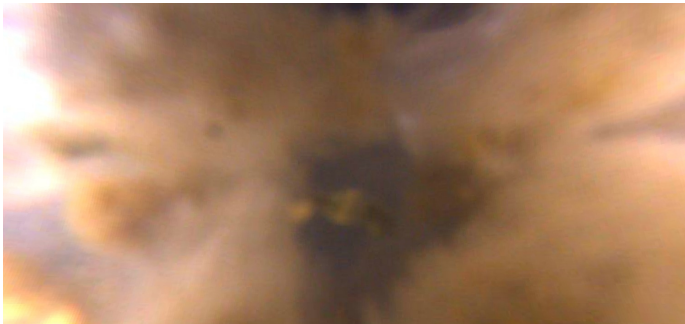
Code: **MWLS**
Description: **Water Level Sag**

Distance (ft): **88.2**
Structural Grade: **2**
O&M Grade: **3**
Clock Start/From:
Clock To:
1st Value:
2nd Value:
Value Percent: **10.000**
Continuous Index: **S01**
Within 8" of Joint: **NO**
Remarks:

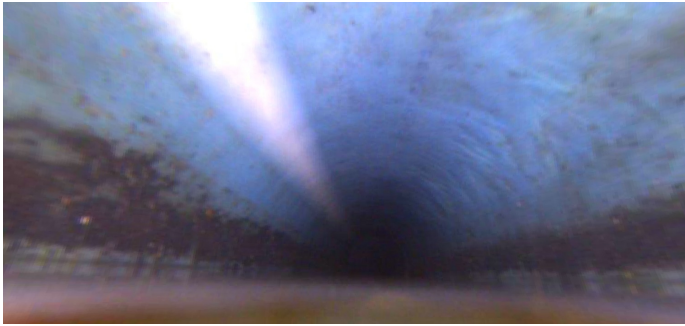
Code: **MWLS**
Description: **Water Level Sag**

Distance (ft): **203.3**
Structural Grade: **2**
O&M Grade: **3**
Clock Start/From:
Clock To:
1st Value:
2nd Value:
Value Percent: **10.000**
Continuous Index: **F01**
Within 8" of Joint: **NO**
Remarks:

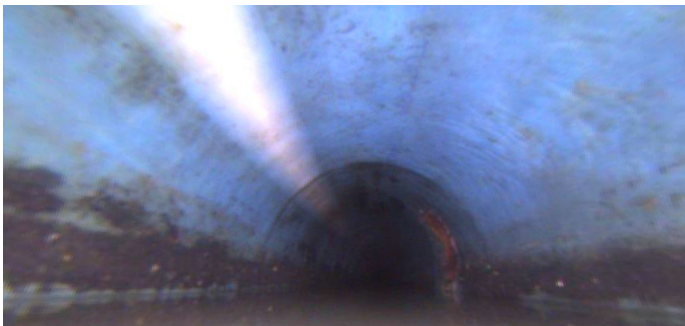
Code: **TF**
Description: **Tap Factory**

Distance (ft): **205.9**
Structural Grade: **0**
O&M Grade: **0**
Clock Start/From: **3**
Clock To:
1st Value: **4.000**
2nd Value:
Value Percent:
Continuous Index:
Within 8" of Joint:
Remarks:

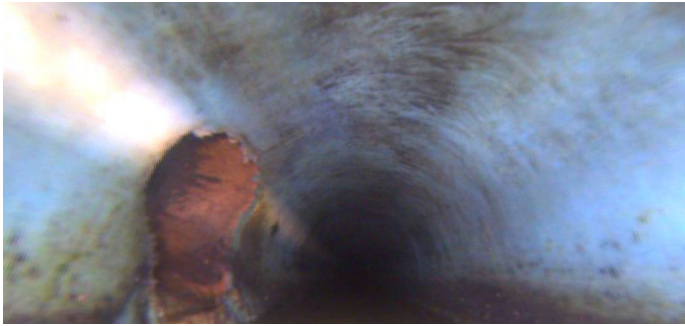
Code: **TF**
Description: **Tap Factory**

Distance (ft): **257.9**
Structural Grade: **0**
O&M Grade: **0**
Clock Start/From: **9**
Clock To:
1st Value: **4.000**
2nd Value:
Value Percent:
Continuous Index:
Within 8" of Joint:
Remarks:

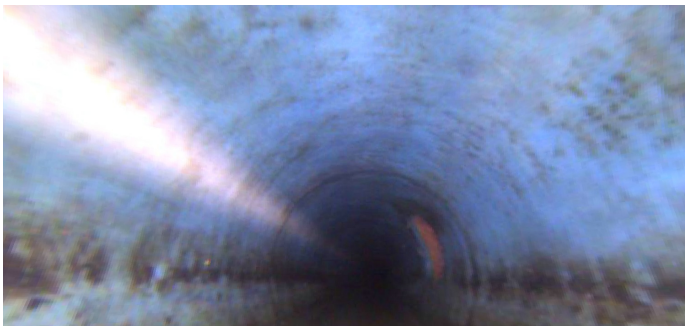
Code: **TF**
Description: **Tap Factory**

Distance (ft): **264.9**
Structural Grade: **0**
O&M Grade: **0**
Clock Start/From: **3**
Clock To:
1st Value: **4.000**
2nd Value:
Value Percent:
Continuous Index:
Within 8" of Joint:
Remarks:

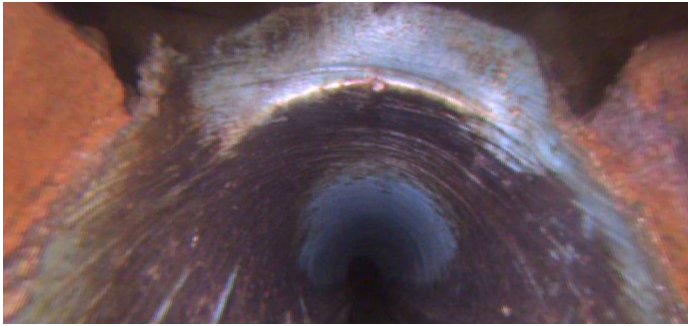
Code:	AMH
Description:	Manhole
Distance (ft):	319.8
Structural Grade:	0
O&M Grade:	0
Clock Start/From:	
Clock To:	
1st Value:	
2nd Value:	
Value Percent:	
Continuous Index:	
Within 8" of Joint:	NO
Remarks:	M-708-008
