Profile/Photo Observation Report

Date:	05/02/2018	Weather:		Coding:	PACP 6.0
Pipe Length (ft):		Owner:	City of Hobart	Pre Clean:	Not Known
P.O.#:	282	Surveyor:	B. Helbling	PSR:	P-608-005-009
Customer:	City of Hobart	Clean Date:		Shape:	C

Street:	South Lake Park	Flow Control:	Not Controlled
City:	Hobart, IN	Year Renewed:	
Location:	Light Highway	Tape/Media #:	DEP282
Purpose:	Routine Assessment	Dia/Height:	8"
Use:	Sanitary	Material:	PVC
Drain Area:		Lining:	
Category:	NA		
Comment:	5-21-2018		
Location Details:		Direction of Survey:	Downstream
US MH:	M-708-009	DS MH:	M-608-005
		Total Length Surveyed (ft):	.1

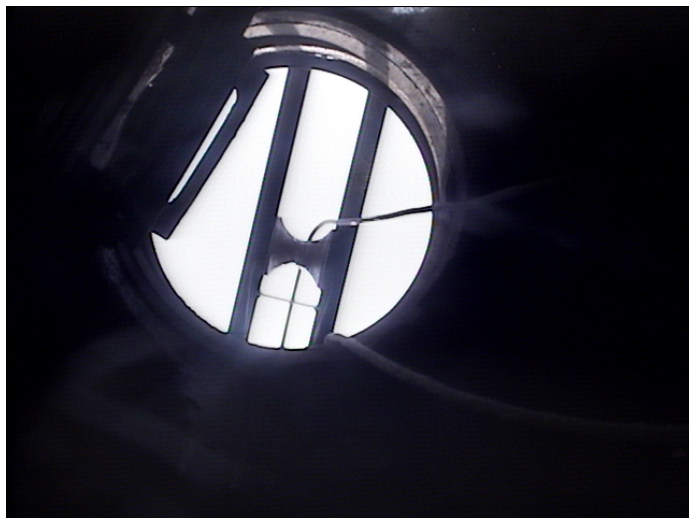
Code: **AMH**
Description: **Manhole**

Distance (ft): **.0**
Structural Grade: **0**
O&M Grade: **0**
Clock Start/From:
Clock To:
1st Value:
2nd Value:
Value Percent:
Continuous Index:
Within 8" of Joint: **NO**
Remarks: **M-608-005**

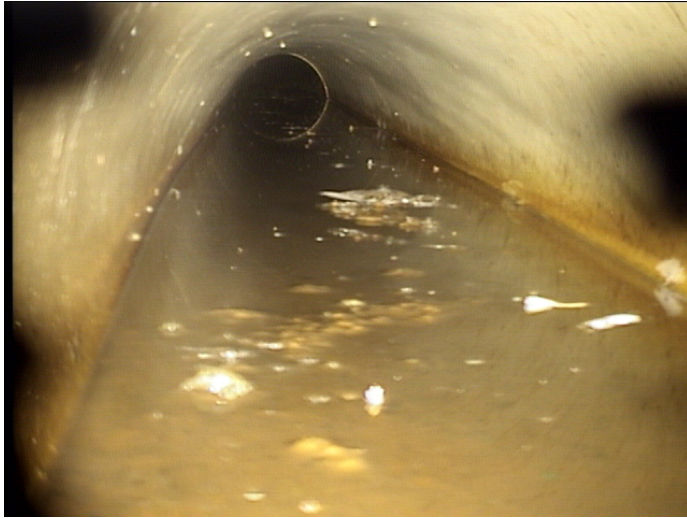
Code: **MWL**
Description: **Water Level**

Distance (ft): **.0**
Structural Grade: **0**
O&M Grade: **0**
Clock Start/From:
Clock To:
1st Value:
2nd Value:
Value Percent: **40.000**
Continuous Index:
Within 8" of Joint: **NO**
Remarks:

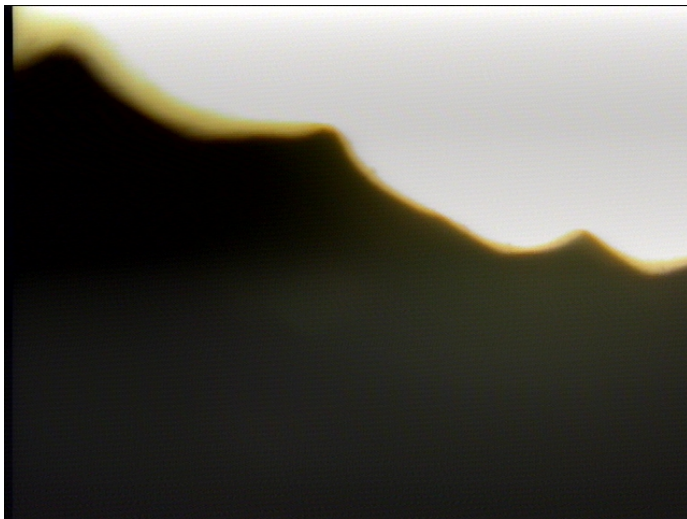
Code: **MSA**
Description: **Abandoned Survey**

Distance (ft): **.1**
Structural Grade: **0**
O&M Grade: **0**
Clock Start/From:
Clock To:
1st Value:
2nd Value:
Value Percent:
Continuous Index:
Within 8" of Joint: **NO**
Remarks: **Under flow and debris**
