Profile/Photo Observation Report

Date:	04/10/2018	Weather:		Coding:	PACP 6.0
Pipe Length (ft):		Owner:	City of Hobart	Pre Clean:	Not Known
P.O.#:	224	Surveyor:	B. Helbling	PSR:	P-708-009-010
Customer:	City of Hobart	Clean Date:		Shape:	C

Street:	South Lake Park Avenue	Flow Control:	Not Controlled
City:	Hobart, IN	Year Renewed:	
Location:	Yard	Tape/Media #:	DEP224
Purpose:	Routine Assessment	Dia/Height:	15"
Use:	Sanitary	Material:	PVC
Drain Area:		Lining:	
Category:	NA		
Comment:	YES501824 Submittal 2		
Location Details:		Direction of Survey:	Upstream
US MH:	M-708-010	DS MH:	M-708-009
		Total Length Surveyed (ft):	65.6

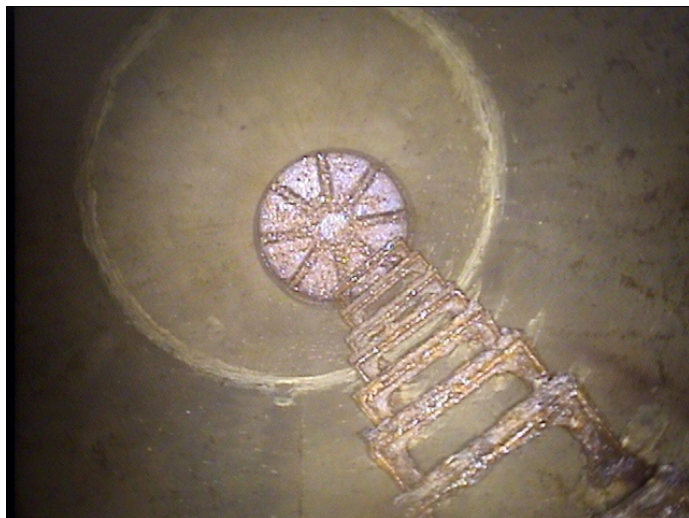
Code: **AMH**
Description: **Manhole**

Distance (ft): **.0**
Structural Grade: **0**
O&M Grade: **0**
Clock Start/From:
Clock To:
1st Value:
2nd Value:
Value Percent:
Continuous Index:
Within 8" of Joint: **NO**
Remarks: **M-708-010**

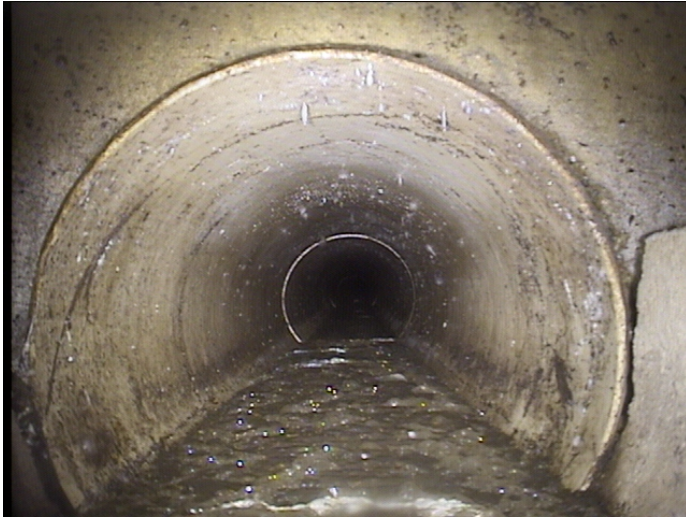
Code: **MWL**
Description: **Water Level**

Distance (ft): **.0**
Structural Grade: **0**
O&M Grade: **0**
Clock Start/From:
Clock To:
1st Value:
2nd Value:
Value Percent: **5.000**
Continuous Index:
Within 8" of Joint: **NO**
Remarks:

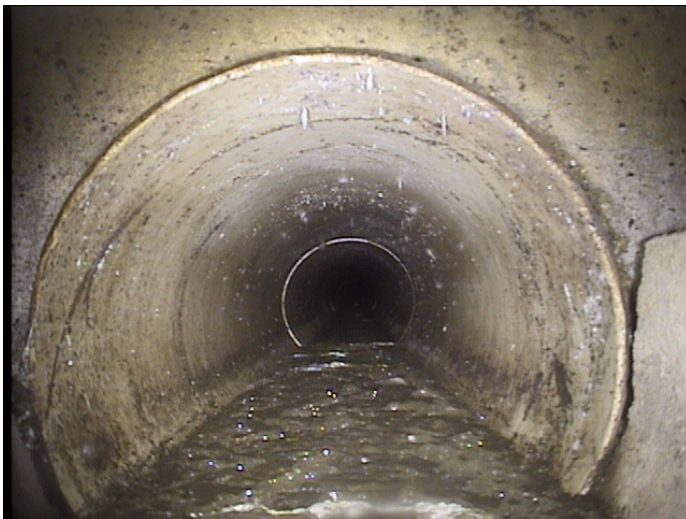
Code: **DSF**
Description: **Deposits Settled Fine**

Distance (ft): **.0**
Structural Grade: **0**
O&M Grade: **2**
Clock Start/From: **5**
Clock To: **7**
1st Value:
2nd Value:
Value Percent: **10.000**
Continuous Index: **S01**
Within 8" of Joint: **NO**
Remarks:

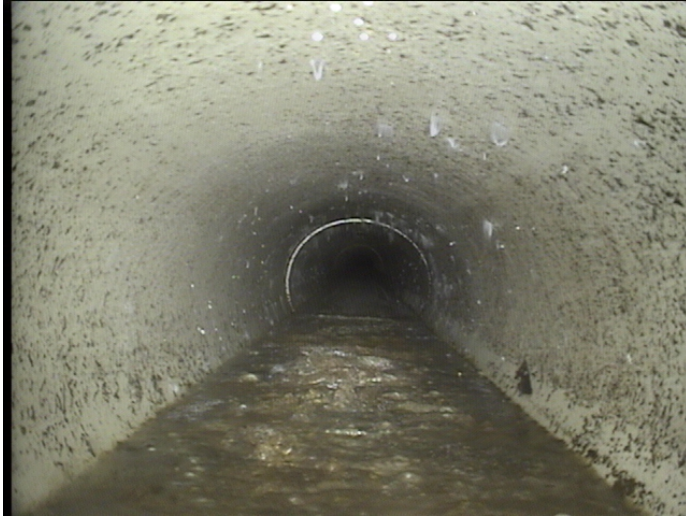
Code: **DSF**
Description: **Deposits Settled Fine**

Distance (ft): **65.6**
Structural Grade: **0**
O&M Grade: **2**
Clock Start/From: **5**
Clock To: **7**
1st Value:
2nd Value:
Value Percent: **10.000**
Continuous Index: **F01**
Within 8" of Joint: **NO**
Remarks:

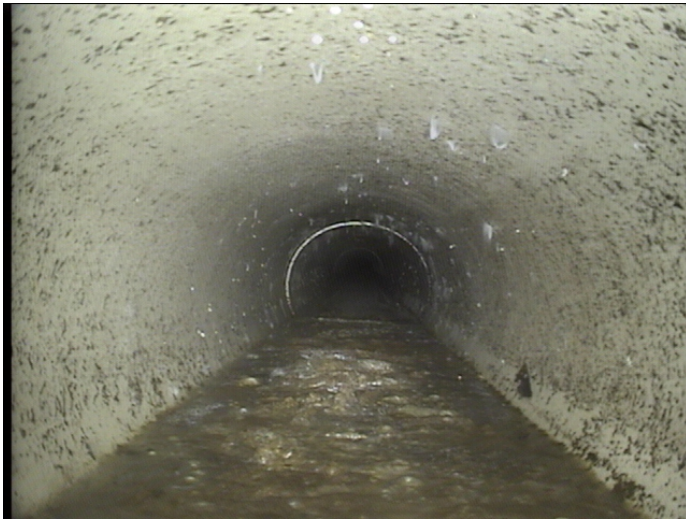
Code: **MSA**
Description: **Abandoned Survey**

Distance (ft): **65.6**
Structural Grade: **0**
O&M Grade: **0**
Clock Start/From:
Clock To:
1st Value:
2nd Value:
Value Percent:
Continuous Index:
Within 8" of Joint: **NO**
Remarks: **Debris/sediment**
