Profile/Photo Observation Report

Date:	04/10/2018	Weather:		Coding:	PACP 6.0
Pipe Length (ft):		Owner:	City of Hobart	Pre Clean:	Not Known
P.O.#:	225	Surveyor:	B. Helbling	PSR:	P-708-009-010
Customer:	City of Hobart	Clean Date:		Shape:	C

Street:	South Lake Park Avenue	Flow Control:	Not Controlled
City:	Hobart, IN	Year Renewed:	
Location:	Light Highway	Tape/Media #:	DEP225
Purpose:	Routine Assessment	Dia/Height:	15"
Use:	Sanitary	Material:	PVC
Drain Area:		Lining:	
Category:	NA		
Comment:	YES501824 Submittal 2		
Location Details:		Direction of Survey:	Downstream
US MH:	M-708-010	DS MH:	M-708-009
		Total Length Surveyed (ft):	8.6

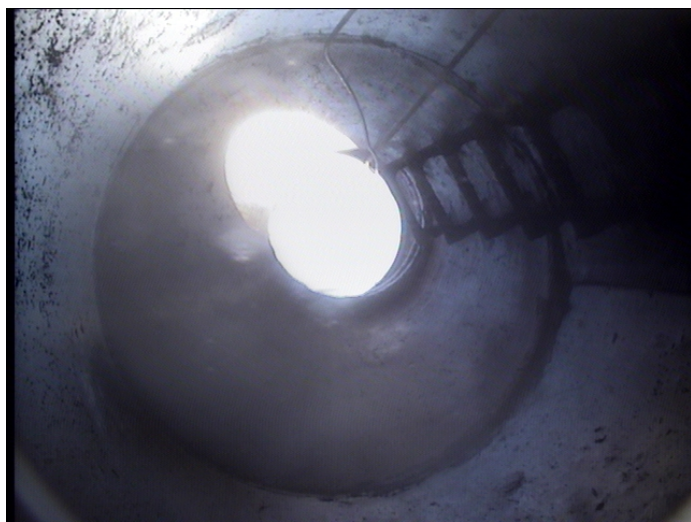
Code: **AMH**
Description: **Manhole**

Distance (ft): **.0**
Structural Grade: **0**
O&M Grade: **0**
Clock Start/From:
Clock To:
1st Value:
2nd Value:
Value Percent:
Continuous Index:
Within 8" of Joint: **NO**
Remarks: **M-708-010**

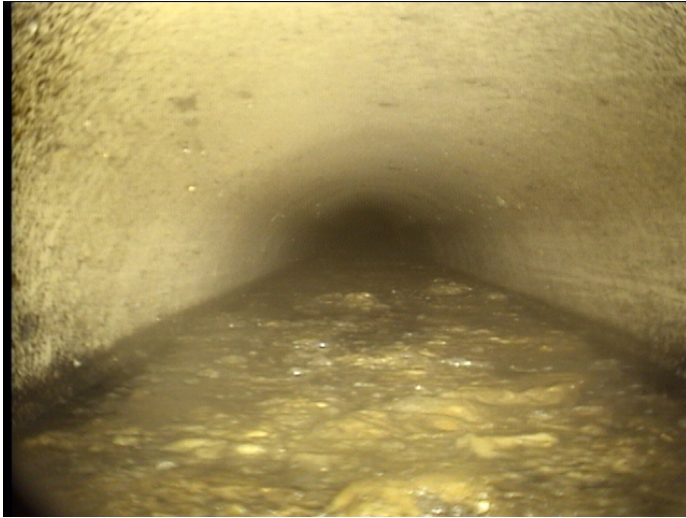
Code: **MWL**
Description: **Water Level**

Distance (ft): **.0**
Structural Grade: **0**
O&M Grade: **0**
Clock Start/From:
Clock To:
1st Value:
2nd Value:
Value Percent: **20.000**
Continuous Index:
Within 8" of Joint: **NO**
Remarks:

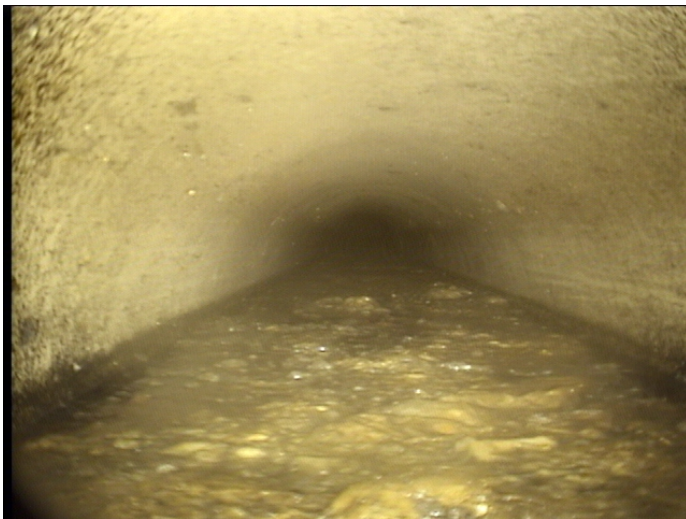
Code: **DSF**
Description: **Deposits Settled Fine**

Distance (ft): **.0**
Structural Grade: **0**
O&M Grade: **4**
Clock Start/From: **4**
Clock To: **8**
1st Value:
2nd Value:
Value Percent: **30.000**
Continuous Index: **S01**
Within 8" of Joint: **NO**
Remarks:

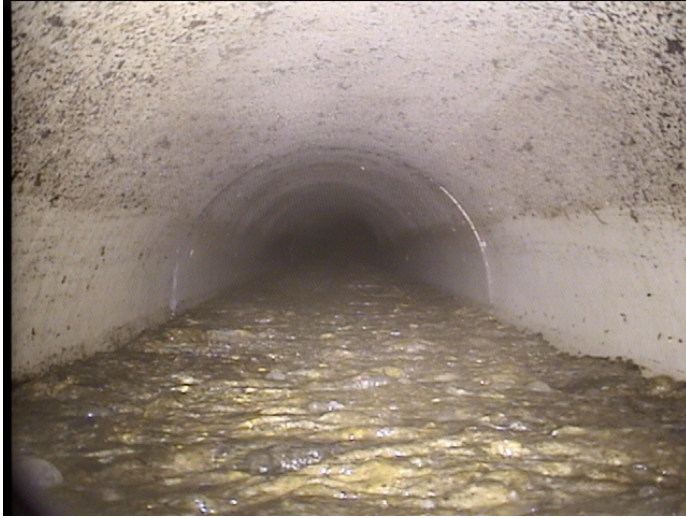
Code: **DSF**
Description: **Deposits Settled Fine**

Distance (ft): **8.6**
Structural Grade: **0**
O&M Grade: **4**
Clock Start/From: **4**
Clock To: **8**
1st Value:
2nd Value:
Value Percent: **30.000**
Continuous Index: **F01**
Within 8" of Joint: **NO**
Remarks:

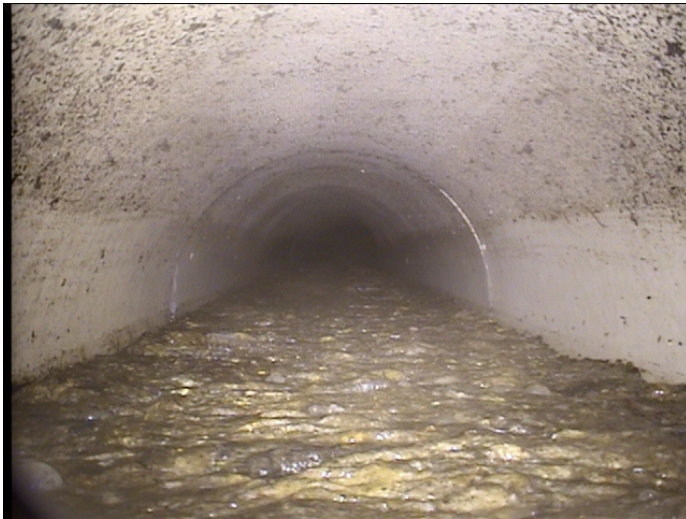
Code: **MSA**
Description: **Abandoned Survey**

Distance (ft): **8.6**
Structural Grade: **0**
O&M Grade: **0**
Clock Start/From:
Clock To:
1st Value:
2nd Value:
Value Percent:
Continuous Index:
Within 8" of Joint: **NO**
Remarks: **Heavy debris**
