Date:	04/10/2018	Weather:			Coding:	PACP 6.0
Pipe Length (f	t):	Owner:	City of Hobar	t	Pre Clean:	No Pre-Cleaning
P.O.#:	223	Surveyor:	B. Helbling		PSR:	P-708-101-011
Customer:	City of Hobart	Clean Date	:		Shape:	С
Street:	South Lake Park Avenue		Flow Control:		Not Controlled	
City:	Hobart, IN		Year Renewed			
Location:	Yard		Tape/Media #:		DEP223	
Purpose:	Routine Assessme	nt	Dia/Height:		15"	
Use:	Sanitary		Material:		PVC	
Drain Area:			Lining:			
Category:	NA					
Comment:	YES501824 Submit	al 2				
Location Deta	ils:		Direction of Su	rvey:	Downstream	
US MH:	M-708-011	DS MH:	M-708-101	Total	Length Surveyed (ft)	: <b>138.3</b>
0&M Index:	2.00	O&M Quick	20	:00	O&M Rating:	44.00
Structural Index	c: <b>0.00</b>	 Structural Q	uick: OC	00	Structural Rating:	0.00
Overall Index: 2.00		Overall Quid		:00	Overall Rating:	44.00

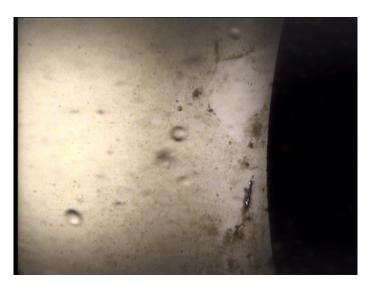
Code: Description:	AMH Manhole
Distance (ft):	.0
Structural Grade:	0
O&M Grade:	0
Clock Start/From:	
Clock To:	
1st Value:	
2nd Value:	
Value Percent:	
Continuous Index:	
Within 8" of Joint:	NO
Remarks:	M-708-101

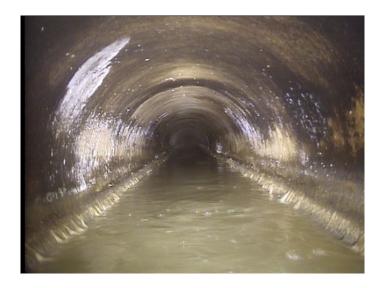
Code:	MWL
Description:	Water Level
<b>D</b> (0)	
Distance (ft):	.0
Structural Grade:	0
O&M Grade:	0
Clock Start/From:	
Clock To:	
1st Value:	
2nd Value:	
Value Percent:	10.000
Continuous Index:	
Within 8" of Joint:	NO
Remarks:

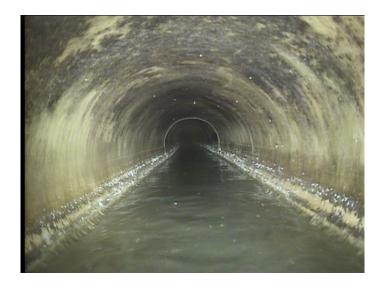
Code: Description:	DSF Deposits Settled Fine
Distance (ft): Structural Grade: O&M Grade: Clock Start/From: Clock To: 1st Value: 2nd Value: Value Percent: Continuous Index: Within 8" of Joint:	29.6 0 2 5 7 5.000 S01 NO
Remarks:

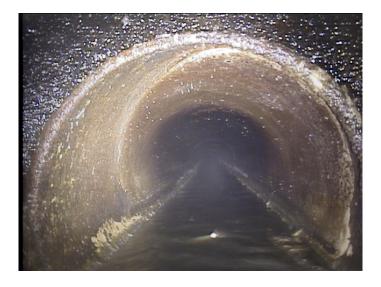
Code:	DSF
Description:	<b>Deposits Settled Fine</b>
Distance (ft):	138.3
Structural Grade:	0
O&M Grade:	2
Clock Start/From:	5
Clock To:	7
1st Value:	
2nd Value:	
Value Percent:	5.000
Continuous Index:	F01
Within 8" of Joint:	NO
Remarks:

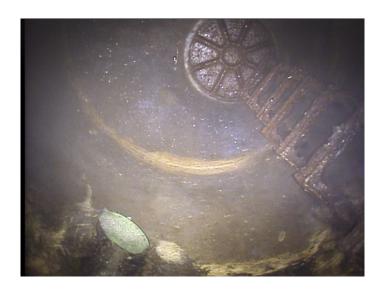
Code: Description:	AMH Manhole
Distance (ft):	138.3
Structural Grade:	0
O&M Grade:	0
Clock Start/From:	
Clock To:	
1st Value:	
2nd Value:	
Value Percent:	
Continuous Index:	
Within 8" of Joint:	NO
Remarks:	M-708-011
