Profile/Photo Observation Report

Date:	04/10/2018	Weather:		Coding:	PACP 6.0
Pipe Length (ft):		Owner:	City of Hobart	Pre Clean:	Not Known
P.O.#:	221	Surveyor:	B. Helbling	PSR:	P-708-011-012
Customer:	City of Hobart	Clean Date:		Shape:	C

Street:	South Lake Park Avenue	Flow Control:	Not Controlled
City:	Hobart, IN	Year Renewed:	
Location:	Parking Lot	Tape/Media #:	DEP221
Purpose:	Routine Assessment	Dia/Height:	15"
Use:	Sanitary	Material:	PVC
Drain Area:		Lining:	
Category:	NA		
Comment:	YES501824 Submital 2		
Location Details:		Direction of Survey:	Upstream
US MH:	M-708-012	DS MH:	M-708-011
		Total Length Surveyed (ft):	146.7

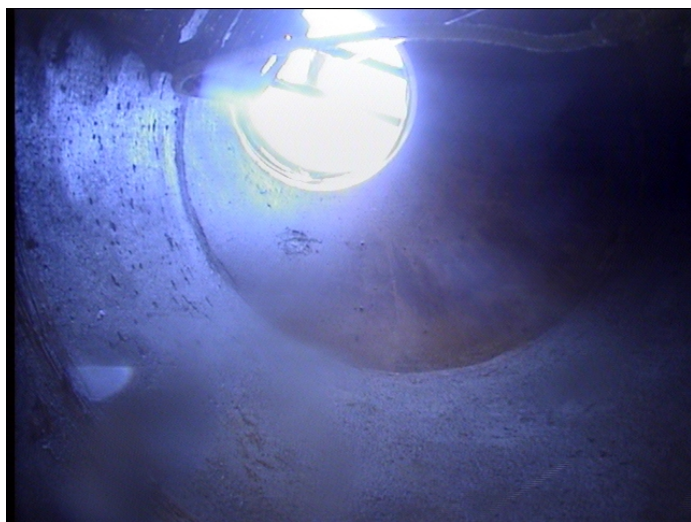
Code: **AMH**
Description: **Manhole**

Distance (ft): **.0**
Structural Grade: **0**
O&M Grade: **0**
Clock Start/From:
Clock To:
1st Value:
2nd Value:
Value Percent:
Continuous Index:
Within 8" of Joint: **NO**
Remarks: **M-708-012**

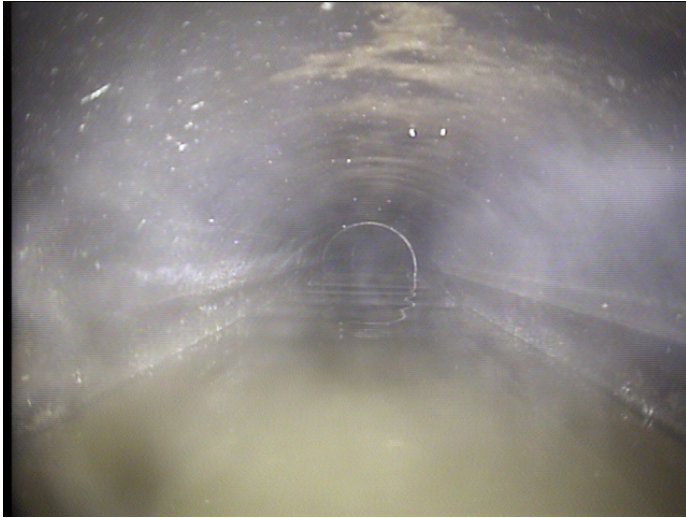
Code:	MWL
Description:	Water Level
Distance (ft):	.0
Structural Grade:	0
O&M Grade:	0
Clock Start/From:	
Clock To:	
1st Value:	
2nd Value:	
Value Percent:	15.000
Continuous Index:	
Within 8" of Joint:	NO
Remarks:

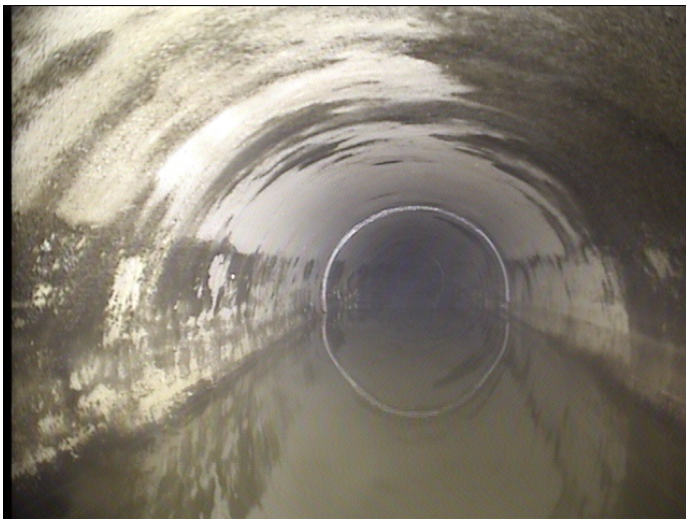
Code:	MWL
Description:	Water Level
Distance (ft):	58.7
Structural Grade:	0
O&M Grade:	0
Clock Start/From:	
Clock To:	
1st Value:	
2nd Value:	
Value Percent:	30.000
Continuous Index:	
Within 8" of Joint:	NO
Remarks:

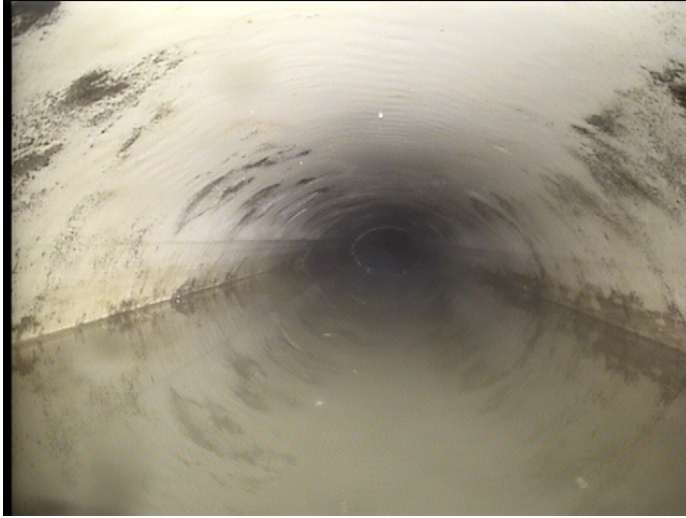
Code: **MWL**
Description: **Water Level**

Distance (ft): **142.0**
Structural Grade: **0**
O&M Grade: **0**
Clock Start/From:
Clock To:
1st Value:
2nd Value:
Value Percent: **55.000**
Continuous Index:
Within 8" of Joint: **NO**
Remarks:

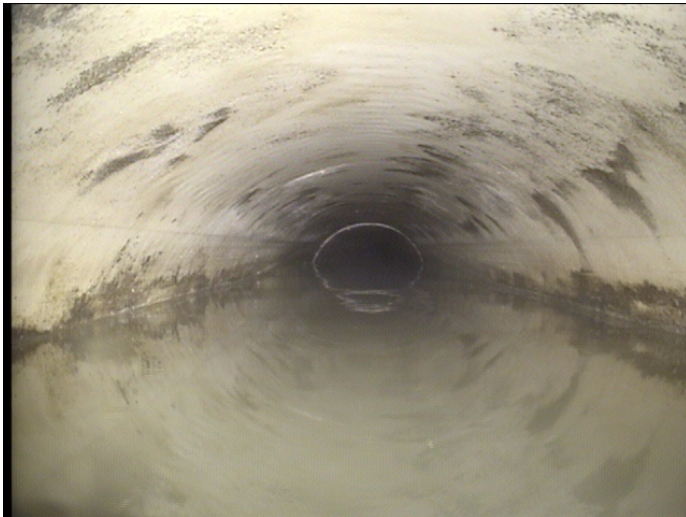
Code: **MSA**
Description: **Abandoned Survey**

Distance (ft): **146.7**
Structural Grade: **0**
O&M Grade: **0**
Clock Start/From:
Clock To:
1st Value:
2nd Value:
Value Percent:
Continuous Index:
Within 8" of Joint: **NO**
Remarks: **Unable to pass debris under flow**
