Profile/Photo Observation Report

Date:	04/10/2018	Weather:		Coding:	PACP 6.0
Pipe Length (ft):		Owner:	City of Hobart	Pre Clean:	Not Known
P.O.#:	223	Surveyor:	B. Helbling	PSR:	P-708-011-012
Customer:	City of Hobart	Clean Date:		Shape:	C

Street:	South Lake Park Avenue	Flow Control:	Not Controlled
City:	Hobart, IN	Year Renewed:	
Location:	Yard	Tape/Media #:	DEP223
Purpose:	Routine Assessment	Dia/Height:	15"
Use:	Sanitary	Material:	PVC
Drain Area:		Lining:	
Category:	NA		
Comment:	YES501824 Submittal 2		
Location Details:		Direction of Survey:	Downstream
US MH:	M-708-012	DS MH:	M-708-011
		Total Length Surveyed (ft):	34.5

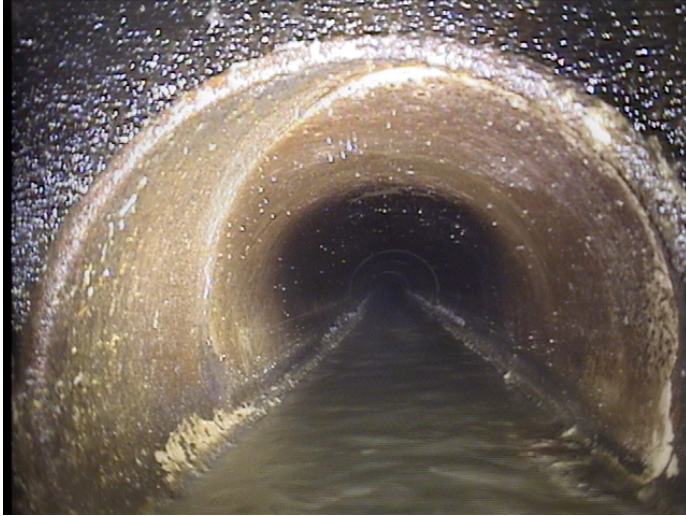
Code: **MWL**
Description: **Water Level**

Distance (ft): **.0**
Structural Grade: **0**
O&M Grade: **0**
Clock Start/From:
Clock To:
1st Value:
2nd Value:
Value Percent: **10.000**
Continuous Index:
Within 8" of Joint: **NO**
Remarks:

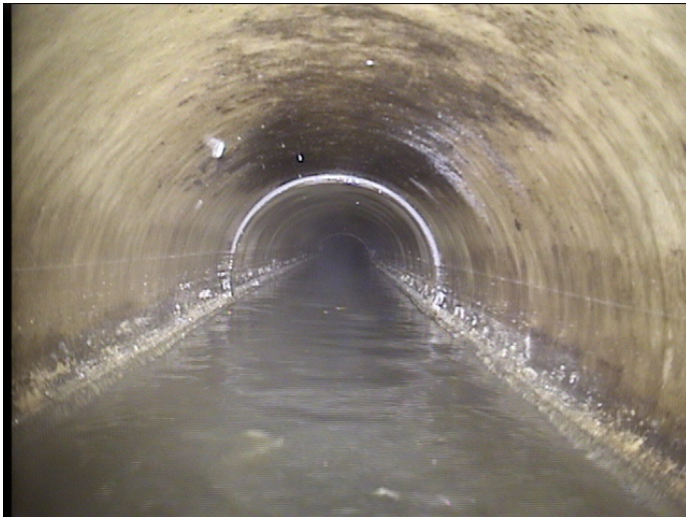
Code: **DSF**
Description: **Deposits Settled Fine**

Distance (ft): **19.5**
Structural Grade: **0**
O&M Grade: **2**
Clock Start/From: **5**
Clock To: **7**
1st Value:
2nd Value:
Value Percent: **5.000**
Continuous Index: **S01**
Within 8" of Joint: **NO**
Remarks:

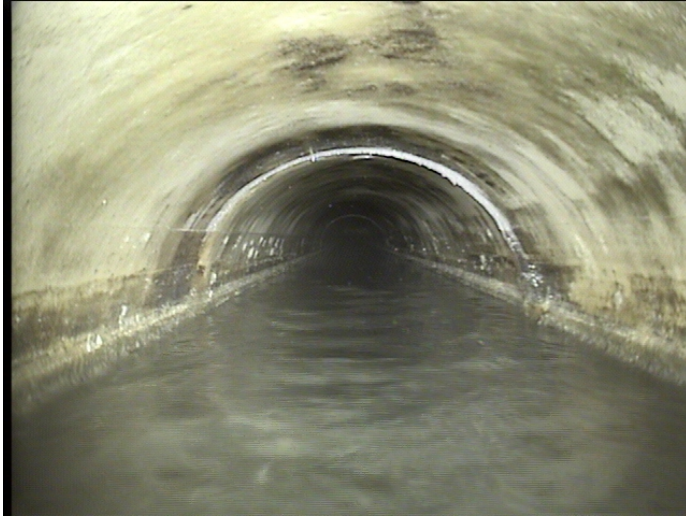
Code: **DSF**
Description: **Deposits Settled Fine**

Distance (ft): **34.5**
Structural Grade: **0**
O&M Grade: **2**
Clock Start/From: **5**
Clock To: **7**
1st Value:
2nd Value:
Value Percent: **5.000**
Continuous Index: **F01**
Within 8" of Joint: **NO**
Remarks:

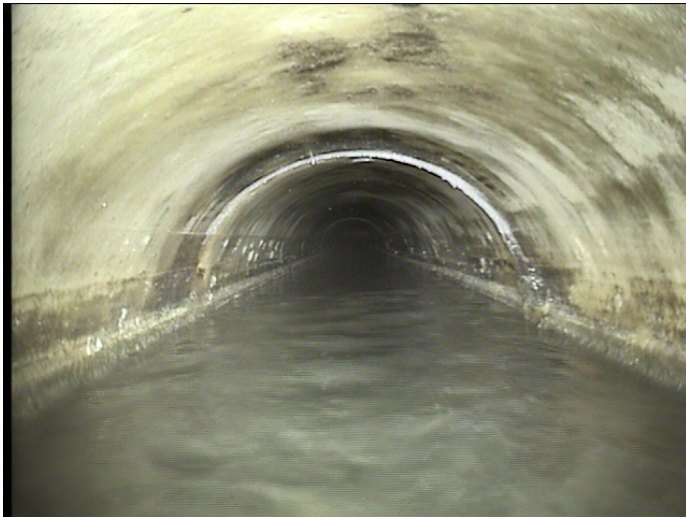
Code: **MSA**
Description: **Abandoned Survey**

Distance (ft): **34.5**
Structural Grade: **0**
O&M Grade: **0**
Clock Start/From:
Clock To:
1st Value:
2nd Value:
Value Percent:
Continuous Index:
Within 8" of Joint: **NO**
Remarks: **Sediment**
