Profile/Ph	noto Observatio	n Report				RedZon
Date:	03/31/2018	Weather:			Coding:	PACP 6.0
Pipe Length (f	t): 198.0	Owner:	NA		Pre Clean:	Not Known
P.O.#:		Surveyor:	Jen Cos	tello	PSR:	P-708-015-016
Customer:		Clean Date	e: 01/01/	1900	Shape:	C
Street: Hidden Oak		Flow Co	ntrol:	Not Controlled		
City:	Hobart, IN		Year Rer	ewed:		
Location:	Sidewalk		Tape/Mo	edia #:		
Purpose: Maintenance Related		Dia/Height:		8"		
Use:	Sanitary		Material	:	PVC	
Drain Area:	NA		Lining:			
Category:	NA					
Comment:	Comment: Flow direction wrong.					
Location Details:			Direction of Survey:		Downstream	
US MH:	M-708-016	DS MH:	M-708-01	5 -	Total Length Surveyed (ft)	: 198.8
0&M Index:	0.00	O&M Quick	:	0000	O&M Rating:	0.00
tructural Index	. 0.00	Structural C	Quick:	0000	Structural Rating:	0.00
Overall Index:	0.00	Overall Qui		0000	Overall Rating:	0.00

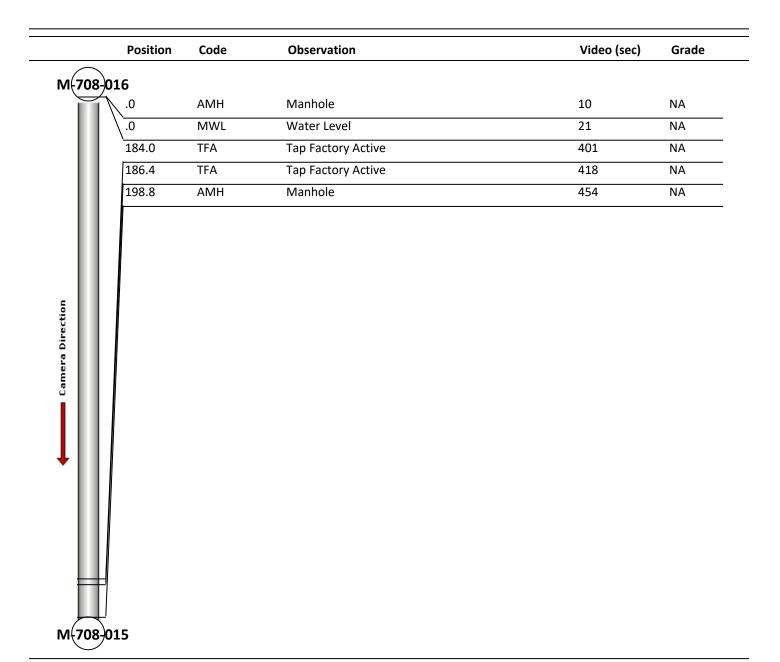
Code: Description:	AMH Manhole
Distance (ft):	.0
Structural Grade:	0
O&M Grade:	0
Clock Start/From:	
Clock To:	
1st Value:	
2nd Value:	
Value Percent:	
Continuous Index:	
Within 8" of Joint:	NO
Remarks:	M-708-016
