Profile/Photo Observation Report

Date:	03/31/2018	Weather:		Coding:	PACP 6.0
Pipe Length (ft):	230.3	Owner:	NA	Pre Clean:	Not Known
P.O.#:		Surveyor:	Jen Costello	PSR:	P-708-017-018
Customer:		Clean Date:	01/01/1900	Shape:	C

Street:	HIDDEN OAK TRL & WOODWARD TR	Flow Control:	Not Controlled
City:	Hobart, IN	Year Renewed:	
Location:	Sidewalk	Tape/Media #:	
Purpose:	Maintenance Related	Dia/Height:	8"
Use:	Sanitary	Material:	PVC
Drain Area:	NA	Lining:	
Category:	NA		
Comment:	Flow direction wrong.

Location Details:		Direction of Survey:	Upstream
US MH:	M-708-018	DS MH:	M-708-017
		Total Length Surveyed (ft):	209.0

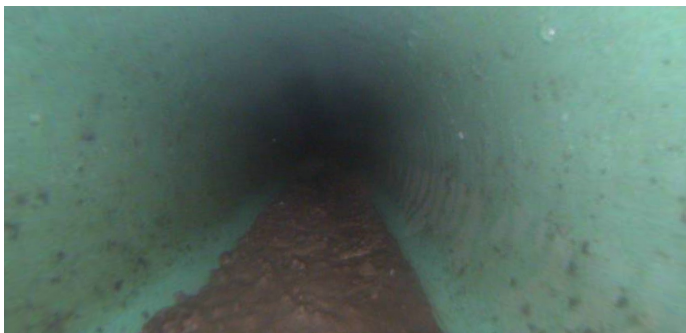
Code: **AMH**
Description: **Manhole**

Distance (ft): **.0**
Structural Grade: **0**
O&M Grade: **0**
Clock Start/From:
Clock To:
1st Value:
2nd Value:
Value Percent:
Continuous Index:
Within 8" of Joint: **NO**
Remarks: **M-708-017**

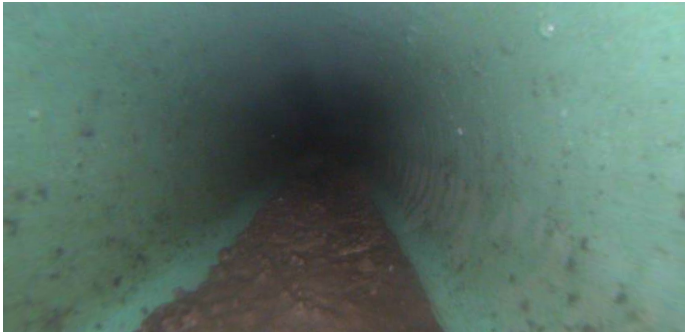
Code:	MWL
Description:	Water Level

Distance (ft):	.0
Structural Grade:	0
O&M Grade:	0
Clock Start/From:	
Clock To:	
1st Value:	
2nd Value:	
Value Percent:	5.000
Continuous Index:	
Within 8" of Joint:	NO
Remarks:

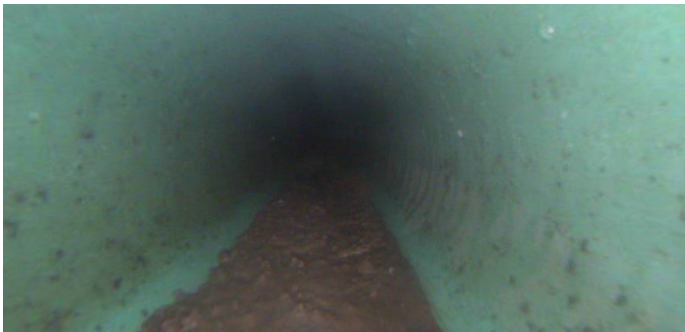
Code:	DSF
Description:	Deposits Settled Fine

Distance (ft):	.0
Structural Grade:	0
O&M Grade:	2
Clock Start/From:	6
Clock To:	
1st Value:	
2nd Value:	
Value Percent:	5.000
Continuous Index:	S01
Within 8" of Joint:	NO
Remarks:

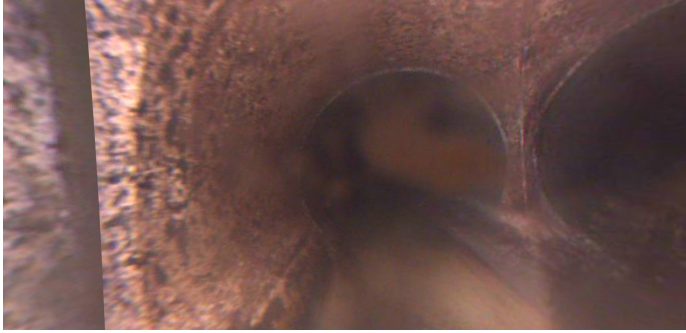
Code: **TFA**
Description: **Tap Factory Active**

Distance (ft): **17.3**
Structural Grade: **0**
O&M Grade: **0**
Clock Start/From: **3**
Clock To:
1st Value: **4.000**
2nd Value:
Value Percent:
Continuous Index:
Within 8" of Joint:
Remarks:

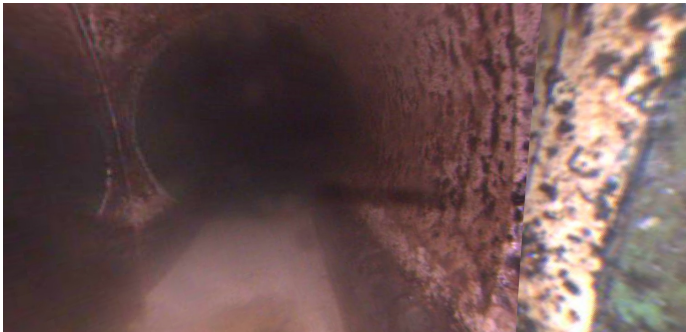
Code: **TFA**
Description: **Tap Factory Active**

Distance (ft): **19.5**
Structural Grade: **0**
O&M Grade: **0**
Clock Start/From: **9**
Clock To:
1st Value: **4.000**
2nd Value:
Value Percent:
Continuous Index:
Within 8" of Joint:
Remarks:

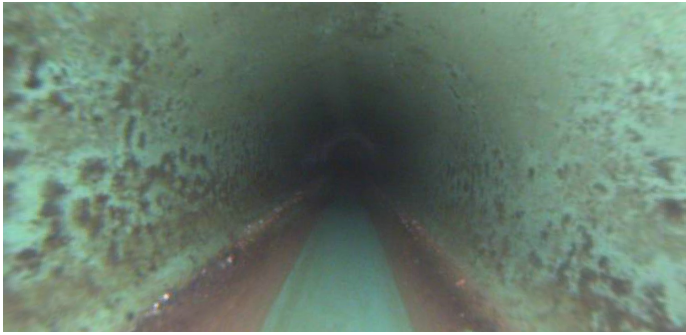
Code: **DSF**
Description: **Deposits Settled Fine**

Distance (ft): **22.0**
Structural Grade: **0**
O&M Grade: **2**
Clock Start/From: **6**
Clock To:
1st Value:
2nd Value:
Value Percent: **5.000**
Continuous Index: **F01**
Within 8" of Joint: **NO**
Remarks:

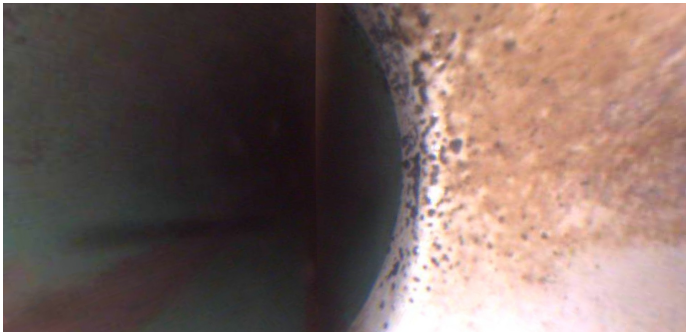
Code: **TF**
Description: **Tap Factory**

Distance (ft): **117.5**
Structural Grade: **0**
O&M Grade: **0**
Clock Start/From: **9**
Clock To:
1st Value: **4.000**
2nd Value:
Value Percent:
Continuous Index:
Within 8" of Joint:
Remarks:

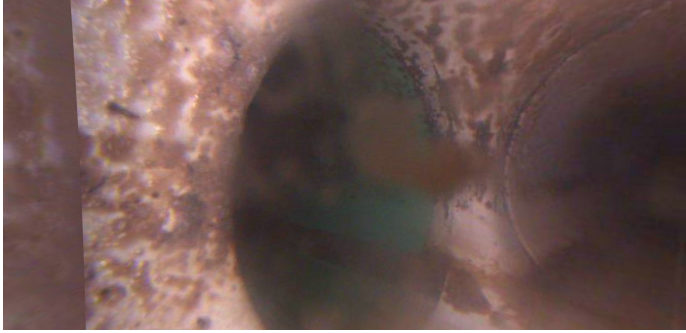
Code: **TF**
Description: **Tap Factory**

Distance (ft): **119.1**
Structural Grade: **0**
O&M Grade: **0**
Clock Start/From: **3**
Clock To:
1st Value: **4.000**
2nd Value:
Value Percent:
Continuous Index:
Within 8" of Joint:
Remarks:

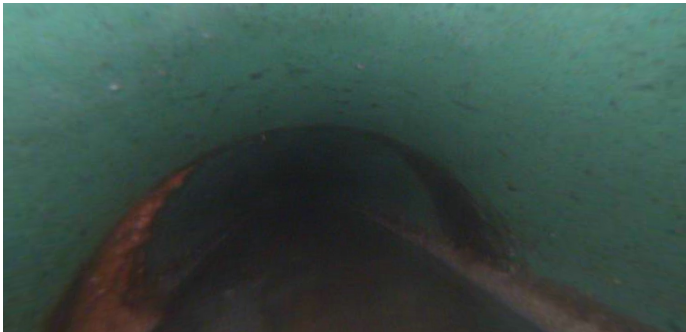
Code: **MWL**
Description: **Water Level**

Distance (ft): **206.0**
Structural Grade: **0**
O&M Grade: **0**
Clock Start/From:
Clock To:
1st Value:
2nd Value:
Value Percent: **30.000**
Continuous Index:
Within 8" of Joint: **NO**
Remarks:

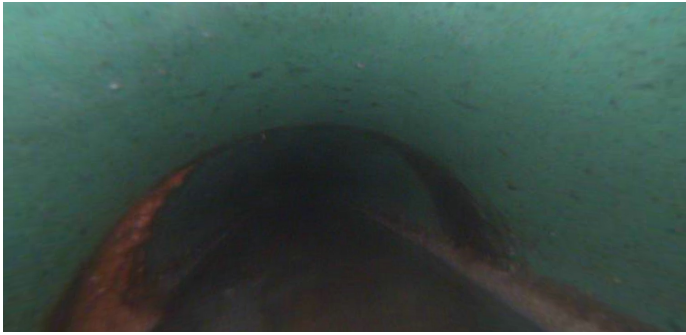
Code: **DAE**
Description: **Deposits Attached Encrustation**

Distance (ft): **206.0**
Structural Grade: **0**
O&M Grade: **2**
Clock Start/From: **8**
Clock To: **4**
1st Value:
2nd Value:
Value Percent: **5.000**
Continuous Index:
Within 8" of Joint: **YES**
Remarks:

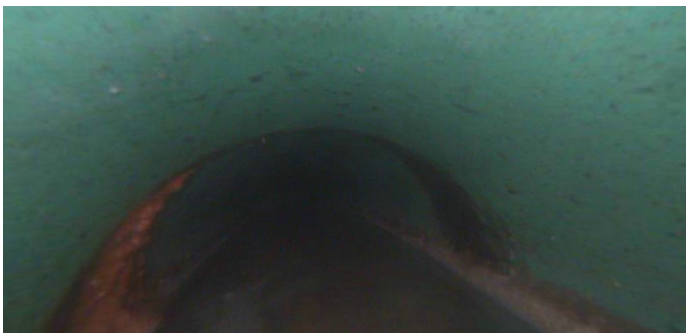
Code: **IW**
Description: **Infil Weeper**

Distance (ft): **206.0**
Structural Grade: **0**
O&M Grade: **2**
Clock Start/From: **8**
Clock To: **4**
1st Value:
2nd Value:
Value Percent:
Continuous Index:
Within 8" of Joint: **YES**
Remarks:

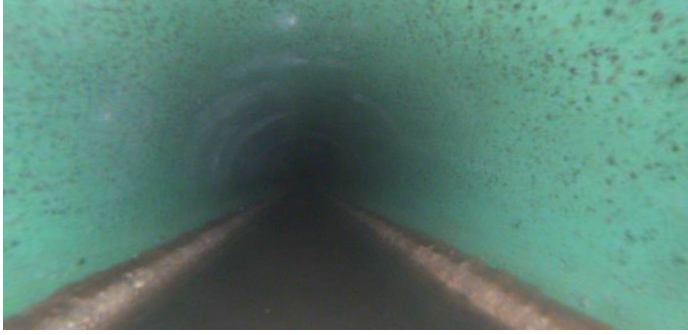
Code:	MSA
Description:	Abandoned Survey
Distance (ft):	209.0
Structural Grade:	0
O&M Grade:	0
Clock Start/From:	
Clock To:	
1st Value:	
2nd Value:	
Value Percent:	
Continuous Index:	
Within 8" of Joint:	NO
Remarks:	DEBRIS UNDER WATER
