Profile/Photo Observation Report

Date:	04/14/2018	Weather:		Coding:	PACP 6.0
Pipe Length (ft):		Owner:	City of Hobart	Pre Clean:	No Pre-Cleaning
P.O.#:	46-1	Surveyor:	M. Pielacha	PSR:	M-708-020-M-708-021
Customer:	City of Hobart	Clean Date:		Shape:	C

Street:	Off Lake Park Avenue	Flow Control:	Not Controlled
City:	Hobart, IN	Year Renewed:	
Location:	Light Highway	Tape/Media #:	DEP 46
Purpose:	Routine Assessment	Dia/Height:	6"
Use:	Sanitary	Material:	PVC
Drain Area:		Lining:	
Category:	NA		
Comment:			
Location Details:		Direction of Survey:	Upstream
US MH:	M-708-020	DS MH:	M-708-021
		Total Length Surveyed (ft):	24.9

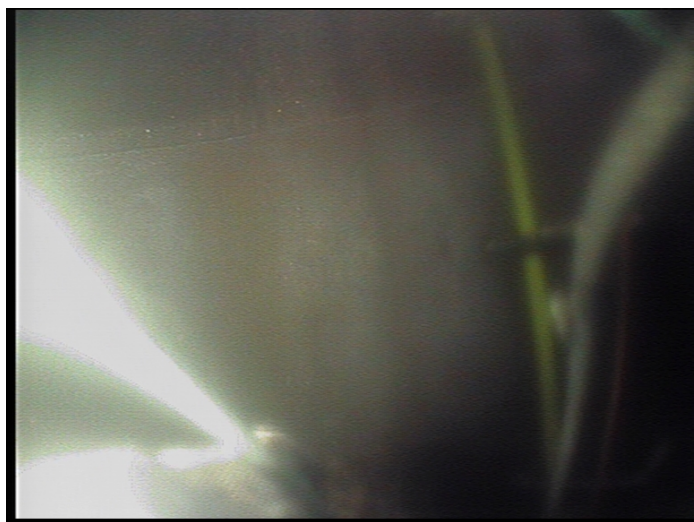
Code: **AMH**
Description: **Manhole**

Distance (ft): **.0**
Structural Grade: **0**
O&M Grade: **0**
Clock Start/From:
Clock To:
1st Value:
2nd Value:
Value Percent:
Continuous Index:
Within 8" of Joint: **NO**
Remarks: **M-708-021**

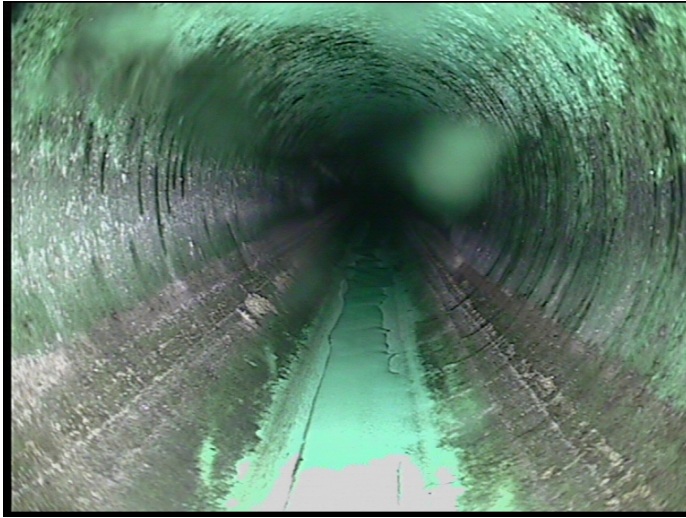
Code: **MWL**
Description: **Water Level**

Distance (ft): **.0**
Structural Grade: **0**
O&M Grade: **0**
Clock Start/From:
Clock To:
1st Value:
2nd Value:
Value Percent: **5.000**
Continuous Index:
Within 8" of Joint: **NO**
Remarks:

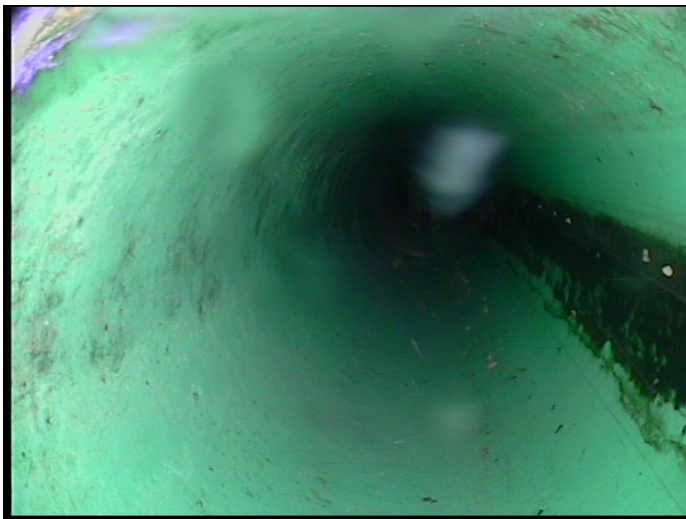
Code: **LR**
Description: **Alignment Right**

Distance (ft): **23.6**
Structural Grade: **0**
O&M Grade: **2**
Clock Start/From:
Clock To:
1st Value:
2nd Value:
Value Percent: **20.000**
Continuous Index:
Within 8" of Joint: **NO**
Remarks:
