Profile/Photo Observation Report

Date:	04/14/2018	Weather:		Coding:	PACP 6.0
Pipe Length (ft):		Owner:	City of Hobart	Pre Clean:	No Pre-Cleaning
P.O.#:	46-1	Surveyor:	M. Pielacha	PSR:	M-708-020-M-708-021
Customer:	City of Hobart	Clean Date:		Shape:	C

Street:	Off Lake Park Avenue	Flow Control:	Not Controlled
City:	Hobart, IN	Year Renewed:	
Location:	Light Highway	Tape/Media #:	DEP 46
Purpose:	Routine Assessment	Dia/Height:	6"
Use:	Sanitary	Material:	PVC
Drain Area:		Lining:	
Category:	NA		
Comment:			
Location Details:		Direction of Survey:	Upstream
US MH:	M-708-020	DS MH:	M-708-021
		Total Length Surveyed (ft):	24.9

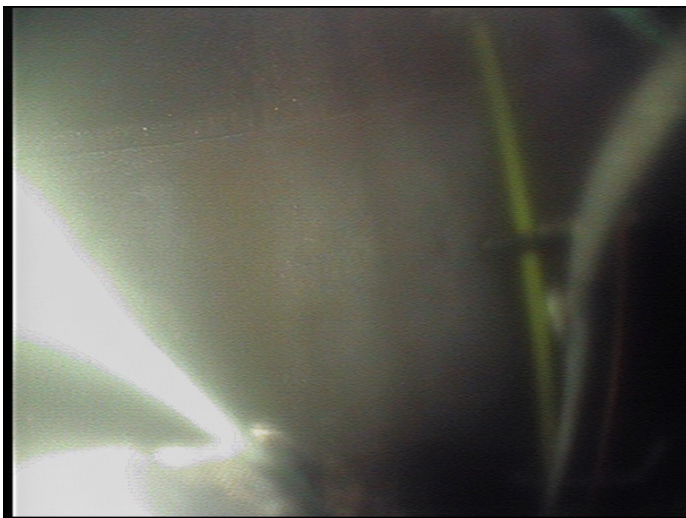
Code:	AMH
Description:	Manhole
Distance (ft):	.0
Structural Grade:	0
O&M Grade:	0
Clock Start/From:	
Clock To:	
1st Value:	
2nd Value:	
Value Percent:	
Continuous Index:	
Within 8" of Joint:	NO
Remarks:	M-708-021

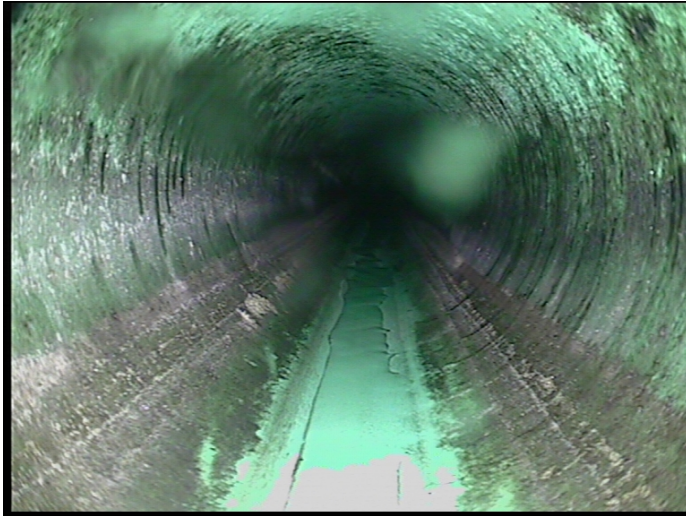
Code: **MWL**
Description: **Water Level**

Distance (ft): **.0**
Structural Grade: **0**
O&M Grade: **0**
Clock Start/From:
Clock To:
1st Value:
2nd Value:
Value Percent: **5.000**
Continuous Index:
Within 8" of Joint: **NO**
Remarks:

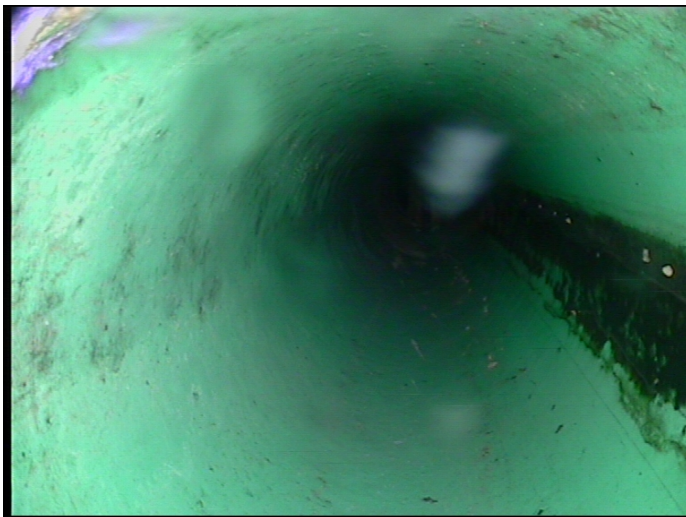
Code: **LR**
Description: **Alignment Right**

Distance (ft): **23.6**
Structural Grade: **0**
O&M Grade: **2**
Clock Start/From:
Clock To:
1st Value:
2nd Value:
Value Percent: **20.000**
Continuous Index:
Within 8" of Joint: **NO**
Remarks:

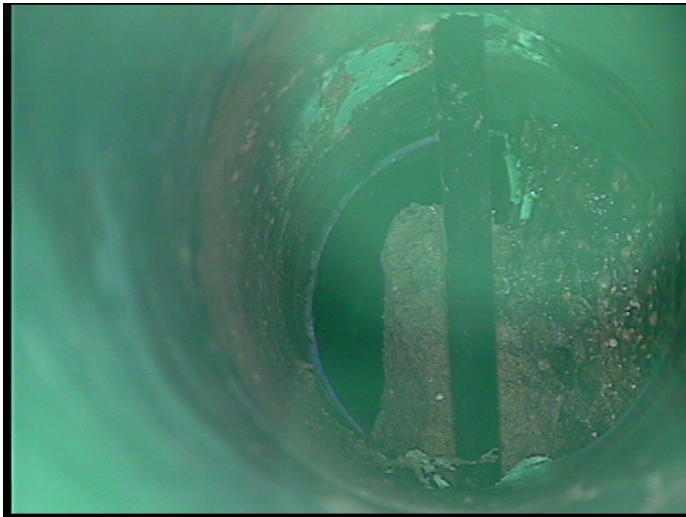
Code:	MGO
Description:	General Observation
Distance (ft):	24.7
Structural Grade:	0
O&M Grade:	0
Clock Start/From:	
Clock To:	
1st Value:	
2nd Value:	
Value Percent:	
Continuous Index:	
Within 8" of Joint:	NO
Remarks:	Can not make bend. Appears to be a crossbore ahead

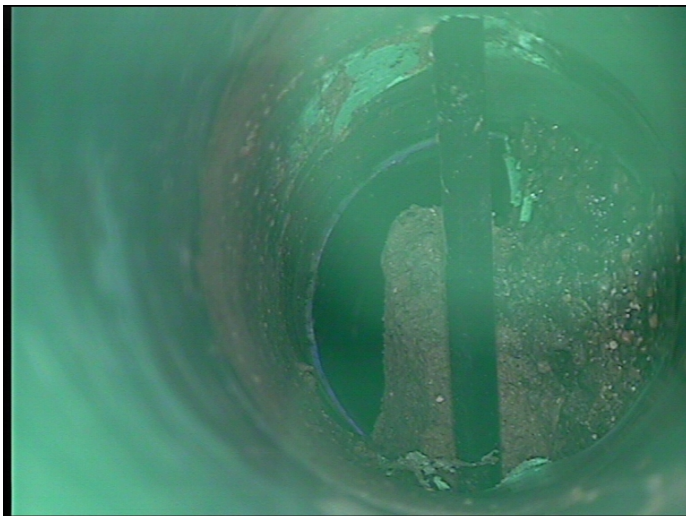
Code:	MSA
Description:	Abandoned Survey
Distance (ft):	24.7
Structural Grade:	0
O&M Grade:	0
Clock Start/From:	
Clock To:	
1st Value:	
2nd Value:	
Value Percent:	
Continuous Index:	
Within 8" of Joint:	NO
Remarks:	can not make bend
