Profile/Photo Observation Report

Date:	04/06/2018	Weather:		Coding:	PACP 6.0
Pipe Length (ft):	82.6	Owner:	NA	Pre Clean:	Not Known
P.O.#:		Surveyor:	Jen Costello	PSR:	P-708-021-022
Customer:		Clean Date:	01/01/1900	Shape:	C

Street:	OFF S LAKE PARK AVE	Flow Control:	Not Controlled
City:	Hobart, IN	Year Renewed:	
Location:	Light Highway	Tape/Media #:	
Purpose:	Maintenance Related	Dia/Height:	8"
Use:	Sanitary	Material:	PVC
Drain Area:	NA	Lining:	Cured in Place
Category:	NA		
Comment:	Debris at 47'.

Location Details:		Direction of Survey:	Downstream
US MH:	M-708-021	DS MH:	M-708-022
		Total Length Surveyed (ft):	48.8

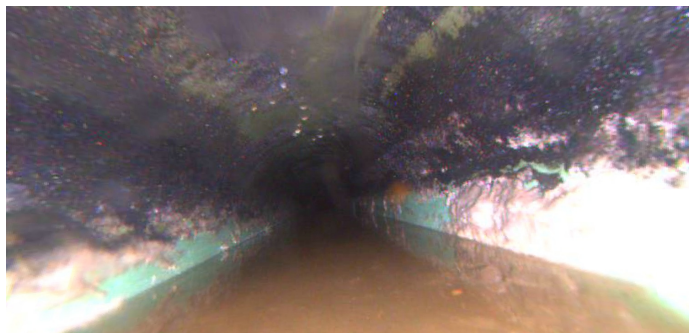
Code: **AMH**
Description: **Manhole**

Distance (ft): **.0**
Structural Grade: **0**
O&M Grade: **0**
Clock Start/From:
Clock To:
1st Value:
2nd Value:
Value Percent:
Continuous Index:
Within 8" of Joint: **NO**
Remarks: **M-708-021**

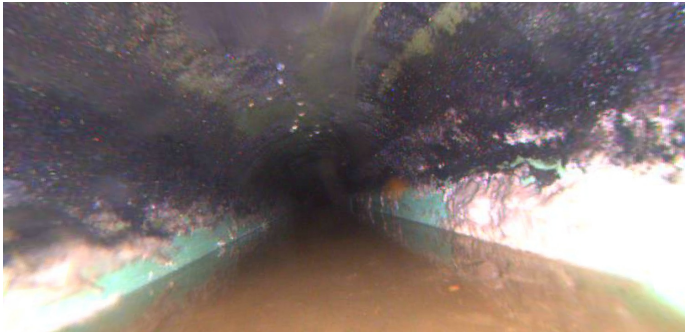
Code:	MWL
Description:	Water Level

Distance (ft):	.0
Structural Grade:	0
O&M Grade:	0
Clock Start/From:	
Clock To:	
1st Value:	
2nd Value:	
Value Percent:	20.000
Continuous Index:	
Within 8" of Joint:	NO
Remarks:

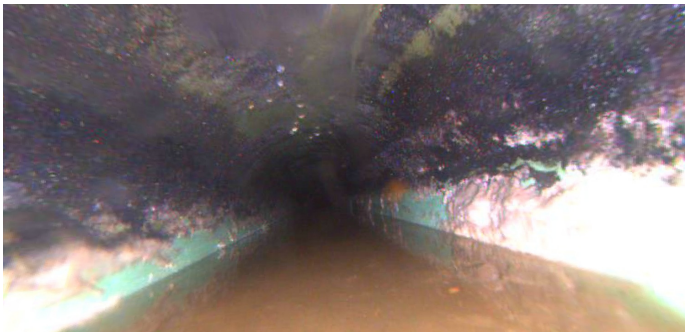
Code:	DAGS
Description:	Deposits Attached Grease

Distance (ft):	.0
Structural Grade:	0
O&M Grade:	2
Clock Start/From:	8
Clock To:	4
1st Value:	
2nd Value:	
Value Percent:	5.000
Continuous Index:	S01
Within 8" of Joint:	NO
Remarks:

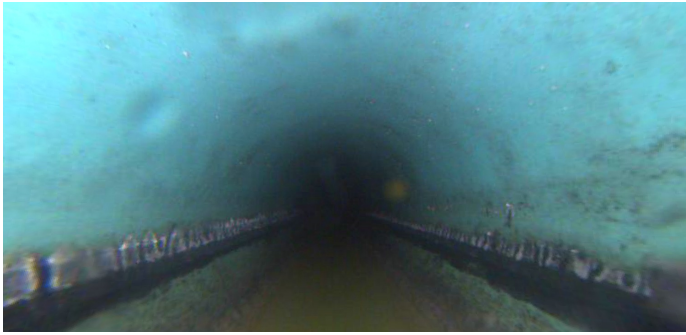
Code: **MWL**
Description: **Water Level**

Distance (ft): **29.6**
Structural Grade: **0**
O&M Grade: **0**
Clock Start/From:
Clock To:
1st Value:
2nd Value:
Value Percent: **5.000**
Continuous Index:
Within 8" of Joint: **NO**
Remarks:

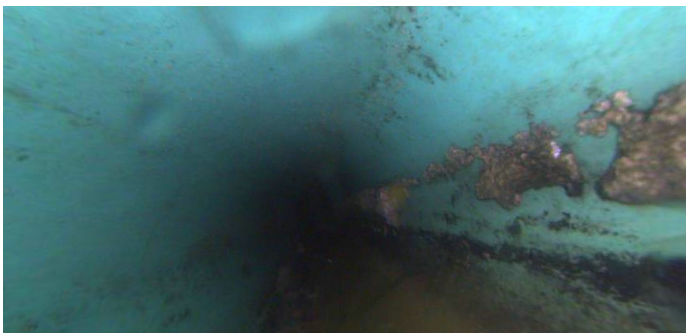
Code: **MSA**
Description: **Abandoned Survey**

Distance (ft): **48.8**
Structural Grade: **0**
O&M Grade: **0**
Clock Start/From:
Clock To:
1st Value:
2nd Value:
Value Percent:
Continuous Index:
Within 8" of Joint: **NO**
Remarks: **OVERTURNED**

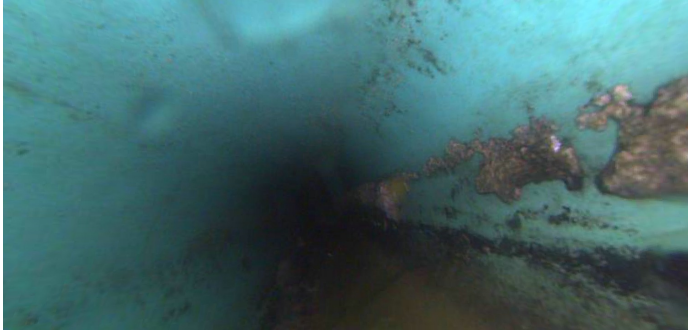
Code:	DAGS
Description:	Deposits Attached Grease
Distance (ft):	48.8
Structural Grade:	0
O&M Grade:	2
Clock Start/From:	8
Clock To:	4
1st Value:	
2nd Value:	
Value Percent:	5.000
Continuous Index:	F01
Within 8" of Joint:	NO
Remarks:
