Profile/Ph	oto Observatio	n Report			RedZone
Date:	04/06/2018	Weather:		Coding:	PACP 6.0
Pipe Length (ft)	: <b>82.0</b>	Owner:	NA	Pre Clean:	Not Known
P.O.#:		Surveyor:	Jen Costello	PSR:	P-708-021-022
Customer:		Clean Date:	01/01/1900	Shape:	С
Street:	OFF S LAKE PARK	AVE	Flow Control:	Not Controlled	
City:	Hobart, IN		Year Renewed:		
Location:	Parking Lot		Tape/Media #:		
Purpose:	Maintenance Rela	ated	Dia/Height:	8"	
Use:	Sanitary		Material:	PVC	
Drain Area:	NA		Lining:	Cured in Place	
Category:	NA				
Comment:	Reverse setup. D	ebris at 28'.			
Location Details	s:		Direction of Surv	vey: Upstream	
US MH:	M-708-021	DS MH:	M-708-022	Total Length Surveyed (ft)	: <b>30.0</b>
0&M Index:	2.00	O&M Quick:	230	0 O&M Rating:	6.00
tructural Index:	0.00	Structural Qu	uick: 000		0.00
Overall Index:	2.00	Overall Quic	k: 230	<b>0</b> Overall Rating:	6.00

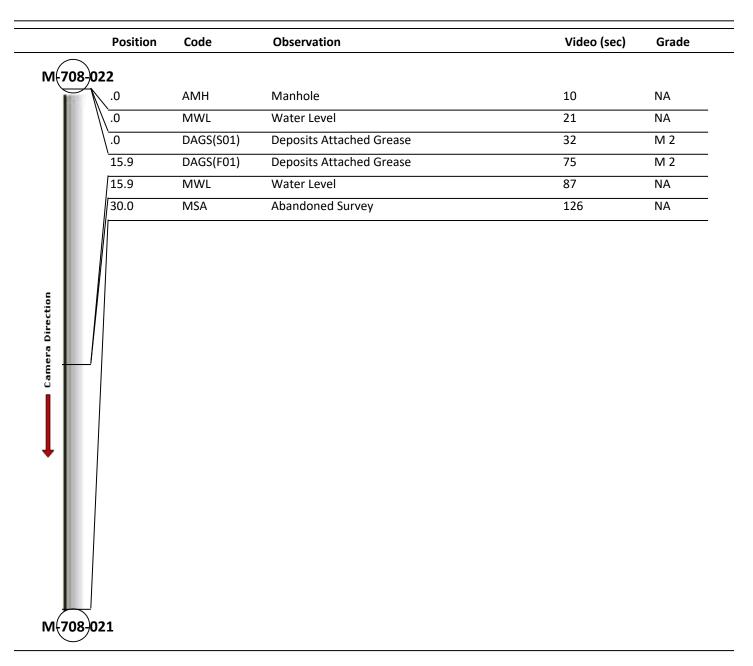
Code: Description:	AMH Manhole
Distance (ft):	.0
Structural Grade:	0
O&M Grade:	0
Clock Start/From:	
Clock To:	
1st Value:	
2nd Value:	
Value Percent:	
Continuous Index:	
Within 8" of Joint:	NO
Remarks:	M-708-022
