## Profile/Photo Observation Report

Street:	<b>Hobart</b>	Flow Control:	<b>Not Controlled</b>
City:	<b>Hobart, IN</b>	Year Renewed:	
Location:	<b>Parking Lot</b>	Tape/Media #:	
Purpose:	<b>Maintenance Related</b>	Dia/Height:	<b>8"</b>
Use:	<b>Sanitary</b>	Material:	<b>PVC</b>
Drain Area:	<b>NA</b>	Lining:	<b>Cured in Place</b>
Category:	<b>NA</b>		
Comment:	<b>Reverse setup. Debris at 28'.</b>

Location Details:		Direction of Survey:	<b>Upstream</b>
US MH:	<b>M-708-021</b>	DS MH:	<b>M-708-022</b>
		Total Length Surveyed (ft):	<b>30.0</b>

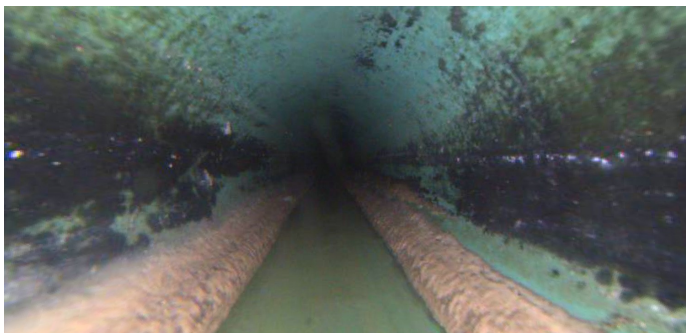
Code: **AMH**  
Description: **Manhole**

Distance (ft): **.0**  
Structural Grade: **0**  
O&M Grade: **0**  
Clock Start/From:  
Clock To:  
1st Value:  
2nd Value:  
Value Percent:  
Continuous Index:  
Within 8" of Joint: **NO**  
Remarks: **M-708-022**

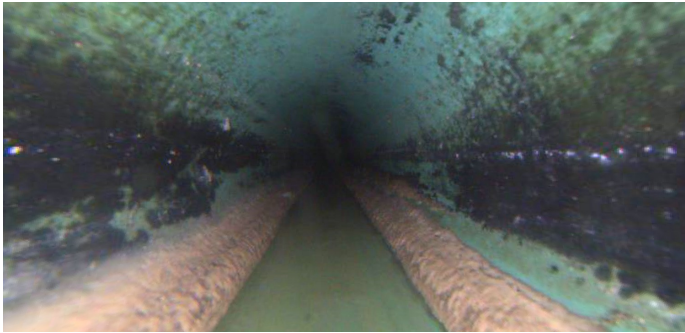
Code:	<b>MWL</b>
Description:	<b>Water Level</b>

Distance (ft):	<b>.0</b>
Structural Grade:	<b>0</b>
O&M Grade:	<b>0</b>
Clock Start/From:	
Clock To:	
1st Value:	
2nd Value:	
Value Percent:	<b>5.000</b>
Continuous Index:	
Within 8" of Joint:	<b>NO</b>
Remarks:

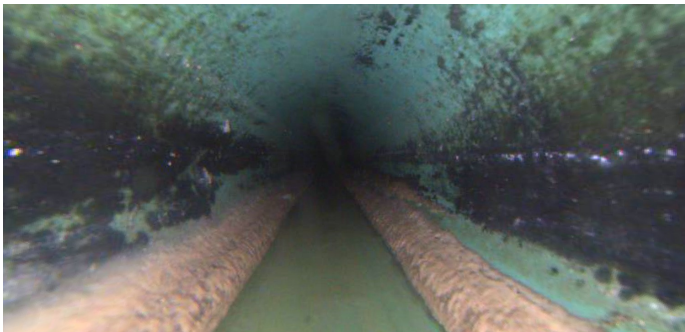
Code:	<b>DAGS</b>
Description:	<b>Deposits Attached Grease</b>

Distance (ft):	<b>.0</b>
Structural Grade:	<b>0</b>
O&M Grade:	<b>2</b>
Clock Start/From:	<b>7</b>
Clock To:	<b>5</b>
1st Value:	
2nd Value:	
Value Percent:	<b>5.000</b>
Continuous Index:	<b>S01</b>
Within 8" of Joint:	<b>NO</b>
Remarks:

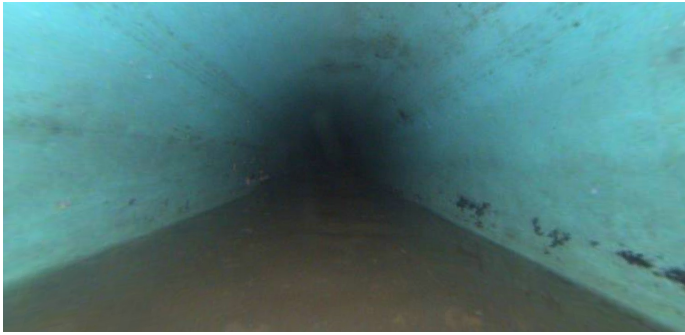
Code: **DAGS**  
Description: **Deposits Attached Grease**

Distance (ft): **15.9**  
Structural Grade: **0**  
O&M Grade: **2**  
Clock Start/From: **7**  
Clock To: **5**  
1st Value:  
2nd Value:  
Value Percent: **5.000**  
Continuous Index: **F01**  
Within 8" of Joint: **NO**  
Remarks:

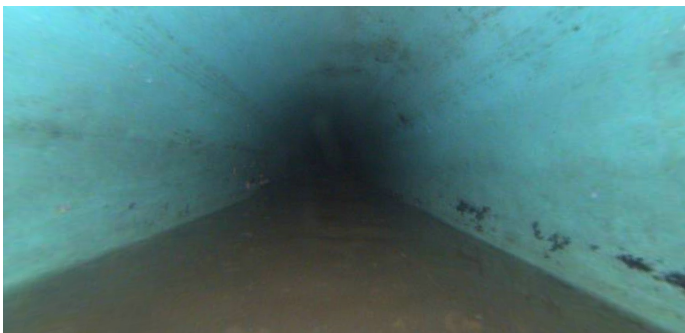
Code: **MWL**  
Description: **Water Level**

Distance (ft): **15.9**  
Structural Grade: **0**  
O&M Grade: **0**  
Clock Start/From:  
Clock To:  
1st Value:  
2nd Value:  
Value Percent: **30.000**  
Continuous Index:  
Within 8" of Joint: **NO**  
Remarks:

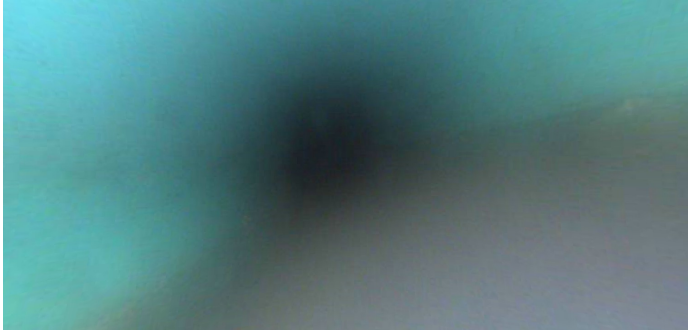
Code:	<b>MSA</b>
Description:	<b>Abandoned Survey</b>
Distance (ft):	<b>30.0</b>
Structural Grade:	<b>0</b>
O&M Grade:	<b>0</b>
Clock Start/From:	
Clock To:	
1st Value:	
2nd Value:	
Value Percent:	
Continuous Index:	
Within 8" of Joint:	<b>NO</b>
Remarks:	<b>overturned</b>
