# Profile/Photo Observation Report

Date:	<b>10/12/2018</b>	Weather:		Coding:	<b>PACP 6.0</b>
Pipe Length (ft):	<b>82.6</b>	Owner:	<b>NA</b>	Pre Clean:	<b>Not Known</b>
P.O.#:		Surveyor:	<b>Selasie Honu</b>	PSR:	<b>P-708-021-022</b>
Customer:		Clean Date:	<b>01/01/1900</b>	Shape:	<b>C</b>

Street:	<b>OFF S LAKE PARK AVE</b>	Flow Control:	<b>Not Controlled</b>
City:	<b>Hobart, IN</b>	Year Renewed:	
Location:	<b>Light Highway</b>	Tape/Media #:	
Purpose:	<b>Routine Assessment</b>	Dia/Height:	<b>8"</b>
Use:	<b>Sanitary</b>	Material:	<b>PVC</b>
Drain Area:	<b>NA</b>	Lining:	
Category:	<b>NA</b>		
Comment:			
Location Details:		Direction of Survey:	<b>Upstream</b>
US MH:	<b>M-708-021</b>	DS MH:	<b>M-708-022</b>
		Total Length Surveyed (ft):	<b>79.3</b>

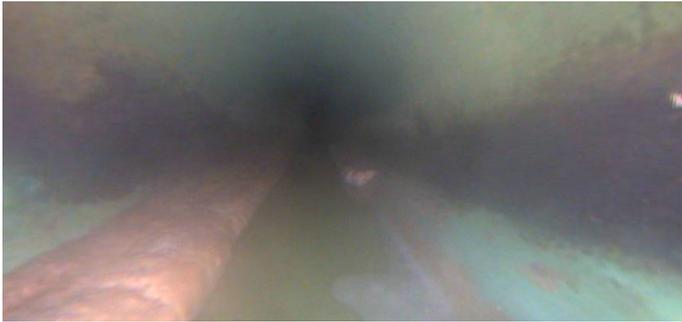
Code: **MWL**  
Description: **Water Level**

Distance (ft): **.0**  
Structural Grade: **0**  
O&M Grade: **0**  
Clock Start/From:  
Clock To:  
1st Value:  
2nd Value:  
Value Percent: **5.000**  
Continuous Index:  
Within 8" of Joint: **NO**  
Remarks:

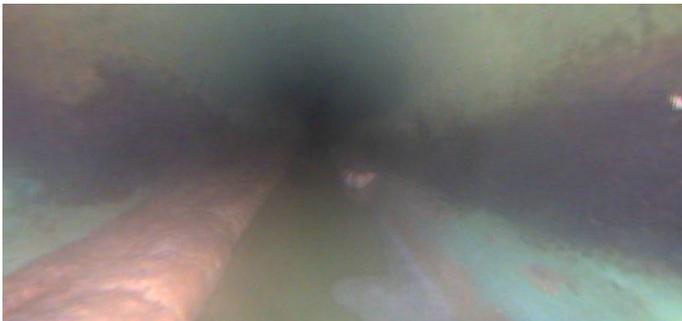
Code: **DAGS**  
Description: **Deposits Attached Grease**

Distance (ft): **.0**  
Structural Grade: **0**  
O&M Grade: **3**  
Clock Start/From: **7**  
Clock To: **8**  
1st Value:  
2nd Value:  
Value Percent: **20.000**  
Continuous Index:  
Within 8" of Joint: **NO**  
Remarks:

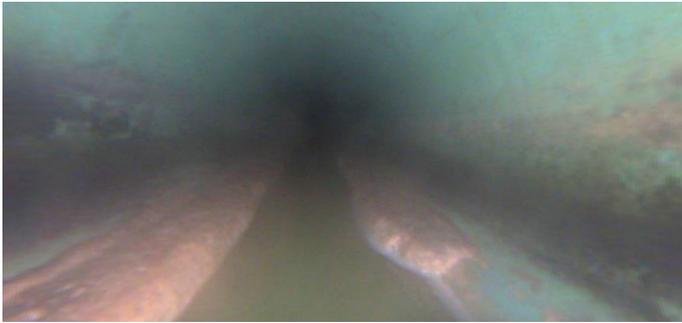
Code: **DAGS**  
Description: **Deposits Attached Grease**

Distance (ft): **1.9**  
Structural Grade: **0**  
O&M Grade: **3**  
Clock Start/From: **4**  
Clock To: **5**  
1st Value:  
2nd Value:  
Value Percent: **15.000**  
Continuous Index: **S01**  
Within 8" of Joint: **NO**  
Remarks:

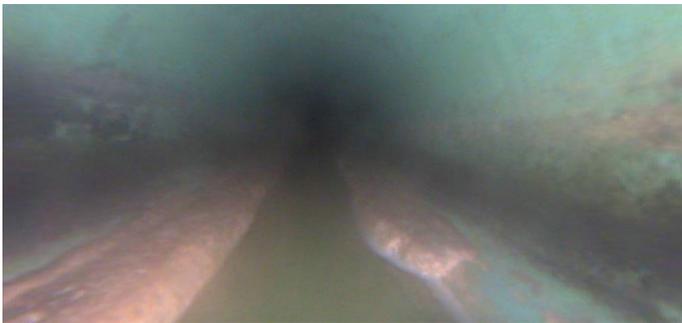
Code: **DAGS**  
Description: **Deposits Attached Grease**

Distance (ft): **1.9**  
Structural Grade: **0**  
O&M Grade: **3**  
Clock Start/From: **7**  
Clock To: **8**  
1st Value:  
2nd Value:  
Value Percent: **20.000**  
Continuous Index: **S02**  
Within 8" of Joint:  
Remarks:

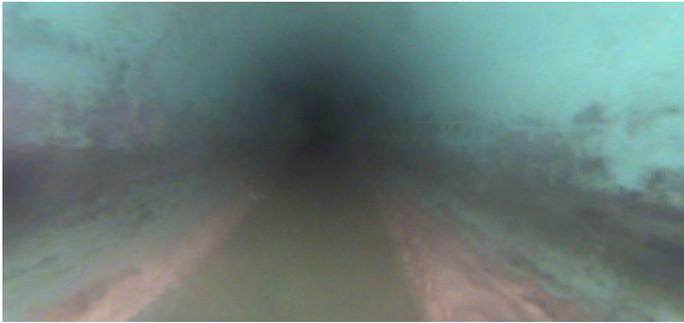
Code: **DAGS**  
Description: **Deposits Attached Grease**

Distance (ft): **4.9**  
Structural Grade: **0**  
O&M Grade: **3**  
Clock Start/From: **7**  
Clock To: **8**  
1st Value:  
2nd Value:  
Value Percent: **20.000**  
Continuous Index: **F02**  
Within 8" of Joint:  
Remarks:

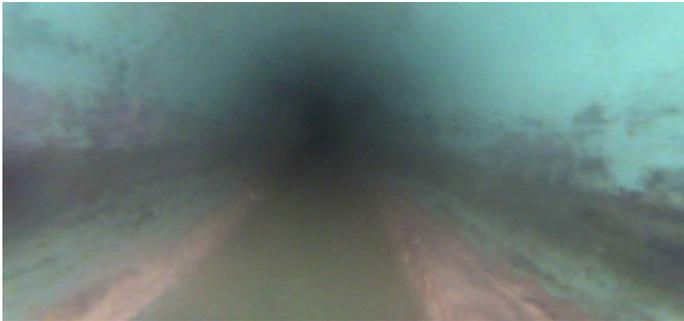
Code: **DAGS**  
Description: **Deposits Attached Grease**

Distance (ft): **4.9**  
Structural Grade: **0**  
O&M Grade: **3**  
Clock Start/From: **4**  
Clock To: **5**  
1st Value:  
2nd Value:  
Value Percent: **15.000**  
Continuous Index: **F01**  
Within 8" of Joint: **NO**  
Remarks:
