## Profile/Photo Observation Report

Street:	<b>Lake Park Ave.</b>	Flow Control:	<b>Not Controlled</b>
City:	<b>Hobart, IN</b>	Year Renewed:	
Location:	<b>Light Highway</b>	Tape/Media #:	
Purpose:	<b>Routine Assessment</b>	Dia/Height:	<b>8"</b>
Use:	<b>Sanitary</b>	Material:	<b>PVC</b>
Drain Area:	<b>NA</b>	Lining:	
Category:	<b>NA</b>		
Comment:

Location Details:		Direction of Survey:	<b>Upstream</b>
US MH:	<b>M-708-021</b>	DS MH:	<b>M-708-022</b>
		Total Length Surveyed (ft):	<b>79.3</b>

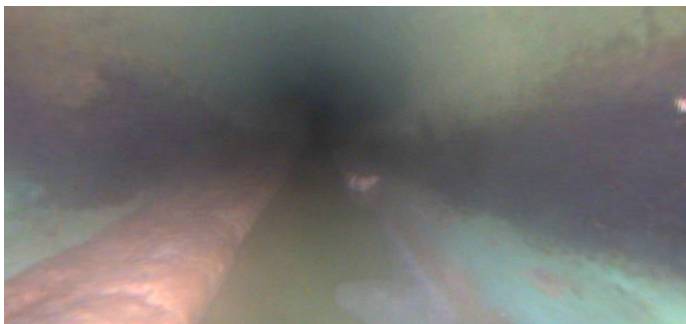
Code: **AMH**  
Description: **Manhole**

Distance (ft): **.0**  
Structural Grade: **0**  
O&M Grade: **0**  
Clock Start/From:  
Clock To:  
1st Value:  
2nd Value:  
Value Percent:  
Continuous Index:  
Within 8" of Joint: **NO**  
Remarks: **M-708-022**

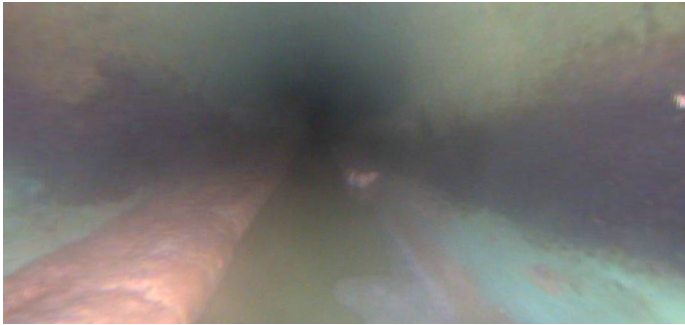
Code:	<b>MWL</b>
Description:	<b>Water Level</b>

Distance (ft):	<b>.0</b>
Structural Grade:	<b>0</b>
O&M Grade:	<b>0</b>
Clock Start/From:	
Clock To:	
1st Value:	
2nd Value:	
Value Percent:	<b>5.000</b>
Continuous Index:	
Within 8" of Joint:	<b>NO</b>
Remarks:

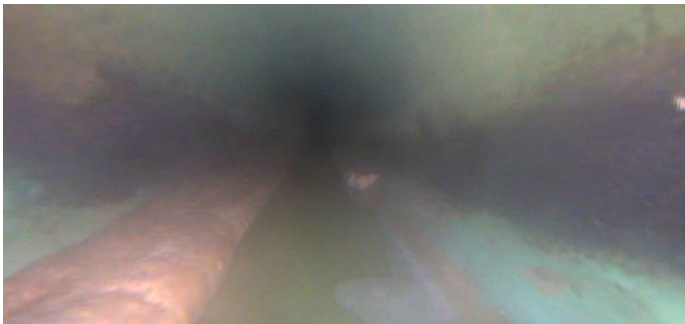
Code:	<b>DAGS</b>
Description:	<b>Deposits Attached Grease</b>

Distance (ft):	<b>.0</b>
Structural Grade:	<b>0</b>
O&M Grade:	<b>3</b>
Clock Start/From:	<b>7</b>
Clock To:	<b>8</b>
1st Value:	
2nd Value:	
Value Percent:	<b>20.000</b>
Continuous Index:	
Within 8" of Joint:	<b>NO</b>
Remarks:

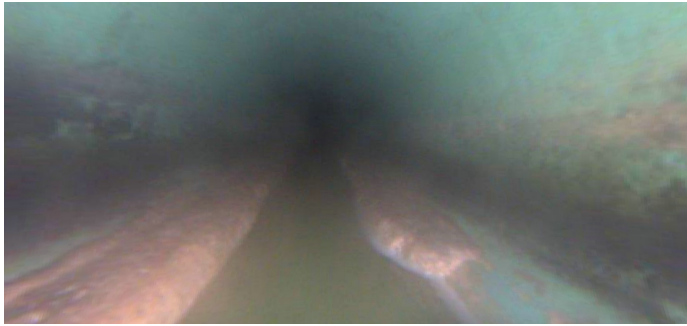
Code: **DAGS**  
Description: **Deposits Attached Grease**

Distance (ft): **1.9**  
Structural Grade: **0**  
O&M Grade: **3**  
Clock Start/From: **4**  
Clock To: **5**  
1st Value:  
2nd Value:  
Value Percent: **15.000**  
Continuous Index: **S01**  
Within 8" of Joint: **NO**  
Remarks:

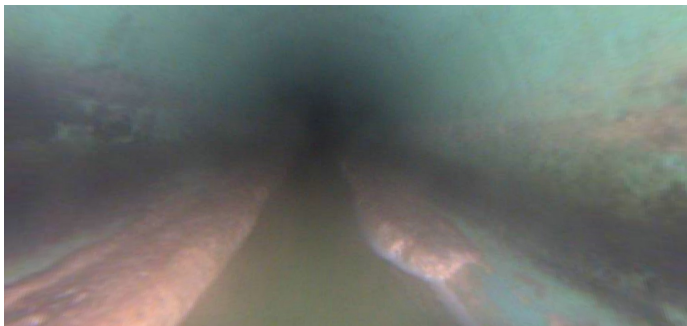
Code: **DAGS**  
Description: **Deposits Attached Grease**

Distance (ft): **1.9**  
Structural Grade: **0**  
O&M Grade: **3**  
Clock Start/From: **7**  
Clock To: **8**  
1st Value:  
2nd Value:  
Value Percent: **20.000**  
Continuous Index: **S02**  
Within 8" of Joint:  
Remarks:

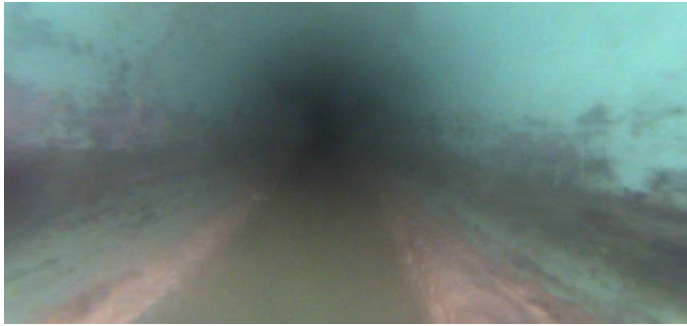
Code: **DAGS**  
Description: **Deposits Attached Grease**

Distance (ft): **4.9**  
Structural Grade: **0**  
O&M Grade: **3**  
Clock Start/From: **7**  
Clock To: **8**  
1st Value:  
2nd Value:  
Value Percent: **20.000**  
Continuous Index: **F02**  
Within 8" of Joint:  
Remarks:

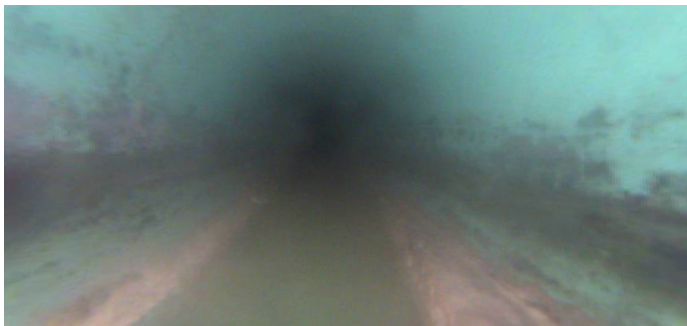
Code: **DAGS**  
Description: **Deposits Attached Grease**

Distance (ft): **4.9**  
Structural Grade: **0**  
O&M Grade: **3**  
Clock Start/From: **4**  
Clock To: **5**  
1st Value:  
2nd Value:  
Value Percent: **15.000**  
Continuous Index: **F01**  
Within 8" of Joint: **NO**  
Remarks:

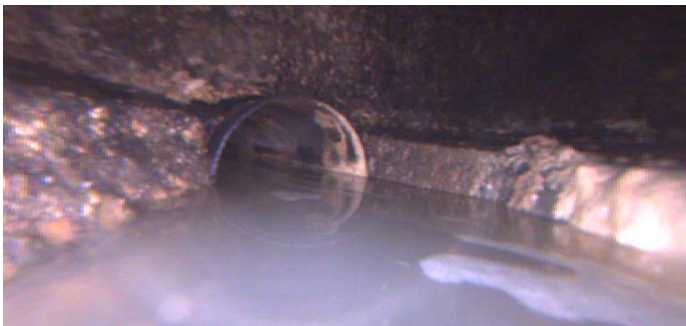
Code: **AMH**  
Description: **Manhole**

Distance (ft): **79.3**  
Structural Grade: **0**  
O&M Grade: **0**  
Clock Start/From:  
Clock To:  
1st Value:  
2nd Value:  
Value Percent:  
Continuous Index:  
Within 8" of Joint: **NO**  
Remarks: **M-708-021**
