Profile/Photo Observation Report

Street:	S LAKE PARK AVE	Flow Control:	Not Controlled
City:	Hobart, IN	Year Renewed:	
Location:	Parking Lot	Tape/Media #:	
Purpose:	Maintenance Related	Dia/Height:	8"
Use:	Sanitary	Material:	PVC
Drain Area:	NA	Lining:	Cured in Place
Category:	NA		
Comment:	Grease at 11'.

Location Details:		Direction of Survey:	Downstream
US MH:	M-708-022	DS MH:	M-708-023
		Total Length Surveyed (ft):	12.6

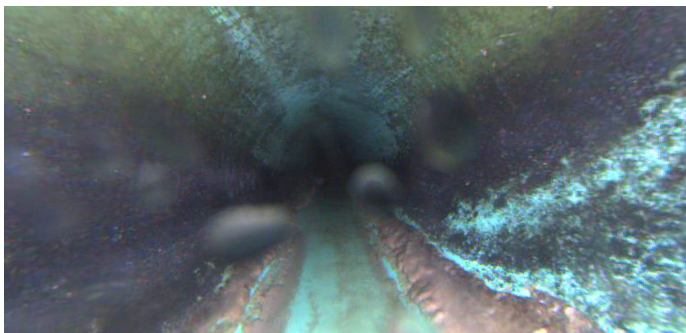
Code: **AMH**
Description: **Manhole**

Distance (ft): **.0**
Structural Grade: **0**
O&M Grade: **0**
Clock Start/From:
Clock To:
1st Value:
2nd Value:
Value Percent:
Continuous Index:
Within 8" of Joint: **NO**
Remarks: **M-708-022**

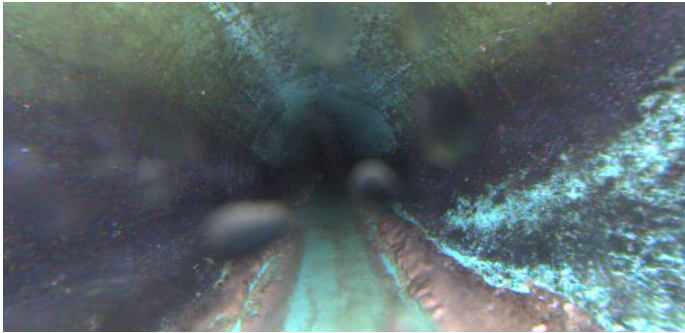
Code:	MWL
Description:	Water Level

Distance (ft):	.0
Structural Grade:	0
O&M Grade:	0
Clock Start/From:	
Clock To:	
1st Value:	
2nd Value:	
Value Percent:	5.000
Continuous Index:	
Within 8" of Joint:	NO
Remarks:

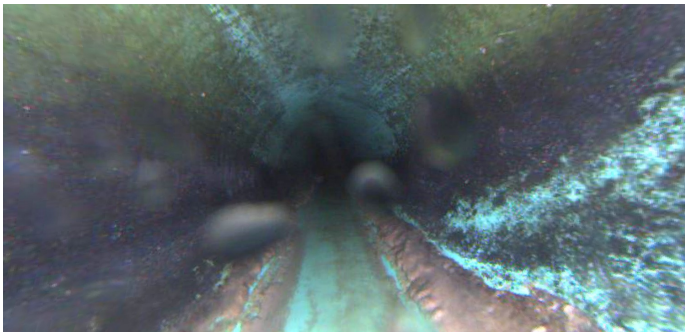
Code:	DAGS
Description:	Deposits Attached Grease

Distance (ft):	.0
Structural Grade:	0
O&M Grade:	2
Clock Start/From:	7
Clock To:	5
1st Value:	
2nd Value:	
Value Percent:	5.000
Continuous Index:	S01
Within 8" of Joint:	NO
Remarks:

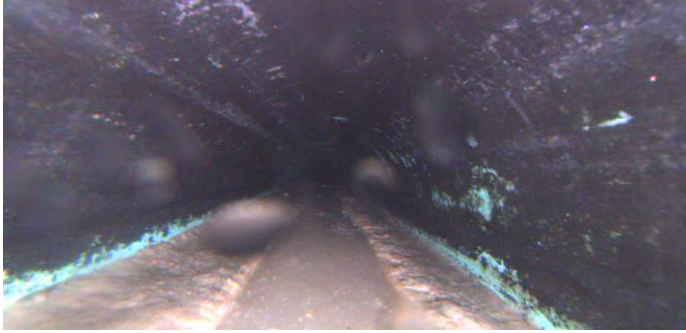
Code: **MSA**
Description: **Abandoned Survey**

Distance (ft): **12.6**
Structural Grade: **0**
O&M Grade: **0**
Clock Start/From:
Clock To:
1st Value:
2nd Value:
Value Percent:
Continuous Index:
Within 8" of Joint: **NO**
Remarks: **debris under water**

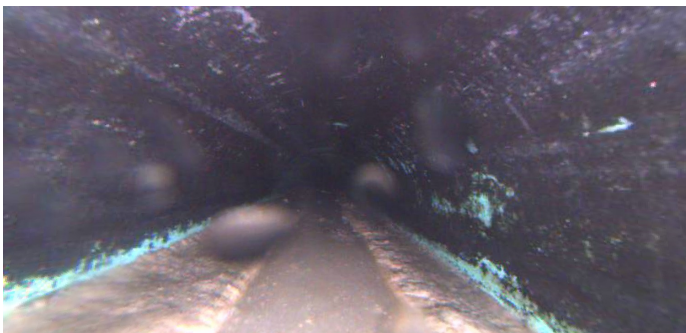
Code: **DAGS**
Description: **Deposits Attached Grease**

Distance (ft): **12.6**
Structural Grade: **0**
O&M Grade: **2**
Clock Start/From: **7**
Clock To: **5**
1st Value:
2nd Value:
Value Percent: **5.000**
Continuous Index: **F01**
Within 8" of Joint: **NO**
Remarks:
