Profile/Photo Observation Report

Date:	04/16/2018	Weather:	Dry	Coding:	PACP 6.0
Pipe Length (ft):		Owner:	City of Hobart	Pre Clean:	No Pre-Cleaning
P.O.#:	65-1	Surveyor:	M. Pielacha	PSR:	M-708-023-M-708-014
Customer:	City of Hobart	Clean Date:		Shape:	C

Street:	Off Lake Park Avenue	Flow Control:	Not Controlled
City:	Hobart, IN	Year Renewed:	
Location:	Parking Lot	Tape/Media #:	DEP 65
Purpose:	Routine Assessment	Dia/Height:	15"
Use:	Sanitary	Material:	PVC
Drain Area:		Lining:	Other
Category:	NA

US MH: **M-708-023** DS MH: **M-708-014** Total Length Surveyed (ft): **.1**

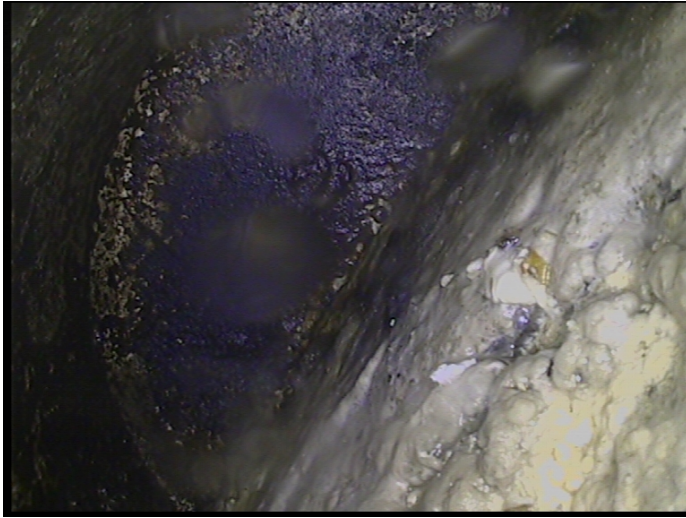
Code: **MWL**
Description: **Water Level**

Distance (ft): **.0**
Structural Grade: **0**
O&M Grade: **0**
Clock Start/From:
Clock To:
1st Value:
2nd Value:
Value Percent: **30.000**
Continuous Index:
Within 8" of Joint: **NO**
Remarks:

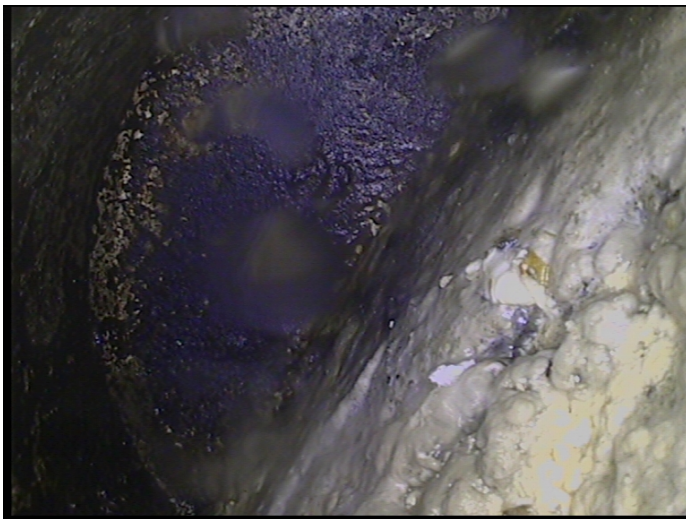
Code: **MSA**
Description: **Abandoned Survey**

Distance (ft): **.0**
Structural Grade: **0**
O&M Grade: **0**
Clock Start/From:
Clock To:
1st Value:
2nd Value:
Value Percent:
Continuous Index:
Within 8" of Joint: **NO**
Remarks: **capped off**
