Profile/Photo Observation Report

Date:	04/10/2018	Weather:		Coding:	PACP 6.0
Pipe Length (ft):		Owner:	City of Hobart	Pre Clean:	Not Known
P.O.#:	222	Surveyor:	B. Helbling	PSR:	P-708-024-023
Customer:	City of Hobart	Clean Date:		Shape:	C

Street:	South Lake Park Avenue	Flow Control:	Not Controlled
City:	Hobart, IN	Year Renewed:	
Location:	Parking Lot	Tape/Media #:	DEP222
Purpose:	Routine Assessment	Dia/Height:	12"
Use:	Sanitary	Material:	PVC
Drain Area:		Lining:	
Category:	NA		
Comment:	YES501824 Submital 2		
Location Details:		Direction of Survey:	Upstream
US MH:	M-708-023	DS MH:	M-708-024
		Total Length Surveyed (ft):	4.6

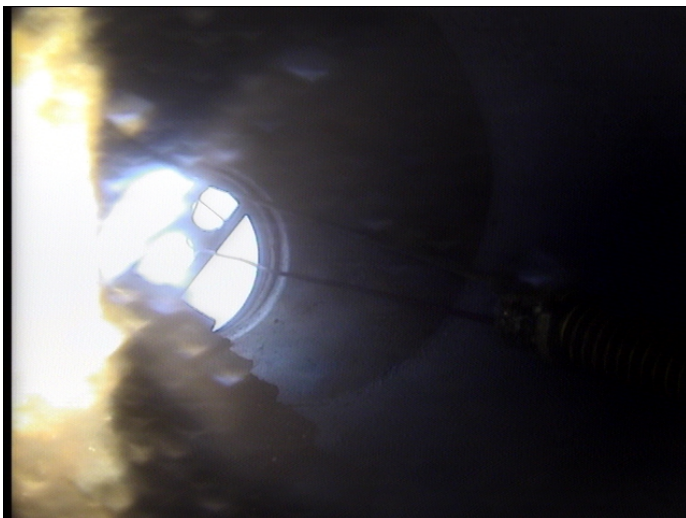
Code: **AMH**
Description: **Manhole**

Distance (ft): **.0**
Structural Grade: **0**
O&M Grade: **0**
Clock Start/From:
Clock To:
1st Value:
2nd Value:
Value Percent:
Continuous Index:
Within 8" of Joint: **NO**
Remarks: **M-708-024**

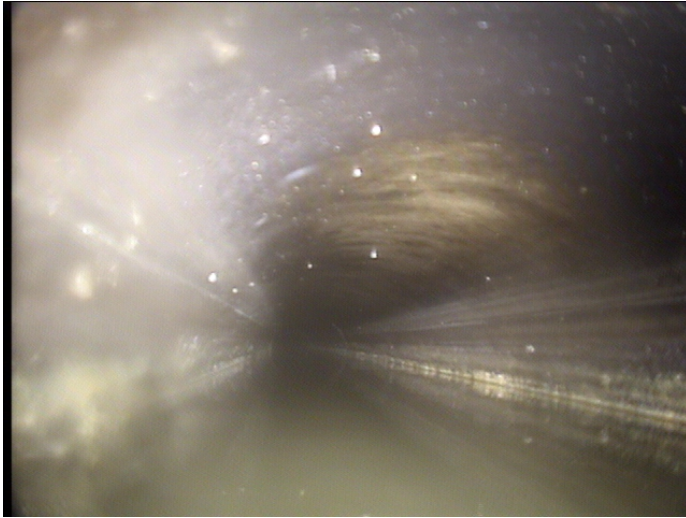
Code: **MWL**
Description: **Water Level**

Distance (ft): **.0**
Structural Grade: **0**
O&M Grade: **0**
Clock Start/From:
Clock To:
1st Value:
2nd Value:
Value Percent: **40.000**
Continuous Index:
Within 8" of Joint: **NO**
Remarks:

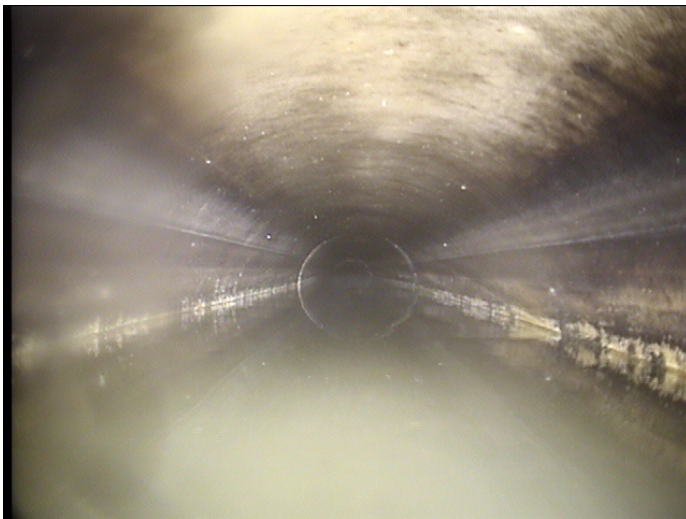
Code: **MSA**
Description: **Abandoned Survey**

Distance (ft): **4.5**
Structural Grade: **0**
O&M Grade: **0**
Clock Start/From:
Clock To:
1st Value:
2nd Value:
Value Percent:
Continuous Index:
Within 8" of Joint: **NO**
Remarks: **Cannot pass debris under flow**
