Profile/Photo Observation Report

| Street: | Hobart | Flow Control: | Not Controlled |

| US MH: | M-708-025 | DS MH: | M-708-198 |

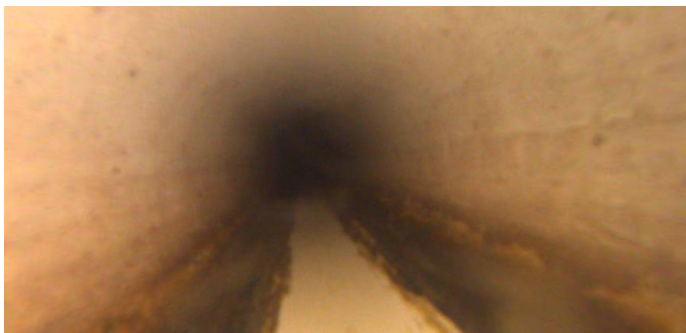
Code: **AMH**
Description: **Manhole**

Distance (ft): **.0**
Structural Grade: **0**
O&M Grade: **0**
Clock Start/From:
Clock To:
1st Value:
2nd Value:
Value Percent:
Continuous Index:
Within 8" of Joint: **NO**
Remarks: **M-708-198**

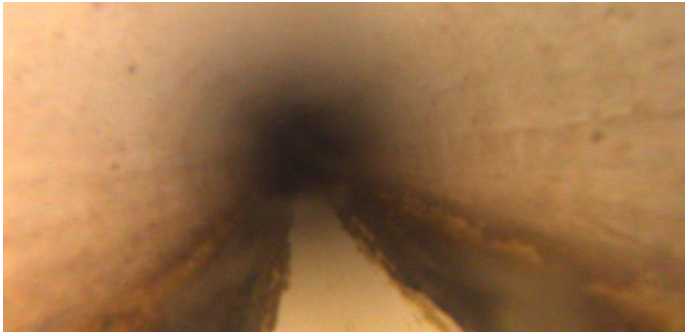
| Code: | MWL |
| Description: | Water Level |

| Value Percent: | 5.000 |

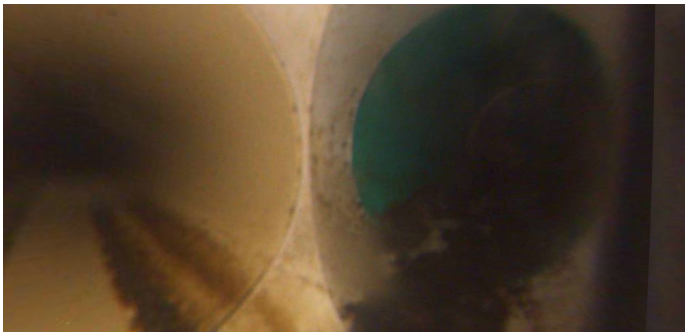
| Code: | TF |
| Description: | Tap Factory |

| Distance (ft): | 55.9 |
| Clock Start/From: | 3 |
| 1st Value: | 4.000 |

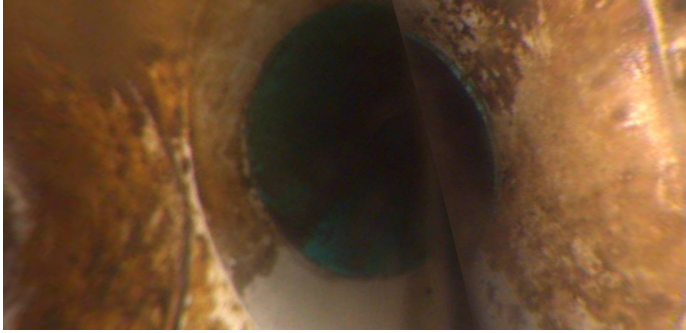
Code: **TF**
Description: **Tap Factory**

Distance (ft): **99.2**
Structural Grade: **0**
O&M Grade: **0**
Clock Start/From: **2**
Clock To:
1st Value: **4.000**
2nd Value:
Value Percent:
Continuous Index:
Within 8" of Joint:
Remarks:

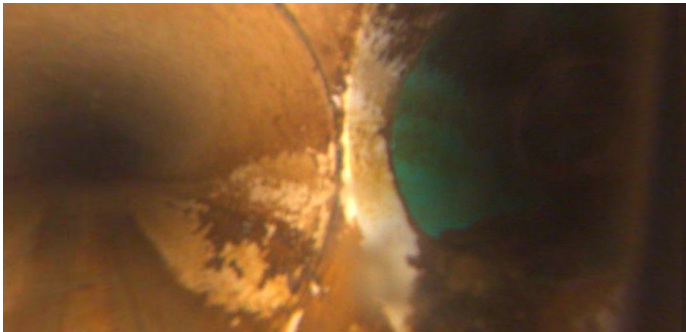
Code: **TFA**
Description: **Tap Factory Active**

Distance (ft): **143.7**
Structural Grade: **0**
O&M Grade: **0**
Clock Start/From: **3**
Clock To:
1st Value: **4.000**
2nd Value:
Value Percent:
Continuous Index:
Within 8" of Joint:
Remarks:

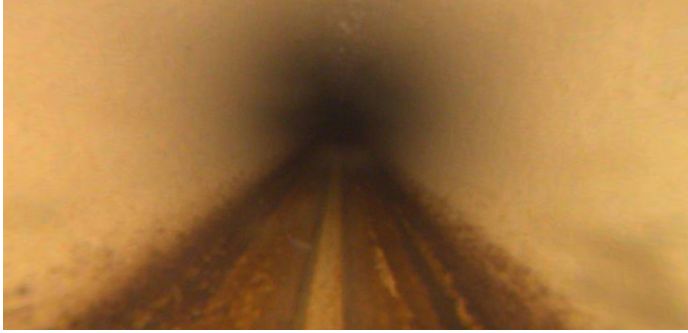
| Code: | MSA |
| Description: | Abandoned Survey |
| Distance (ft): | 172.5 |
| Remarks: | unknown |
