Profile/Photo Observation Report

Date:	04/07/2018	Weather:		Coding:	PACP 6.0
Pipe Length (ft):	392.2	Owner:	NA	Pre Clean:	Not Known
P.O.#:		Surveyor:	Jen Costello	PSR:	P-708-025-019
Customer:		Clean Date:	01/01/1900	Shape:	C

Street:	OFF LAKE ST	Flow Control:	Not Controlled
City:	Hobart, IN	Year Renewed:	
Location:	Parking Lot	Tape/Media #:	
Purpose:	Maintenance Related	Dia/Height:	8"
Use:	Sanitary	Material:	PVC
Drain Area:	NA	Lining:	Cured in Place
Category:	NA		
Comment:	Reverse setup. Debris obstruction at 64'.		
Location Details:		Direction of Survey:	Downstream
US MH:	M-708-025	DS MH:	M-708-198
		Total Length Surveyed (ft):	65.4

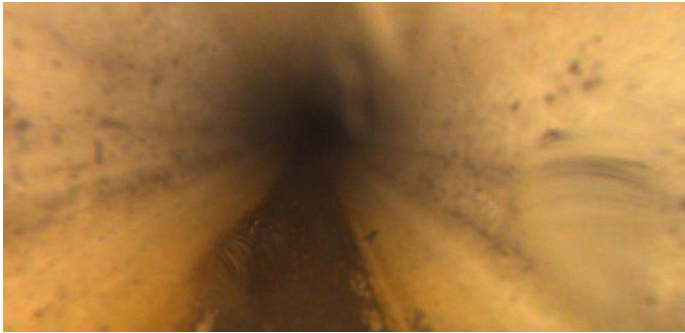
Code:	MWL
Description:	Water Level

Distance (ft):	.0
Structural Grade:	0
O&M Grade:	0
Clock Start/From:	
Clock To:	
1st Value:	
2nd Value:	
Value Percent:	5.000
Continuous Index:	
Within 8" of Joint:	NO
Remarks:

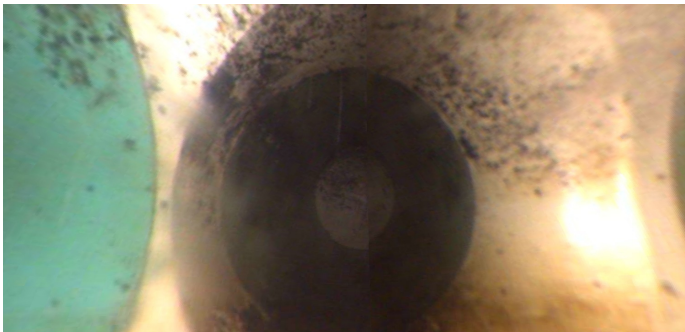
Code:	TFC
Description:	Tap Factory Capped

Distance (ft):	36.5
Structural Grade:	0
O&M Grade:	0
Clock Start/From:	9
Clock To:	
1st Value:	4.000
2nd Value:	
Value Percent:	
Continuous Index:	
Within 8" of Joint:	
Remarks:

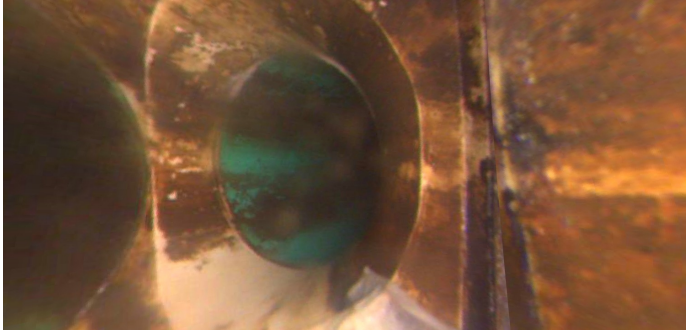
Code: **TF**
Description: **Tap Factory**

Distance (ft): **54.8**
Structural Grade: **0**
O&M Grade: **0**
Clock Start/From: **9**
Clock To:
1st Value: **4.000**
2nd Value:
Value Percent:
Continuous Index:
Within 8" of Joint:
Remarks:

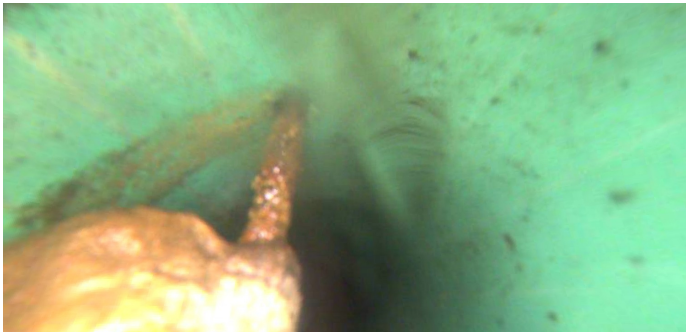
Code: **OBP**
Description: **Obstacle External Pipe or Cable**

Distance (ft): **64.0**
Structural Grade: **0**
O&M Grade: **2**
Clock Start/From: **12**
Clock To: **6**
1st Value:
2nd Value:
Value Percent: **5.000**
Continuous Index:
Within 8" of Joint: **NO**
Remarks:

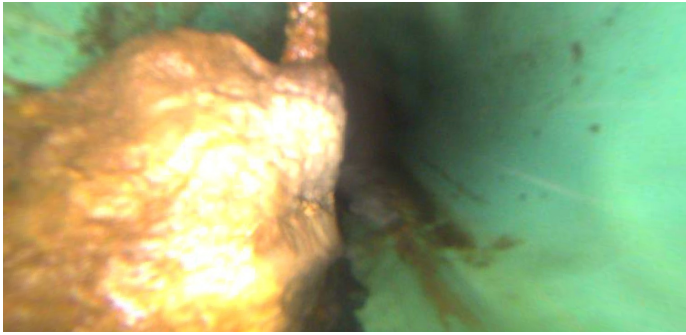
Code: **DAE**
Description: **Deposits Attached Encrustation**

Distance (ft): **64.0**
Structural Grade: **0**
O&M Grade: **5**
Clock Start/From: **6**
Clock To: **10**
1st Value:
2nd Value:
Value Percent: **40.000**
Continuous Index:
Within 8" of Joint: **NO**
Remarks:

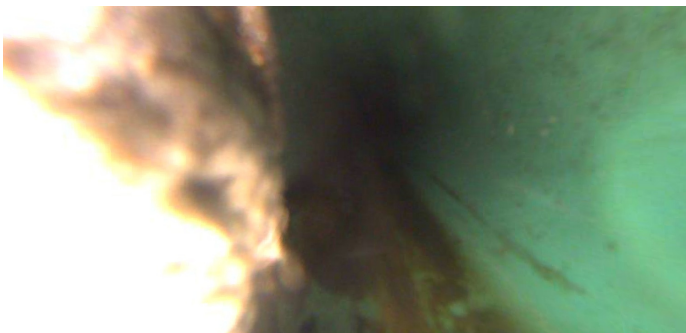
Code: **MSA**
Description: **Abandoned Survey**

Distance (ft): **64.5**
Structural Grade: **0**
O&M Grade: **0**
Clock Start/From:
Clock To:
1st Value:
2nd Value:
Value Percent:
Continuous Index:
Within 8" of Joint: **NO**
Remarks: **OBP**
