## Profile/Photo Observation Report

Date:	<b>04/07/2018</b>	Weather:		Coding:	<b>PACP 6.0</b>
Pipe Length (ft):	<b>392.2</b>	Owner:	<b>NA</b>	Pre Clean:	<b>Not Known</b>
P.O.#:		Surveyor:	<b>Jen Costello</b>	PSR:	<b>P-708-025-019</b>
Customer:		Clean Date:	<b>01/01/1900</b>	Shape:	<b>C</b>

Street:	<b>Hobart</b>	Flow Control:	<b>Not Controlled</b>
City:	<b>Hobart, IN</b>	Year Renewed:	
Location:	<b>Parking Lot</b>	Tape/Media #:	
Purpose:	<b>Maintenance Related</b>	Dia/Height:	<b>8"</b>
Use:	<b>Sanitary</b>	Material:	<b>PVC</b>
Drain Area:	<b>NA</b>	Lining:	<b>Cured in Place</b>
Category:	<b>NA</b>		
Comment:	<b>Reverse setup. Debris obstruction at 64'.</b>		
Location Details:		Direction of Survey:	<b>Downstream</b>
US MH:	<b>M-708-025</b>	DS MH:	<b>M-708-198</b>
		Total Length Surveyed (ft):	<b>65.4</b>

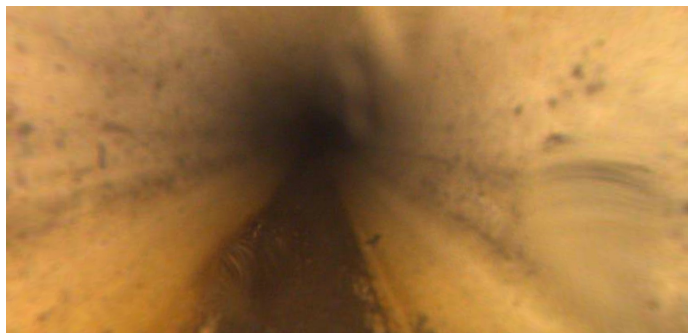
Code: **AMH**  
Description: **Manhole**

Distance (ft): **.0**  
Structural Grade: **0**  
O&M Grade: **0**  
Clock Start/From:  
Clock To:  
1st Value:  
2nd Value:  
Value Percent:  
Continuous Index:  
Within 8" of Joint: **NO**  
Remarks: **M-708-025**

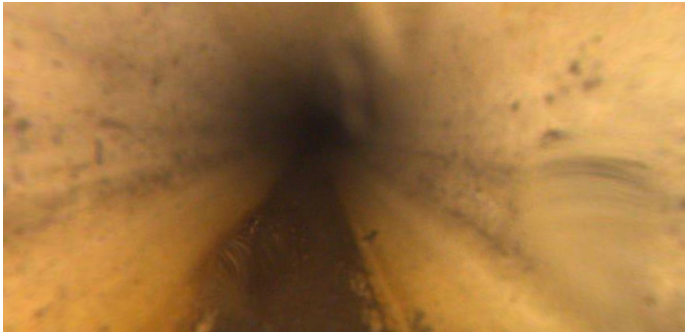
Code:	<b>MWL</b>
Description:	<b>Water Level</b>

Distance (ft):	<b>.0</b>
Structural Grade:	<b>0</b>
O&M Grade:	<b>0</b>
Clock Start/From:	
Clock To:	
1st Value:	
2nd Value:	
Value Percent:	<b>5.000</b>
Continuous Index:	
Within 8" of Joint:	<b>NO</b>
Remarks:

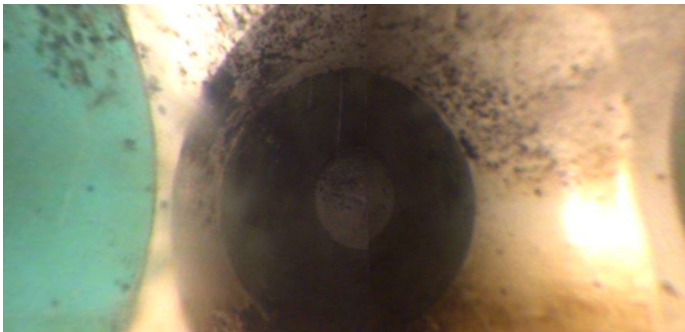
Code:	<b>TFC</b>
Description:	<b>Tap Factory Capped</b>

Distance (ft):	<b>36.5</b>
Structural Grade:	<b>0</b>
O&M Grade:	<b>0</b>
Clock Start/From:	<b>9</b>
Clock To:	
1st Value:	<b>4.000</b>
2nd Value:	
Value Percent:	
Continuous Index:	
Within 8" of Joint:	
Remarks:

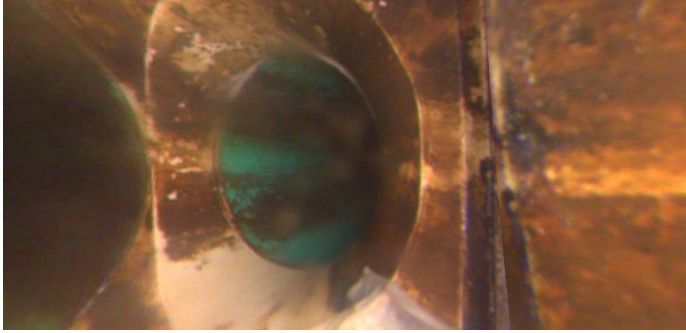
Code: **TF**  
Description: **Tap Factory**

Distance (ft): **54.8**  
Structural Grade: **0**  
O&M Grade: **0**  
Clock Start/From: **9**  
Clock To:  
1st Value: **4.000**  
2nd Value:  
Value Percent:  
Continuous Index:  
Within 8" of Joint:  
Remarks:

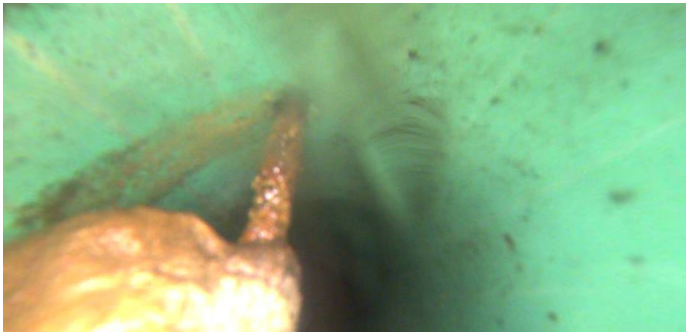
Code: **OBP**  
Description: **Obstacle External Pipe or Cable**

Distance (ft): **64.0**  
Structural Grade: **0**  
O&M Grade: **2**  
Clock Start/From: **12**  
Clock To: **6**  
1st Value:  
2nd Value:  
Value Percent: **5.000**  
Continuous Index:  
Within 8" of Joint: **NO**  
Remarks:

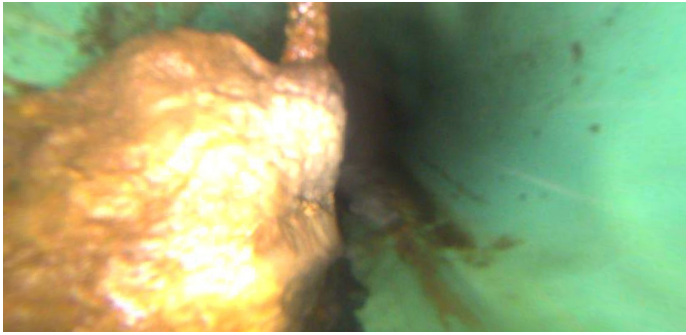
Code: **DAE**  
Description: **Deposits Attached Encrustation**

Distance (ft): **64.0**  
Structural Grade: **0**  
O&M Grade: **5**  
Clock Start/From: **6**  
Clock To: **10**  
1st Value:  
2nd Value:  
Value Percent: **40.000**  
Continuous Index:  
Within 8" of Joint: **NO**  
Remarks:

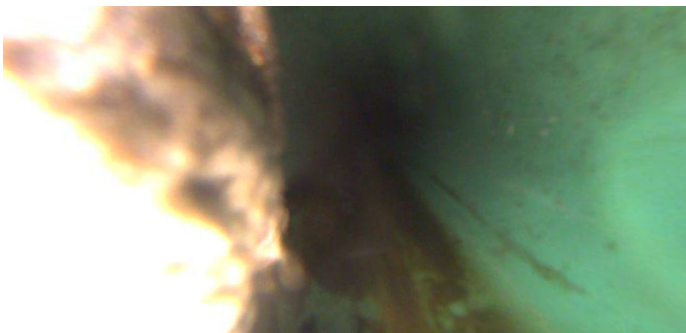
Code: **MSA**  
Description: **Abandoned Survey**

Distance (ft): **64.5**  
Structural Grade: **0**  
O&M Grade: **0**  
Clock Start/From:  
Clock To:  
1st Value:  
2nd Value:  
Value Percent:  
Continuous Index:  
Within 8" of Joint: **NO**  
Remarks: **OBP**
