## Profile/Photo Observation Report

Date:	<b>04/07/2018</b>	Weather:		Coding:	<b>PACP 6.0</b>
Pipe Length (ft):	<b>392.2</b>	Owner:	<b>NA</b>	Pre Clean:	<b>Not Known</b>
P.O.#:		Surveyor:	<b>Jen Costello</b>	PSR:	<b>P-708-025-019</b>
Customer:		Clean Date:	<b>01/01/1900</b>	Shape:	<b>C</b>

Street:	<b>OFF LAKE ST</b>	Flow Control:	<b>Not Controlled</b>
City:	<b>Hobart, IN</b>	Year Renewed:	
Location:	<b>Parking Lot</b>	Tape/Media #:	
Purpose:	<b>Maintenance Related</b>	Dia/Height:	<b>8"</b>
Use:	<b>Sanitary</b>	Material:	<b>PVC</b>
Drain Area:	<b>NA</b>	Lining:	<b>Cured in Place</b>
Category:	<b>NA</b>		
Comment:	<b>Reverse setup. Vertical crossboar at 317'.</b>		
Location Details:		Direction of Survey:	<b>Upstream</b>
US MH:	<b>M-708-025</b>	DS MH:	<b>M-708-198</b>
		Total Length Surveyed (ft):	<b>317.9</b>

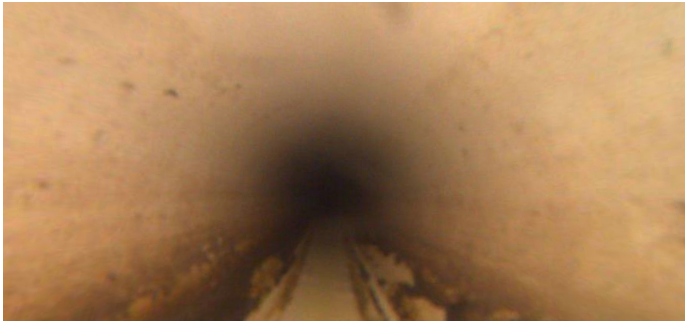
Code:	<b>MWL</b>
Description:	<b>Water Level</b>

Distance (ft):	<b>.0</b>
Structural Grade:	<b>0</b>
O&M Grade:	<b>0</b>
Clock Start/From:	
Clock To:	
1st Value:	
2nd Value:	
Value Percent:	<b>5.000</b>
Continuous Index:	
Within 8" of Joint:	<b>NO</b>
Remarks:

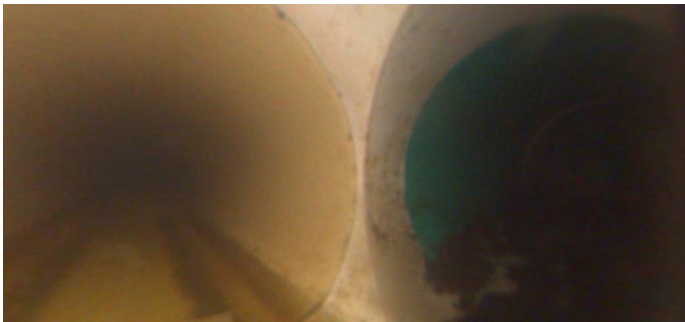
Code:	<b>TF</b>
Description:	<b>Tap Factory</b>

Distance (ft):	<b>56.4</b>
Structural Grade:	<b>0</b>
O&M Grade:	<b>0</b>
Clock Start/From:	<b>3</b>
Clock To:	
1st Value:	<b>4.000</b>
2nd Value:	
Value Percent:	
Continuous Index:	
Within 8" of Joint:	
Remarks:

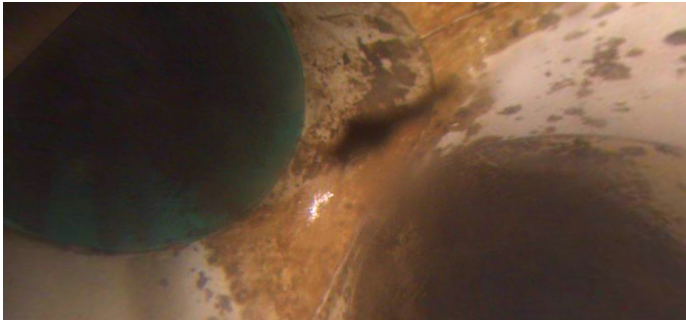
Code: **TF**  
Description: **Tap Factory**

Distance (ft): **100.0**  
Structural Grade: **0**  
O&M Grade: **0**  
Clock Start/From: **2**  
Clock To:  
1st Value: **4.000**  
2nd Value:  
Value Percent:  
Continuous Index:  
Within 8" of Joint:  
Remarks:

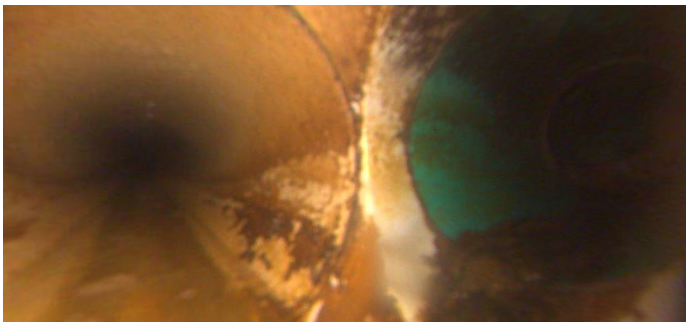
Code: **TF**  
Description: **Tap Factory**

Distance (ft): **144.1**  
Structural Grade: **0**  
O&M Grade: **0**  
Clock Start/From: **3**  
Clock To:  
1st Value: **4.000**  
2nd Value:  
Value Percent:  
Continuous Index:  
Within 8" of Joint:  
Remarks:

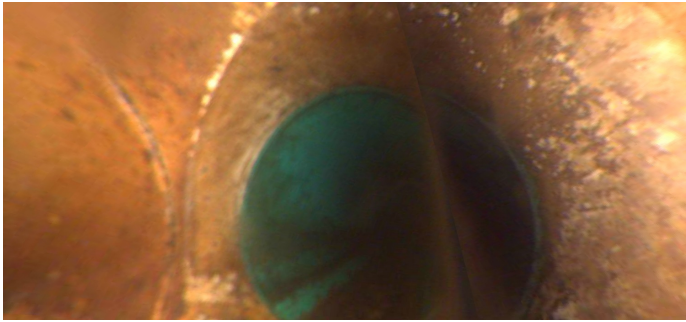
Code: **TF**  
Description: **Tap Factory**

Distance (ft): **190.1**  
Structural Grade: **0**  
O&M Grade: **0**  
Clock Start/From: **3**  
Clock To:  
1st Value: **4.000**  
2nd Value:  
Value Percent:  
Continuous Index:  
Within 8" of Joint:  
Remarks:

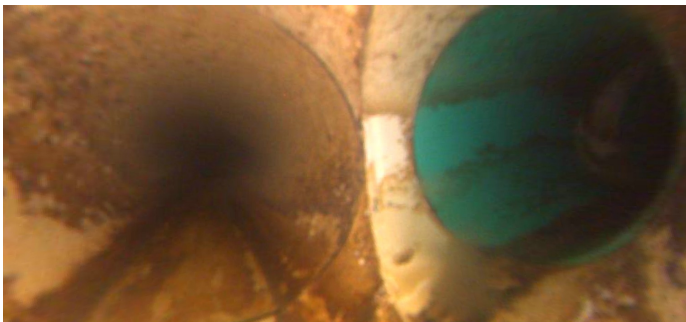
Code: **TF**  
Description: **Tap Factory**

Distance (ft): **254.0**  
Structural Grade: **0**  
O&M Grade: **0**  
Clock Start/From: **3**  
Clock To:  
1st Value: **4.000**  
2nd Value:  
Value Percent:  
Continuous Index:  
Within 8" of Joint:  
Remarks:

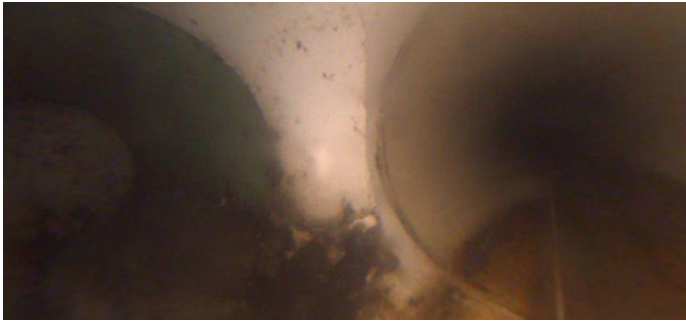
Code: **TFC**  
Description: **Tap Factory Capped**

Distance (ft): **286.8**  
Structural Grade: **0**  
O&M Grade: **0**  
Clock Start/From: **3**  
Clock To:  
1st Value: **4.000**  
2nd Value:  
Value Percent:  
Continuous Index:  
Within 8" of Joint:  
Remarks:

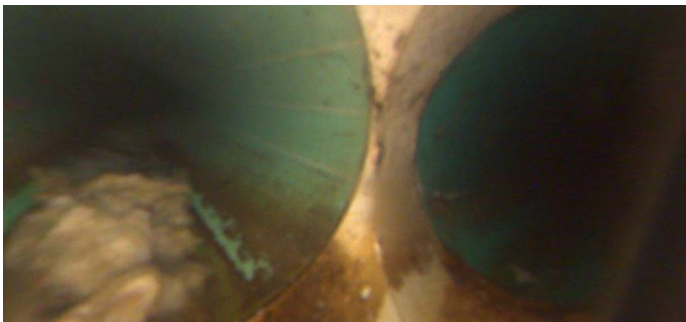
Code: **TF**  
Description: **Tap Factory**

Distance (ft): **307.0**  
Structural Grade: **0**  
O&M Grade: **0**  
Clock Start/From: **3**  
Clock To:  
1st Value: **4.000**  
2nd Value:  
Value Percent:  
Continuous Index:  
Within 8" of Joint:  
Remarks:

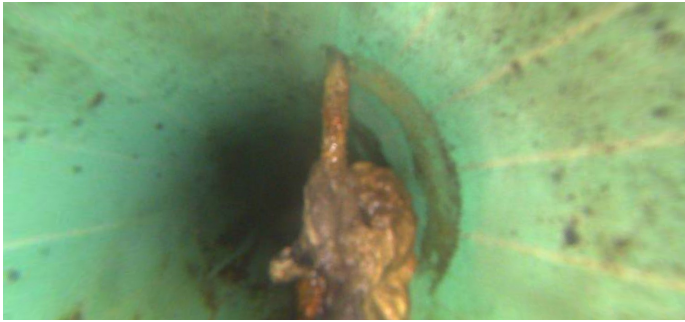
Code: **OBP**  
Description: **Obstacle External Pipe or Cable**

Distance (ft): **316.5**  
Structural Grade: **0**  
O&M Grade: **2**  
Clock Start/From: **12**  
Clock To: **6**  
1st Value:  
2nd Value:  
Value Percent: **10.000**  
Continuous Index:  
Within 8" of Joint: **NO**  
Remarks:

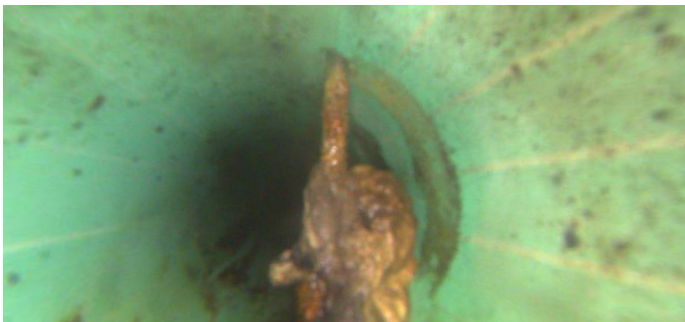
Code: **DAGS**  
Description: **Deposits Attached Grease**

Distance (ft): **316.5**  
Structural Grade: **0**  
O&M Grade: **3**  
Clock Start/From: **3**  
Clock To: **6**  
1st Value:  
2nd Value:  
Value Percent: **20.000**  
Continuous Index:  
Within 8" of Joint: **NO**  
Remarks:

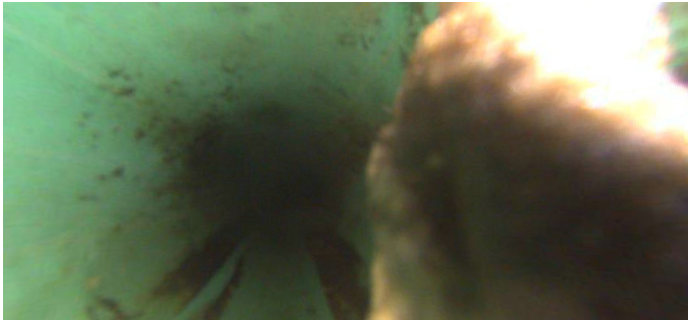
Code:	<b>MSA</b>
Description:	<b>Abandoned Survey</b>
Distance (ft):	<b>317.5</b>
Structural Grade:	<b>0</b>
O&M Grade:	<b>0</b>
Clock Start/From:	
Clock To:	
1st Value:	
2nd Value:	
Value Percent:	
Continuous Index:	
Within 8" of Joint:	<b>NO</b>
Remarks:	<b>obp</b>
