Profile/Photo Observation Report

| Street: | HARBOR CLUB DR | Flow Control: | Not Controlled |
| US MH: | M-705-075.3 | DS MH: | M-705-075.1 |

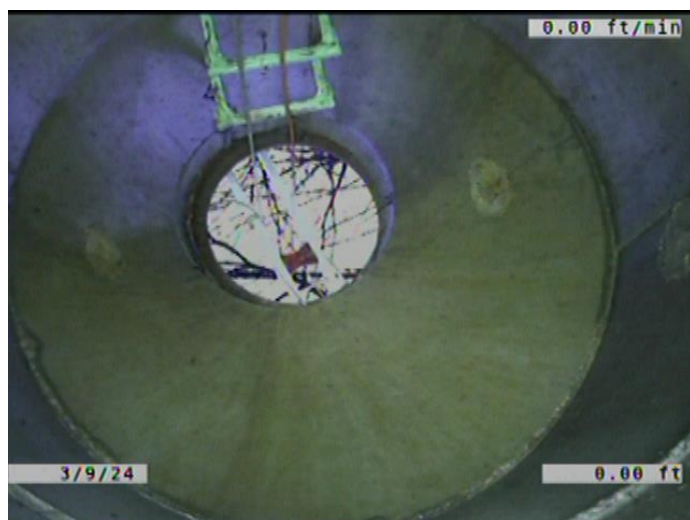
Code: **AMH**
 Description: **Manhole**

Distance (ft): **.0**
 Structural Grade: **0**
 O&M Grade: **0**
 Clock Start/From:
 Clock To:
 1st Value:
 2nd Value:
 Value Percent:
 Continuous Index:
 Within 8" of Joint: **NO**
 Remarks: **M-705-075.1**

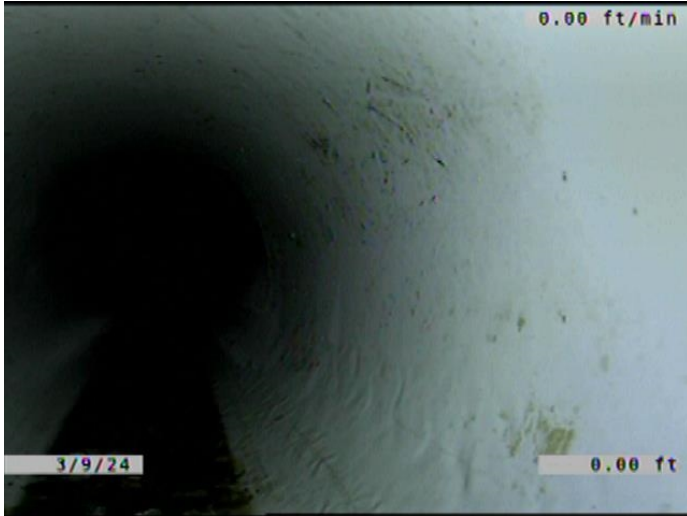
| Code: | MWL |
| Description: | Miscellaneous Water Level |
| Value Percent: | 5.000 |

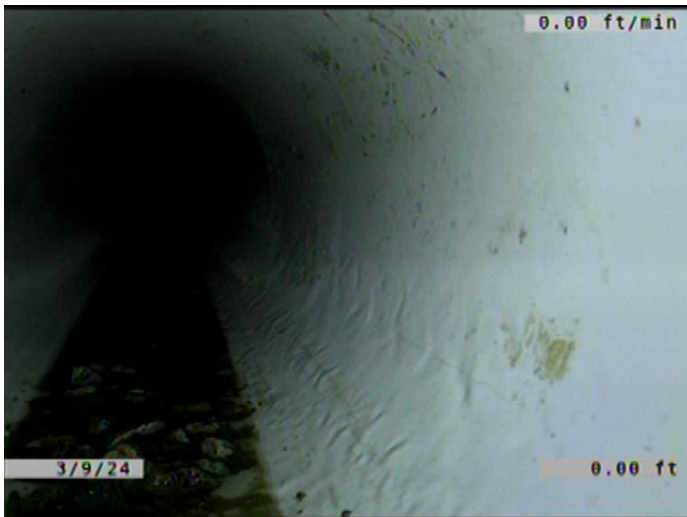
| Code: | DSGV |
| Description: | Deposits Settled Gravel |
| O&M Grade: | 2 |
| Clock Start/From: | 6 |

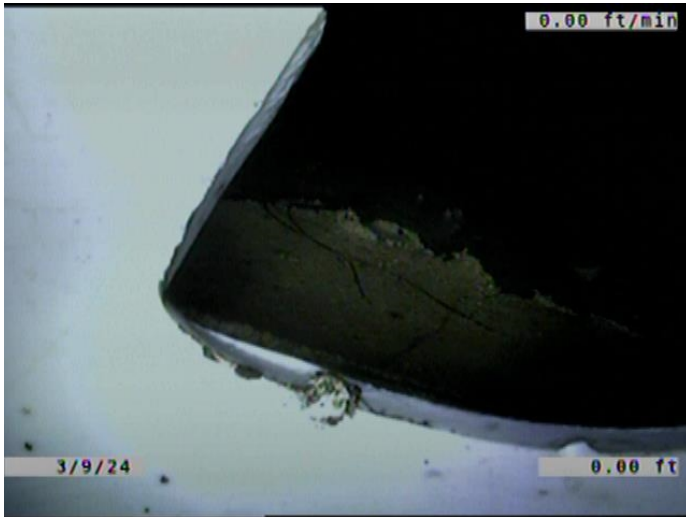
| | Position | Code | Observation | Video (sec) | Grade |
|--|---|---|---|---|---|
| | 0.0 | SMW | Surface Damage Missing Wall | 135 | S 5 |

Code: **SMW**
Description: **Surface Damage Missing Wall**

Distance (ft): **.0**
Structural Grade: **5**
O&M Grade: **0**
Clock Start/From: **11**
Clock To: **1**
1st Value:
2nd Value:
Value Percent:
Continuous Index:
Within 8" of Joint: **YES**
Remarks: **RIGHT AT THE MANHOLE.**

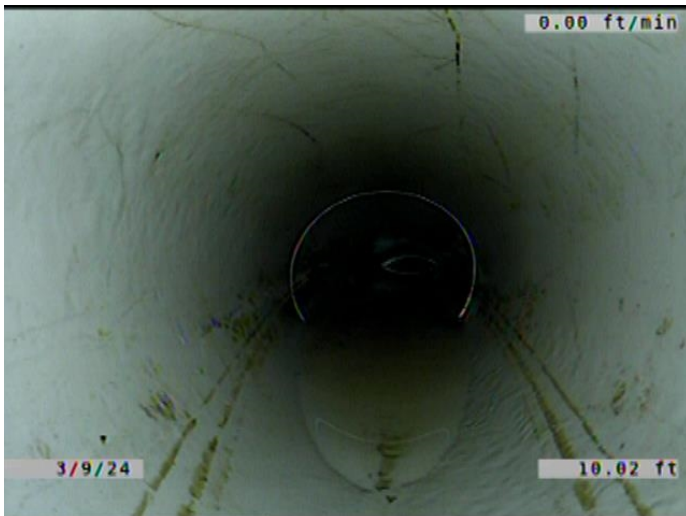
| | Position | Code | Observation | Video (sec) | Grade |
|--|---|---|---|---|---|
| | 10.0 | MWLS(S01) | Miscellaneous Water Level Sag | 204 | S 5 |

Code: **MWLS**
Description: **Miscellaneous Water Level Sag**

Distance (ft): **10.0**
Structural Grade: **5**
O&M Grade: **0**
Clock Start/From:
Clock To:
1st Value:
2nd Value:
Value Percent: **80.000**
Continuous Index: **S01**
Within 8" of Joint: **NO**
Remarks:

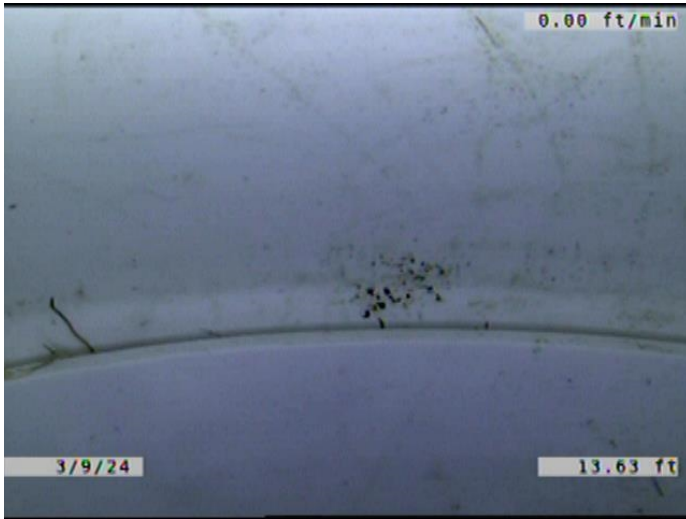
| | Position | Code | Observation | Video (sec) | Grade |
|--|---|---|---|---|---|
| | 13.6 | JAM | Joint Angular Medium | 275 | S 3 |

Code: **JAM**
Description: **Joint Angular Medium**

Distance (ft): **13.6**
Structural Grade: **3**
O&M Grade: **0**
Clock Start/From:
Clock To:
1st Value:
2nd Value:
Value Percent:
Continuous Index:
Within 8" of Joint: **NO**
Remarks:

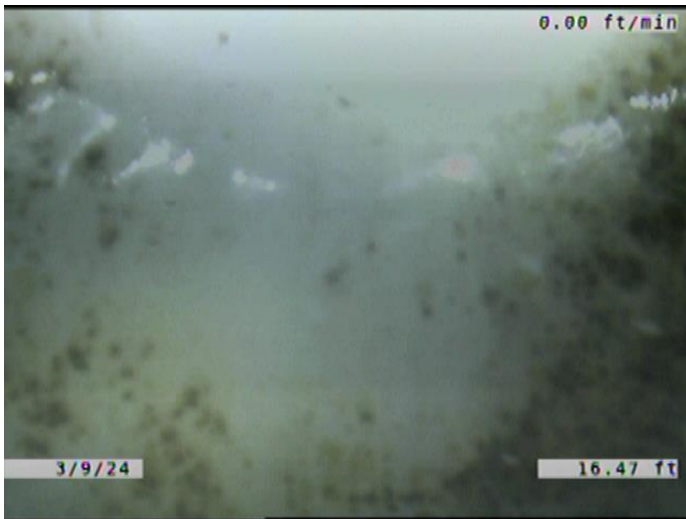
Code: **MCU**
Description: **Miscellaneous Camera Underwater**

Distance (ft): **16.5**
Structural Grade: **0**
O&M Grade: **4**
Clock Start/From:
Clock To:
1st Value:
2nd Value:
Value Percent:
Continuous Index: **S02**
Within 8" of Joint: **NO**
Remarks:

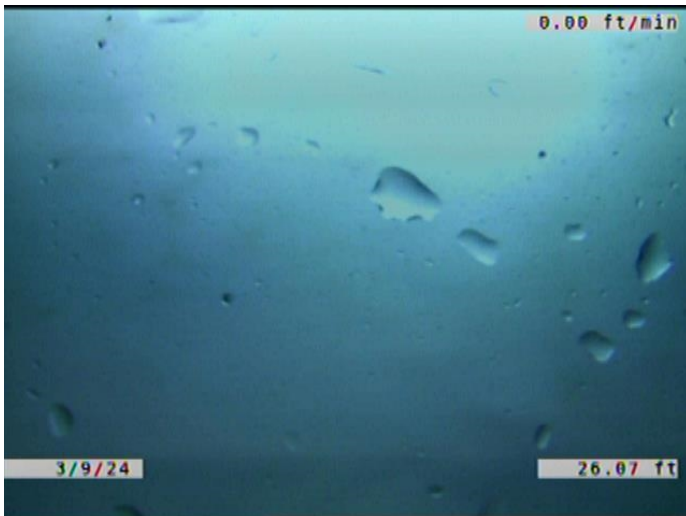
| Code: | MCU |
| Description: | Miscellaneous Camera Underwater |
| O&M Grade: | 4 |

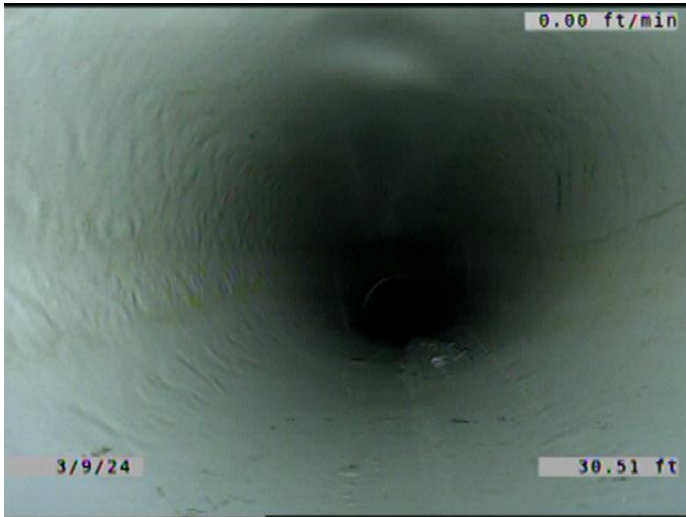
| | Position | Code | Observation | Video (sec) | Grade |
|--|---|---|---|---|---|
| | 30.5 | MWLS(F01) | Miscellaneous Water Level Sag | 494 | S 5 |

Code: **MWLS**
Description: **Miscellaneous Water Level Sag**

Distance (ft): **30.5**
Structural Grade: **5**
O&M Grade: **0**
Clock Start/From:
Clock To:
1st Value:
2nd Value:
Value Percent: **80.000**
Continuous Index: **F01**
Within 8" of Joint: **NO**
Remarks:

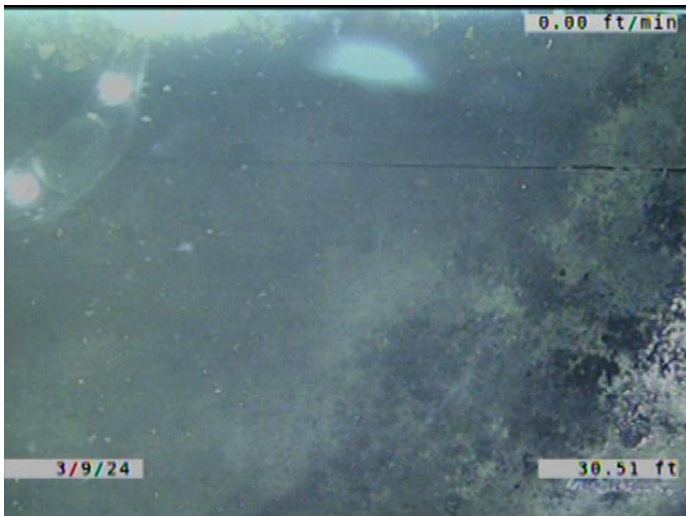
| | Position | Code | Observation | Video (sec) | Grade |
|--|---|---|---|---|---|
| | 30.5 | JAL | Joint Angular Large | 563 | S 4 |

Code: **JAL**
Description: **Joint Angular Large**

Distance (ft): **30.5**
Structural Grade: **4**
O&M Grade: **0**
Clock Start/From:
Clock To:
1st Value:
2nd Value:
Value Percent:
Continuous Index:
Within 8" of Joint: **NO**
Remarks:

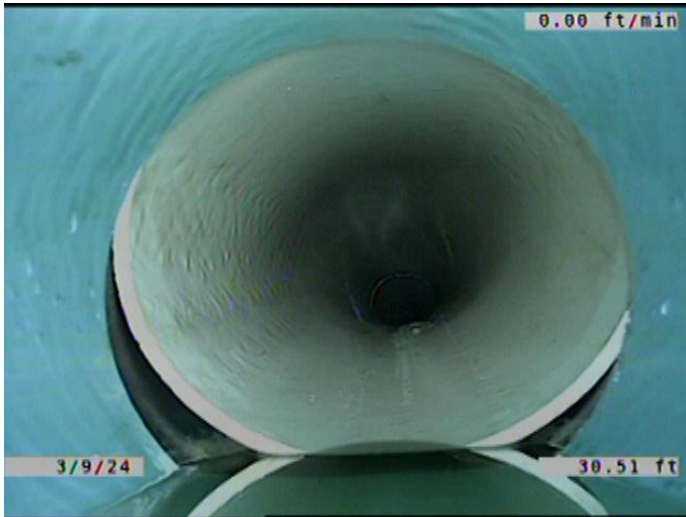
| | Position | Code | Observation | Video (sec) | Grade |
|--|---|---|---|---|---|
| | 30.5 | JOLD | Joint Offset Large Defective | 597 | S 4 |

Code: **JOLD**
Description: **Joint Offset Large Defective**

Distance (ft): **30.5**
Structural Grade: **4**
O&M Grade: **0**
Clock Start/From:
Clock To:
1st Value:
2nd Value:
Value Percent:
Continuous Index:
Within 8" of Joint: **NO**
Remarks:

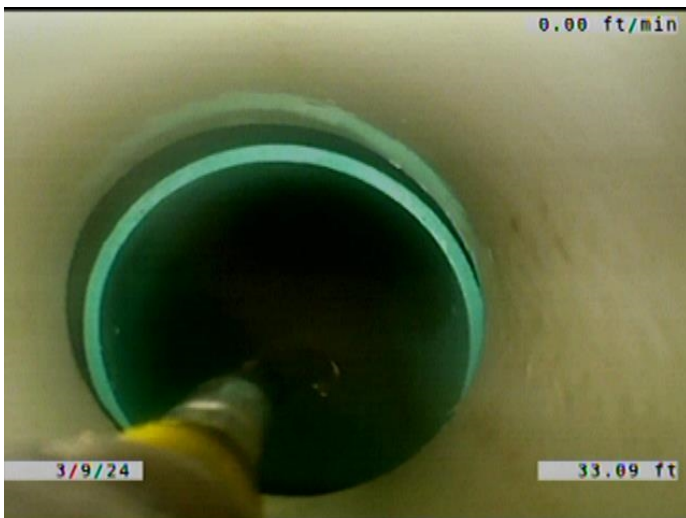
Code: **MGO**
Description: **Miscellaneous General Observation**

Distance (ft): **30.5**
Structural Grade: **0**
O&M Grade: **0**
Clock Start/From:
Clock To:
1st Value:
2nd Value:
Value Percent:
Continuous Index:
Within 8" of Joint: **NO**
Remarks: **WHERE BOWEN TIED BACK INTO THE EXISTING SEWER IN 2018.**

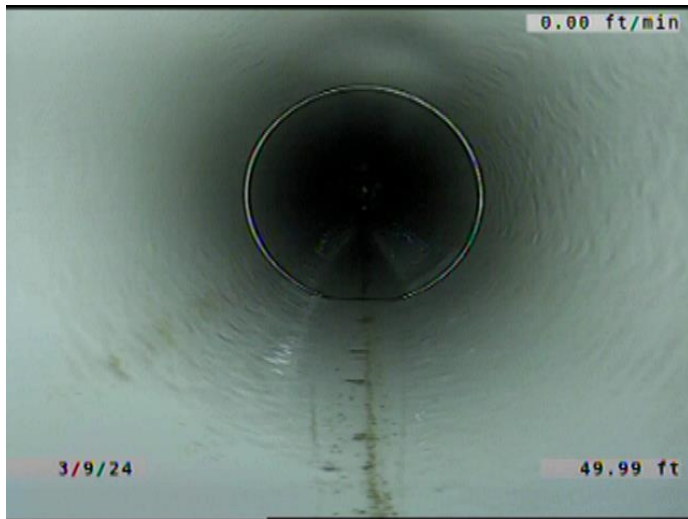
Code: **MWLS**
Description: **Miscellaneous Water Level Sag**

Distance (ft): **50.0**
Structural Grade: **2**
O&M Grade: **0**
Clock Start/From:
Clock To:
1st Value:
2nd Value:
Value Percent: **5.000**
Continuous Index: **S03**
Within 8" of Joint: **NO**
Remarks:

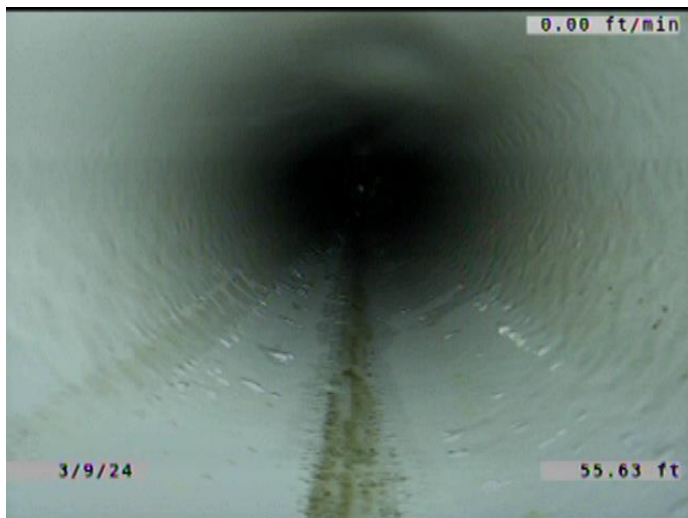
Code: **MWLS**
Description: **Miscellaneous Water Level Sag**

Distance (ft): **55.6**
Structural Grade: **2**
O&M Grade: **0**
Clock Start/From:
Clock To:
1st Value:
2nd Value:
Value Percent: **5.000**
Continuous Index: **F03**
Within 8" of Joint: **NO**
Remarks:

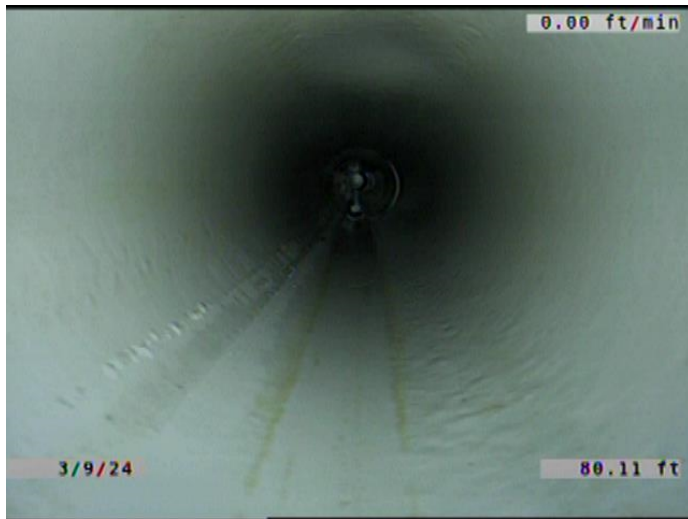
Code: **MWLS**
Description: **Miscellaneous Water Level Sag**

Distance (ft): **80.1**
Structural Grade: **2**
O&M Grade: **0**
Clock Start/From:
Clock To:
1st Value:
2nd Value:
Value Percent: **5.000**
Continuous Index: **S04**
Within 8" of Joint: **NO**
Remarks:

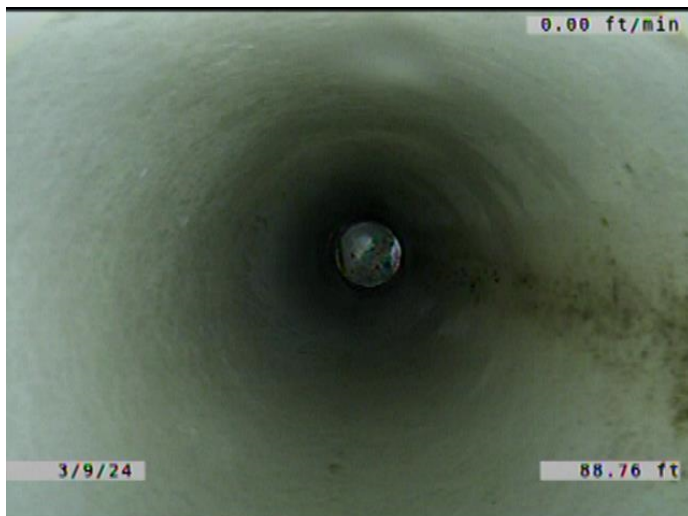
Code: **TFC**
Description: **Tap Factory Capped**

Distance (ft): **88.8**
Structural Grade: **0**
O&M Grade: **0**
Clock Start/From: **3**
Clock To:
1st Value: **6.000**
2nd Value:
Value Percent:
Continuous Index:
Within 8" of Joint: **YES**
Remarks:

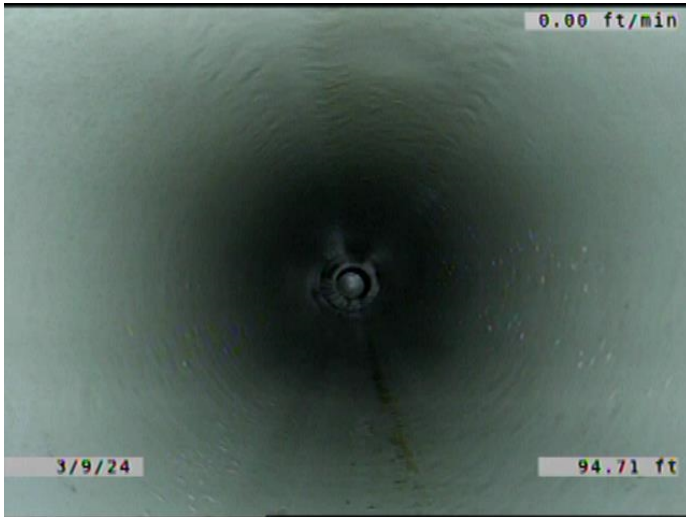
Code: **MWLS**
Description: **Miscellaneous Water Level Sag**

Distance (ft): **94.7**
Structural Grade: **2**
O&M Grade: **0**
Clock Start/From:
Clock To:
1st Value:
2nd Value:
Value Percent: **5.000**
Continuous Index: **F04**
Within 8" of Joint: **NO**
Remarks:

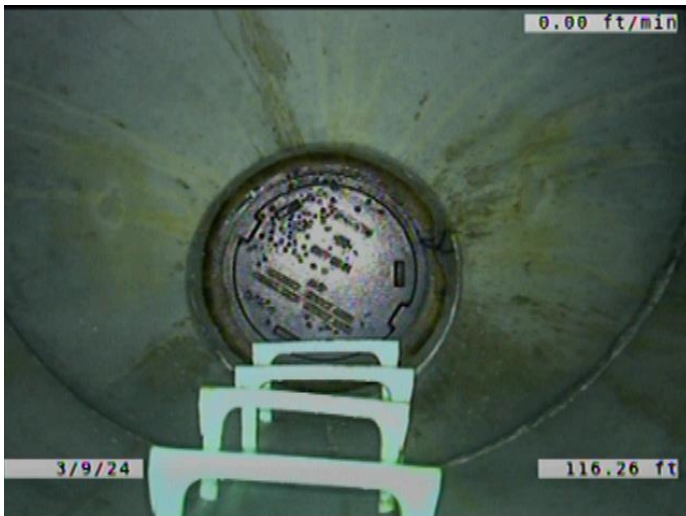
Code: **AMH**
Description: **Manhole**

Distance (ft): **116.3**
Structural Grade: **0**
O&M Grade: **0**
Clock Start/From:
Clock To:
1st Value:
2nd Value:
Value Percent:
Continuous Index:
Within 8" of Joint: **NO**
Remarks: **M-705-075.3**
