Profile/Photo Observation Report

Date:	04/04/2018	Weather:		Coding:	PACP 6.0
Pipe Length (ft):	281.7	Owner:	NA	Pre Clean:	Not Known
P.O.#:		Surveyor:	Jen Costello	PSR:	P-708-028-102
Customer:		Clean Date:	01/01/1900	Shape:	C

Street:	BRACKEN PKWY	Flow Control:	Not Controlled
City:	Hobart, IN	Year Renewed:	
Location:	Sidewalk	Tape/Media #:	
Purpose:	Maintenance Related	Dia/Height:	8"
Use:	Sanitary	Material:	PVC
Drain Area:	NA	Lining:	Cured in Place
Category:	NA		
Comment:

Location Details:		Direction of Survey:	Downstream
US MH:	M-708-102	DS MH:	M-708-028
		Total Length Surveyed (ft):	104.1

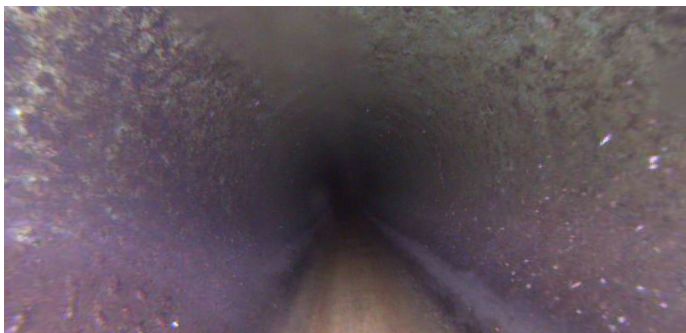
Code: **AMH**
Description: **Manhole**

Distance (ft): **.0**
Structural Grade: **0**
O&M Grade: **0**
Clock Start/From:
Clock To:
1st Value:
2nd Value:
Value Percent:
Continuous Index:
Within 8" of Joint: **NO**
Remarks: **M-708-102**

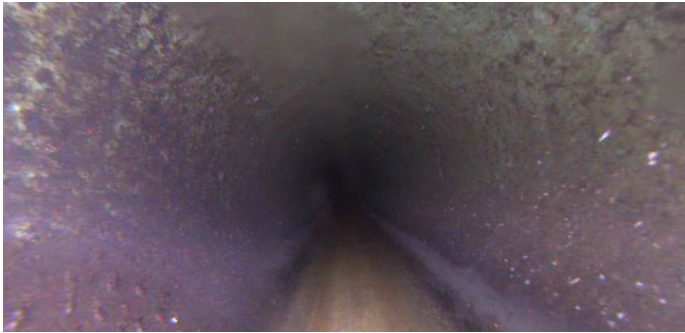
Code:	MWL
Description:	Water Level

Distance (ft):	.0
Structural Grade:	0
O&M Grade:	0
Clock Start/From:	
Clock To:	
1st Value:	
2nd Value:	
Value Percent:	5.000
Continuous Index:	
Within 8" of Joint:	NO
Remarks:

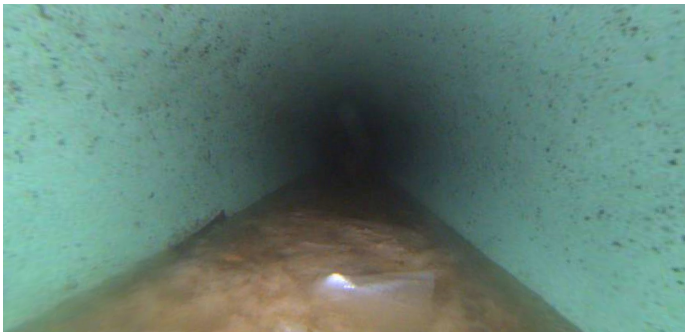
Code:	MWL
Description:	Water Level

Distance (ft):	21.2
Structural Grade:	0
O&M Grade:	0
Clock Start/From:	
Clock To:	
1st Value:	
2nd Value:	
Value Percent:	20.000
Continuous Index:	
Within 8" of Joint:	NO
Remarks:

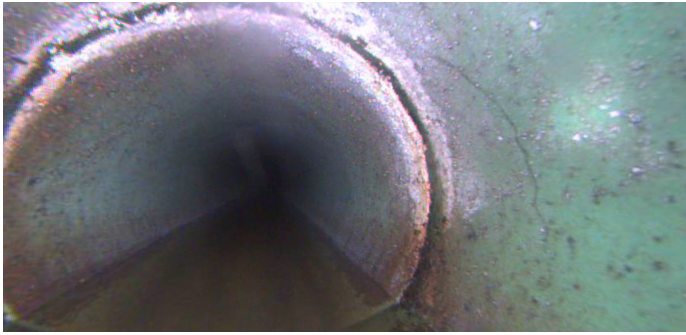
Code: **CS**
Description: **Crack Spiral**

Distance (ft): **76.5**
Structural Grade: **2**
O&M Grade: **0**
Clock Start/From: **2**
Clock To: **4**
1st Value:
2nd Value:
Value Percent:
Continuous Index:
Within 8" of Joint: **YES**
Remarks:

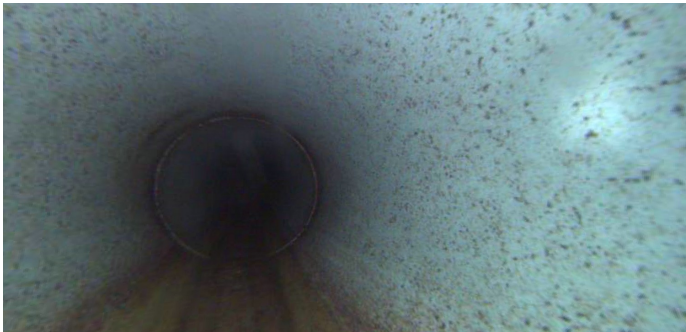
Code: **MWL**
Description: **Water Level**

Distance (ft): **89.3**
Structural Grade: **0**
O&M Grade: **0**
Clock Start/From:
Clock To:
1st Value:
2nd Value:
Value Percent: **5.000**
Continuous Index:
Within 8" of Joint: **NO**
Remarks:

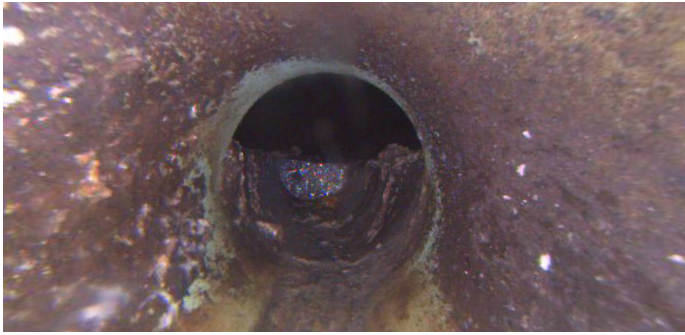
Code: **DAGS**
Description: **Deposits Attached Grease**

Distance (ft): **101.4**
Structural Grade: **0**
O&M Grade: **2**
Clock Start/From: **8**
Clock To: **4**
1st Value:
2nd Value:
Value Percent: **5.000**
Continuous Index:
Within 8" of Joint: **NO**
Remarks:

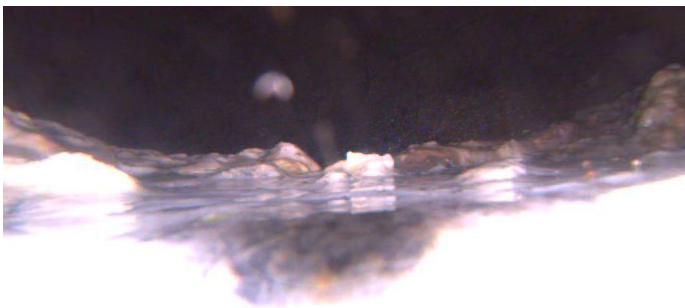
Code: **AMH**
Description: **Manhole**

Distance (ft): **104.1**
Structural Grade: **0**
O&M Grade: **0**
Clock Start/From:
Clock To:
1st Value:
2nd Value:
Value Percent:
Continuous Index:
Within 8" of Joint: **NO**
Remarks: **M-708-028**
