Profile/Photo Observation Report

Street:	Bracken	Flow Control:	Not Controlled
City:	Hobart, IN	Year Renewed:	
Location:	Sidewalk	Tape/Media #:	
Purpose:	Maintenance Related	Dia/Height:	8"
Use:	Sanitary	Material:	PVC
Drain Area:	NA	Lining:	Cured in Place
Category:	NA		
Comment:

Location Details:		Direction of Survey:	Downstream
US MH:	M-708-102	DS MH:	M-708-028
		Total Length Surveyed (ft):	104.1

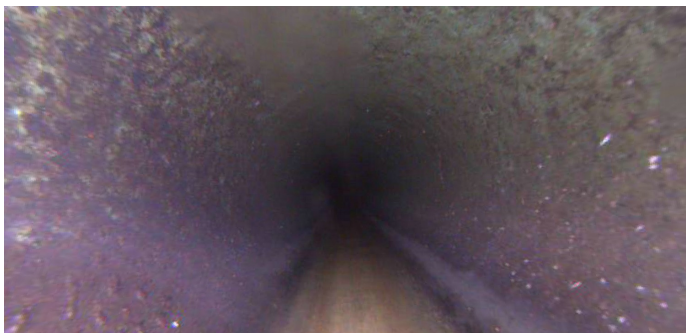
Code: **AMH**
Description: **Manhole**

Distance (ft): **.0**
Structural Grade: **0**
O&M Grade: **0**
Clock Start/From:
Clock To:
1st Value:
2nd Value:
Value Percent:
Continuous Index:
Within 8" of Joint: **NO**
Remarks: **M-708-102**

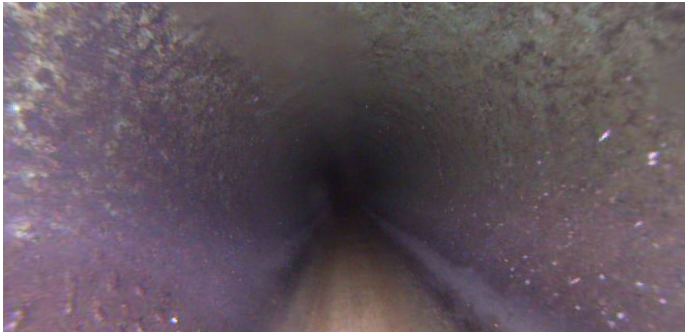
Code:	MWL
Description:	Water Level

Distance (ft):	.0
Structural Grade:	0
O&M Grade:	0
Clock Start/From:	
Clock To:	
1st Value:	
2nd Value:	
Value Percent:	5.000
Continuous Index:	
Within 8" of Joint:	NO
Remarks:

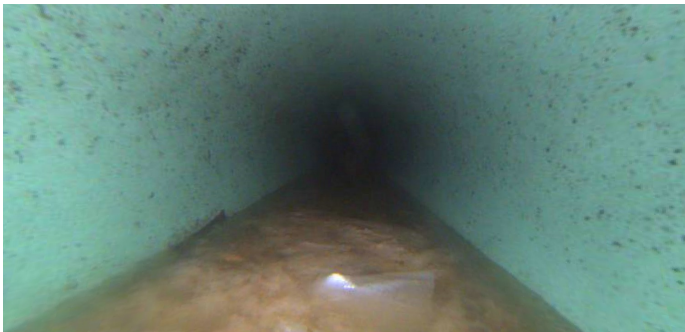
Code:	MWL
Description:	Water Level

Distance (ft):	21.2
Structural Grade:	0
O&M Grade:	0
Clock Start/From:	
Clock To:	
1st Value:	
2nd Value:	
Value Percent:	20.000
Continuous Index:	
Within 8" of Joint:	NO
Remarks:

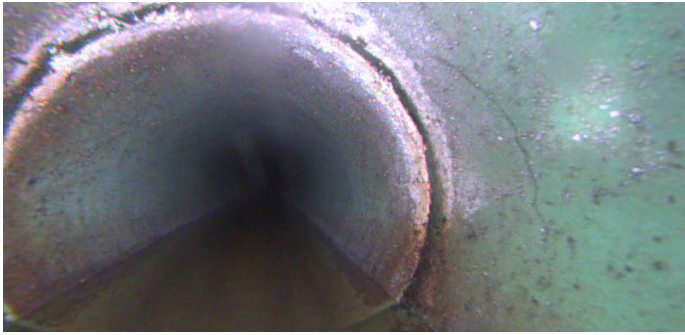
Code: **CS**
Description: **Crack Spiral**

Distance (ft): **76.5**
Structural Grade: **2**
O&M Grade: **0**
Clock Start/From: **2**
Clock To: **4**
1st Value:
2nd Value:
Value Percent:
Continuous Index:
Within 8" of Joint: **YES**
Remarks:

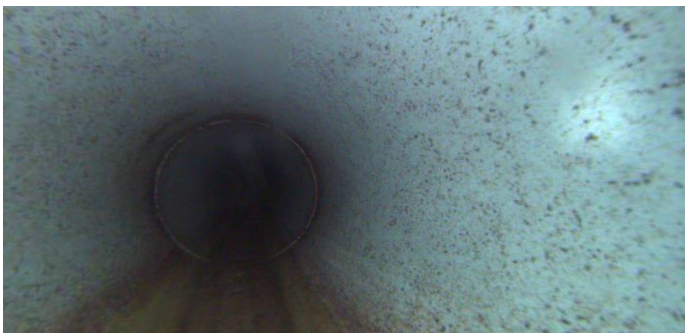
Code: **MWL**
Description: **Water Level**

Distance (ft): **89.3**
Structural Grade: **0**
O&M Grade: **0**
Clock Start/From:
Clock To:
1st Value:
2nd Value:
Value Percent: **5.000**
Continuous Index:
Within 8" of Joint: **NO**
Remarks:

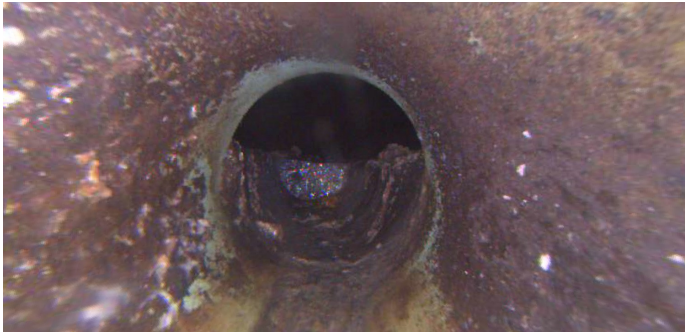
Code: **DAGS**
Description: **Deposits Attached Grease**

Distance (ft): **101.4**
Structural Grade: **0**
O&M Grade: **2**
Clock Start/From: **8**
Clock To: **4**
1st Value:
2nd Value:
Value Percent: **5.000**
Continuous Index:
Within 8" of Joint: **NO**
Remarks:

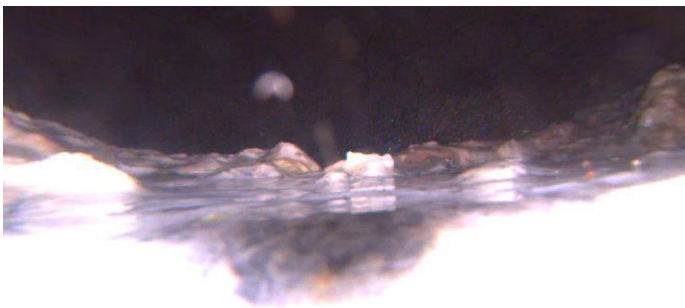
Code: **AMH**
Description: **Manhole**

Distance (ft): **104.1**
Structural Grade: **0**
O&M Grade: **0**
Clock Start/From:
Clock To:
1st Value:
2nd Value:
Value Percent:
Continuous Index:
Within 8" of Joint: **NO**
Remarks: **M-708-028**
