## Profile/Photo Observation Report

Street:	<b>BRACKEN PKWY</b>	Flow Control:	<b>Not Controlled</b>
City:	<b>Hobart, IN</b>	Year Renewed:	
Location:	<b>Sidewalk</b>	Tape/Media #:	
Purpose:	<b>Maintenance Related</b>	Dia/Height:	<b>12"</b>
Use:	<b>Sanitary</b>	Material:	<b>PVC</b>
Drain Area:	<b>NA</b>	Lining:	<b>Cured in Place</b>
Category:	<b>NA</b>		
Comment:

Location Details:		Direction of Survey:	<b>Downstream</b>
US MH:	<b>M-708-102</b>	DS MH:	<b>M-708-101</b>
		Total Length Surveyed (ft):	<b>261.0</b>

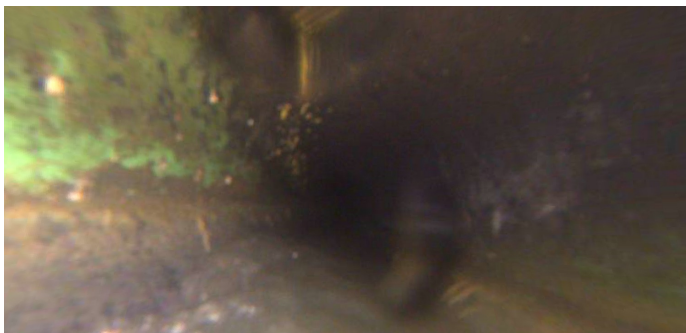
Code: **AMH**  
Description: **Manhole**

Distance (ft): **.0**  
Structural Grade: **0**  
O&M Grade: **0**  
Clock Start/From:  
Clock To:  
1st Value:  
2nd Value:  
Value Percent:  
Continuous Index:  
Within 8" of Joint: **NO**  
Remarks: **M-708-102**

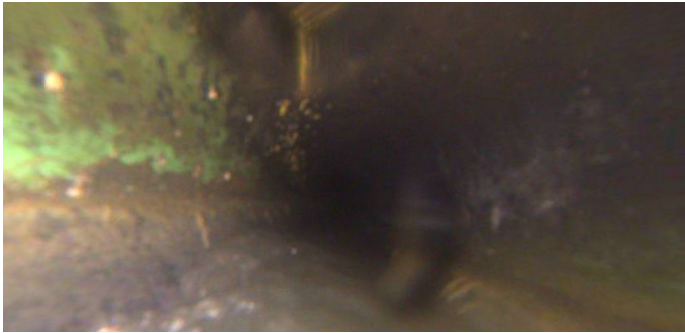
Code:	<b>MWL</b>
Description:	<b>Water Level</b>

Distance (ft):	<b>.0</b>
Structural Grade:	<b>0</b>
O&M Grade:	<b>0</b>
Clock Start/From:	
Clock To:	
1st Value:	
2nd Value:	
Value Percent:	<b>10.000</b>
Continuous Index:	
Within 8" of Joint:	<b>NO</b>
Remarks:

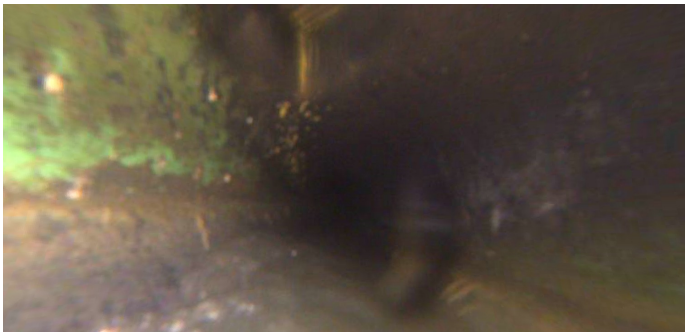
Code:	<b>DAGS</b>
Description:	<b>Deposits Attached Grease</b>

Distance (ft):	<b>.0</b>
Structural Grade:	<b>0</b>
O&M Grade:	<b>2</b>
Clock Start/From:	<b>8</b>
Clock To:	<b>4</b>
1st Value:	
2nd Value:	
Value Percent:	<b>5.000</b>
Continuous Index:	<b>S01</b>
Within 8" of Joint:	<b>NO</b>
Remarks:

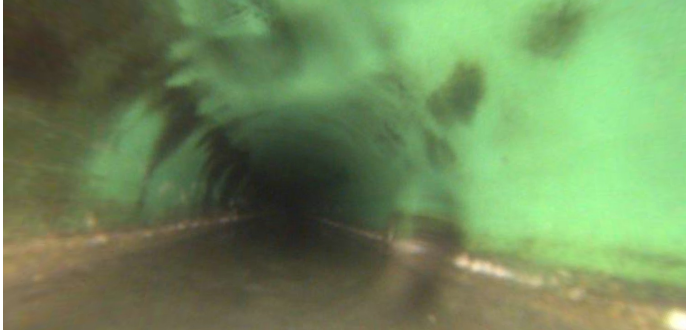
Code: **MWL**  
Description: **Water Level**

Distance (ft): **204.4**  
Structural Grade: **0**  
O&M Grade: **0**  
Clock Start/From:  
Clock To:  
1st Value:  
2nd Value:  
Value Percent: **30.000**  
Continuous Index:  
Within 8" of Joint: **NO**  
Remarks:

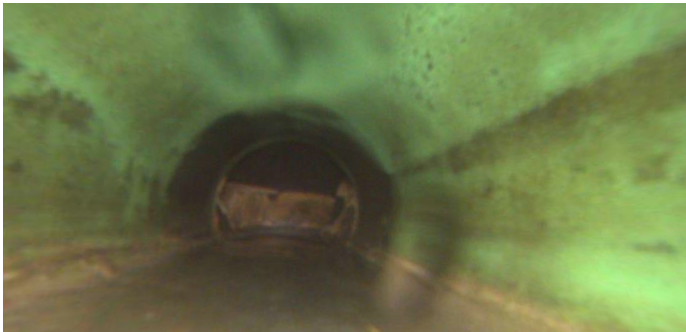
Code: **DAGS**  
Description: **Deposits Attached Grease**

Distance (ft): **257.2**  
Structural Grade: **0**  
O&M Grade: **2**  
Clock Start/From: **8**  
Clock To: **4**  
1st Value:  
2nd Value:  
Value Percent: **5.000**  
Continuous Index: **F01**  
Within 8" of Joint: **NO**  
Remarks:
