Profile/Photo Observation Report

Street:	BRACKEN PKWY	Flow Control:	Not Controlled
City:	Hobart, IN	Year Renewed:	
Location:	Sidewalk	Tape/Media #:	
Purpose:	Maintenance Related	Dia/Height:	12"
Use:	Sanitary	Material:	PVC
Drain Area:	NA	Lining:	Cured in Place
Category:	NA		
Comment:

Location Details:		Direction of Survey:	Downstream
US MH:	M-708-103	DS MH:	M-708-102
		Total Length Surveyed (ft):	140.9

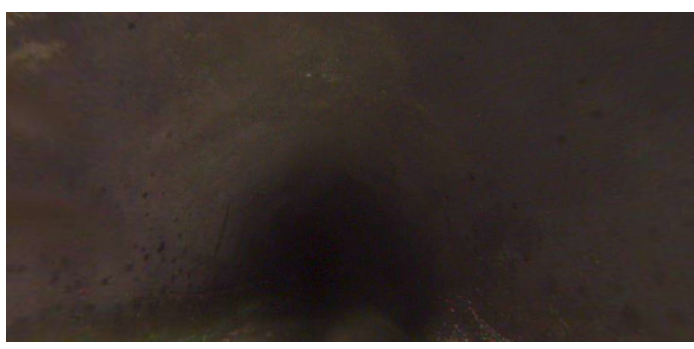
Code: **AMH**
Description: **Manhole**

Distance (ft): **.0**
Structural Grade: **0**
O&M Grade: **0**
Clock Start/From:
Clock To:
1st Value:
2nd Value:
Value Percent:
Continuous Index:
Within 8" of Joint: **NO**
Remarks: **M-708-103**

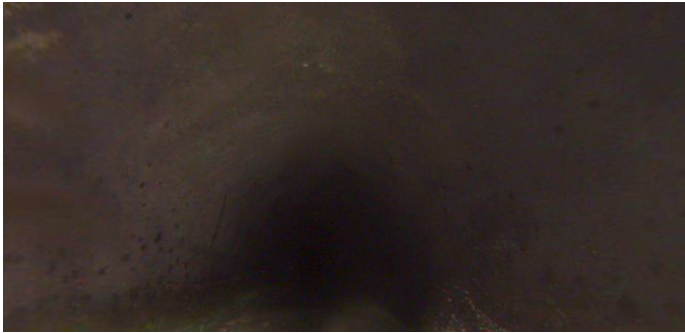
Code:	MWL
Description:	Water Level

Distance (ft):	.0
Structural Grade:	0
O&M Grade:	0
Clock Start/From:	
Clock To:	
1st Value:	
2nd Value:	
Value Percent:	5.000
Continuous Index:	
Within 8" of Joint:	NO
Remarks:

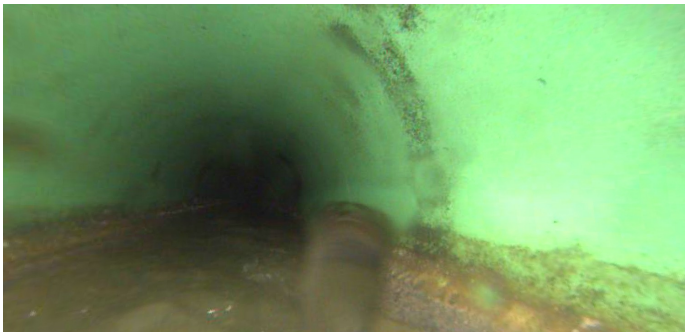
Code:	MSA
Description:	Abandoned Survey

Distance (ft):	140.9
Structural Grade:	0
O&M Grade:	0
Clock Start/From:	
Clock To:	
1st Value:	
2nd Value:	
Value Percent:	
Continuous Index:	
Within 8" of Joint:	NO
Remarks:	DEBRIS UNDER WATER
