Profile/Photo Observation Report

Street:	Bracken	Flow Control:	Not Controlled
City:	Hobart, IN	Year Renewed:	
Location:	Sidewalk	Tape/Media #:	
Purpose:	Maintenance Related	Dia/Height:	12"
Use:	Sanitary	Material:	PVC
Drain Area:	NA	Lining:	Cured in Place
Category:	NA		
Comment:

Location Details:		Direction of Survey:	Downstream
US MH:	M-708-103	DS MH:	M-708-102
		Total Length Surveyed (ft):	140.9

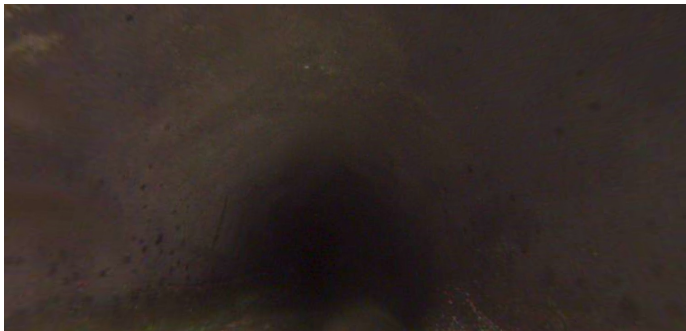
Code: **AMH**
Description: **Manhole**

Distance (ft): **.0**
Structural Grade: **0**
O&M Grade: **0**
Clock Start/From:
Clock To:
1st Value:
2nd Value:
Value Percent:
Continuous Index:
Within 8" of Joint: **NO**
Remarks: **M-708-103**

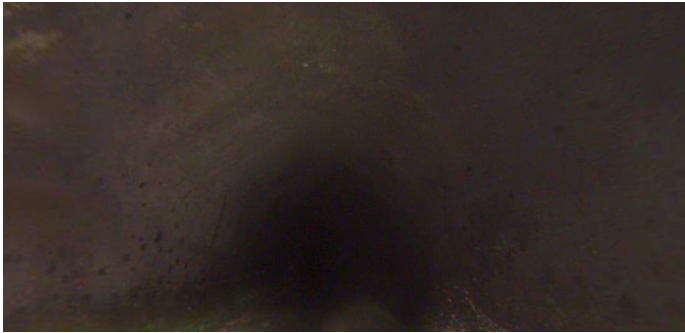
Code:	MWL
Description:	Water Level

Distance (ft):	.0
Structural Grade:	0
O&M Grade:	0
Clock Start/From:	
Clock To:	
1st Value:	
2nd Value:	
Value Percent:	5.000
Continuous Index:	
Within 8" of Joint:	NO
Remarks:

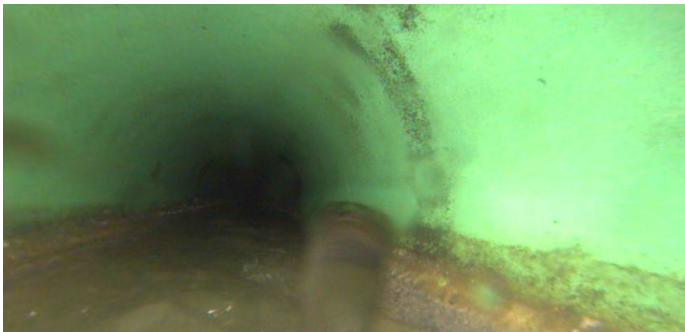
Code:	MSA
Description:	Abandoned Survey

Distance (ft):	140.9
Structural Grade:	0
O&M Grade:	0
Clock Start/From:	
Clock To:	
1st Value:	
2nd Value:	
Value Percent:	
Continuous Index:	
Within 8" of Joint:	NO
Remarks:	DEBRIS UNDER WATER
