Profile/Photo Observation Report

| Street: | BRACKEN PKWY | Flow Control: | Not Controlled |

| US MH: | M-708-103 | DS MH: | M-708-102 |

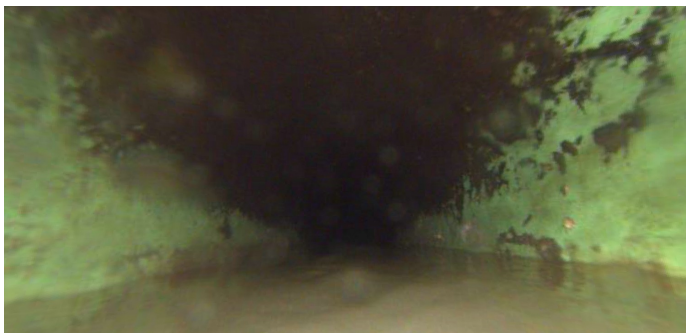
Code: **AMH**
Description: **Manhole**

Distance (ft): **.0**
Structural Grade: **0**
O&M Grade: **0**
Clock Start/From:
Clock To:
1st Value:
2nd Value:
Value Percent:
Continuous Index:
Within 8" of Joint: **NO**
Remarks: **M-708-102**

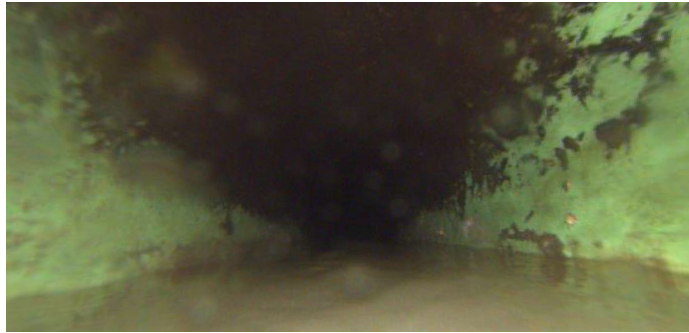
Code: **MWL**
Description: **Water Level**

Distance (ft): **.0**
Structural Grade: **0**
O&M Grade: **0**
Clock Start/From:
Clock To:
1st Value:
2nd Value:
Value Percent: **40.000**
Continuous Index:
Within 8" of Joint: **NO**
Remarks:

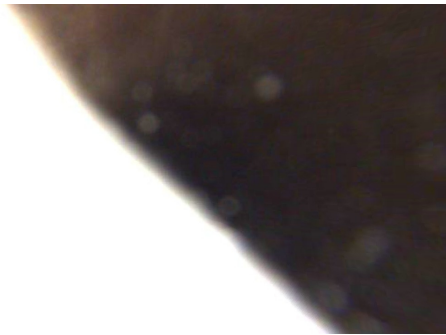
Code: **MSA**
Description: **Abandoned Survey**

Distance (ft): **27.7**
Structural Grade: **0**
O&M Grade: **0**
Clock Start/From:
Clock To:
1st Value:
2nd Value:
Value Percent:
Continuous Index:
Within 8" of Joint: **NO**
Remarks: **debris under water**
