Profile/Photo Observation Report

Street:	Bracken	Flow Control:	Not Controlled
City:	Hobart, IN	Year Renewed:	
Location:	Sidewalk	Tape/Media #:	
Purpose:	Maintenance Related	Dia/Height:	12"
Use:	Sanitary	Material:	PVC
Drain Area:	NA	Lining:	Cured in Place
Category:	NA		
Comment:

Location Details:		Direction of Survey:	Upstream
US MH:	M-708-103	DS MH:	M-708-102
		Total Length Surveyed (ft):	27.7

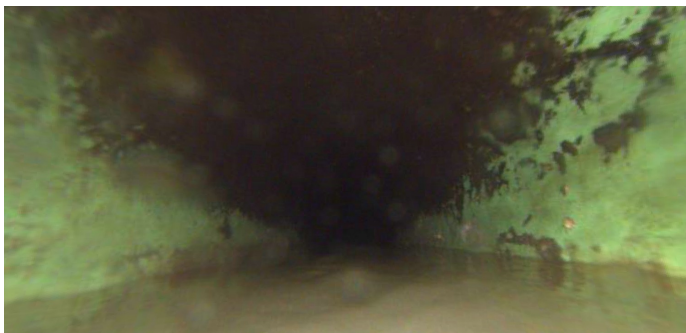
Code: **AMH**
Description: **Manhole**

Distance (ft): **.0**
Structural Grade: **0**
O&M Grade: **0**
Clock Start/From:
Clock To:
1st Value:
2nd Value:
Value Percent:
Continuous Index:
Within 8" of Joint: **NO**
Remarks: **M-708-102**

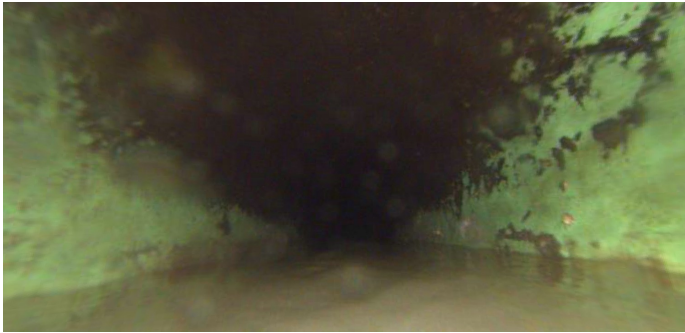
Code:	MWL
Description:	Water Level

Distance (ft):	.0
Structural Grade:	0
O&M Grade:	0
Clock Start/From:	
Clock To:	
1st Value:	
2nd Value:	
Value Percent:	40.000
Continuous Index:	
Within 8" of Joint:	NO
Remarks:
