Profile/Photo Observation Report

Street:	Bracken Pkwy.	Flow Control:	Not Controlled
City:	Hobart, IN	Year Renewed:	
Location:	Light Highway	Tape/Media #:	
Purpose:	Routine Assessment	Dia/Height:	12"
Use:	Sanitary	Material:	VCP
Drain Area:	NA	Lining:	
Category:	NA		
Comment:

Location Details:		Direction of Survey:	Downstream
US MH:	M-708-103	DS MH:	M-708-102
		Total Length Surveyed (ft):	406.7

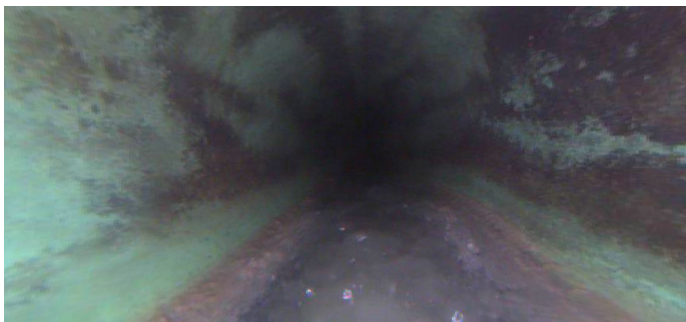
Code: **AMH**
Description: **Manhole**

Distance (ft): **.0**
Structural Grade: **0**
O&M Grade: **0**
Clock Start/From:
Clock To:
1st Value:
2nd Value:
Value Percent:
Continuous Index:
Within 8" of Joint: **NO**
Remarks: **M-708-103**

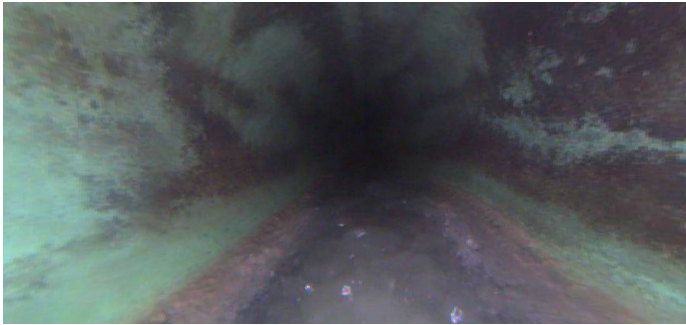
Code:	MWL
Description:	Water Level

Distance (ft):	.0
Structural Grade:	0
O&M Grade:	0
Clock Start/From:	
Clock To:	
1st Value:	
2nd Value:	
Value Percent:	5.000
Continuous Index:	
Within 8" of Joint:	NO
Remarks:

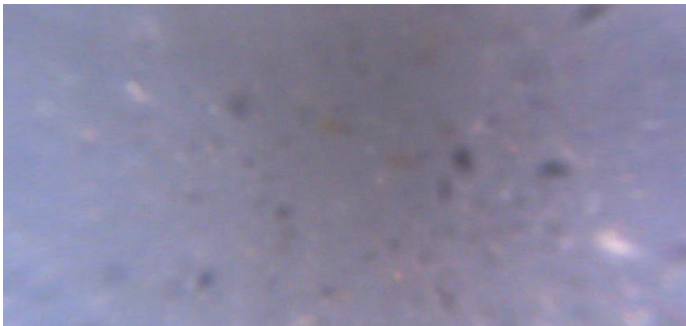
Code:	MWLS
Description:	Water Level Sag

Distance (ft):	403.2
Structural Grade:	2
O&M Grade:	3
Clock Start/From:	
Clock To:	
1st Value:	
2nd Value:	
Value Percent:	10.000
Continuous Index:	
Within 8" of Joint:	NO
Remarks:

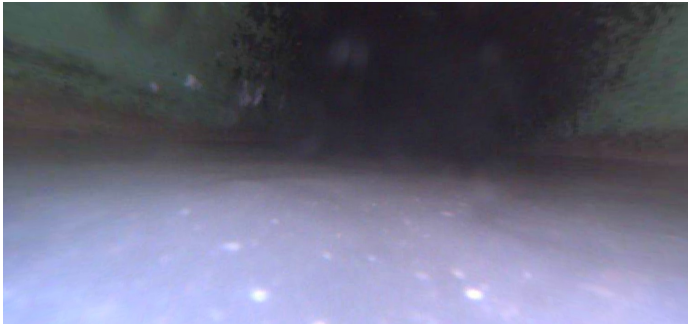
Code:	AMH
Description:	Manhole
Distance (ft):	406.7
Structural Grade:	0
O&M Grade:	0
Clock Start/From:	
Clock To:	
1st Value:	
2nd Value:	
Value Percent:	
Continuous Index:	
Within 8" of Joint:	NO
Remarks:	M-708-102
