Profile/Photo Observation Report

| Street: | Bracken | Flow Control: | Not Controlled |
| City: | Hobart, IN | Year Renewed: | |

| US MH: | M-708-104 | DS MH: | M-708-103 |

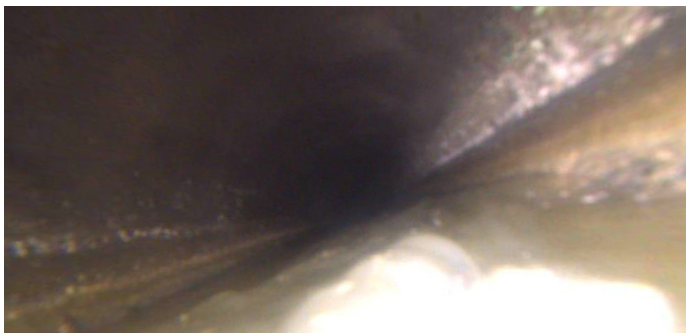
Code: **AMH**
Description: **Manhole**

Distance (ft): **.0**
Structural Grade: **0**
O&M Grade: **0**
Clock Start/From:
Clock To:
1st Value:
2nd Value:
Value Percent:
Continuous Index:
Within 8" of Joint: **NO**
Remarks: **M-708-104**

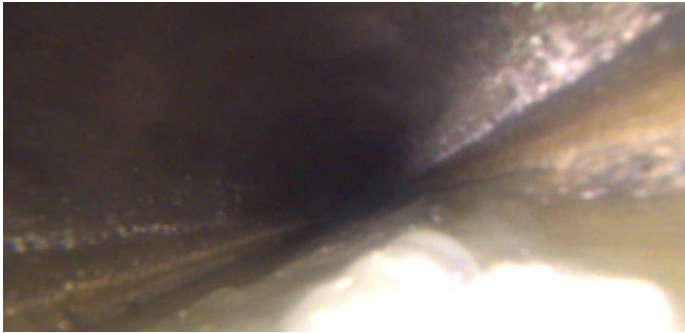
| Code: | MWL |
| Description: | Water Level |

| Value Percent: | 30.000 |

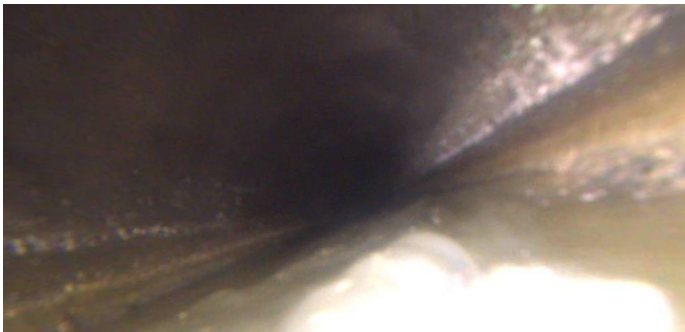
| Code: | DAGS |
| Description: | Deposits Attached Grease |

| O&M Grade: | 2 |
| Clock Start/From: | 8 |
| Clock To: | 4 |
| Value Percent: | 5.000 |

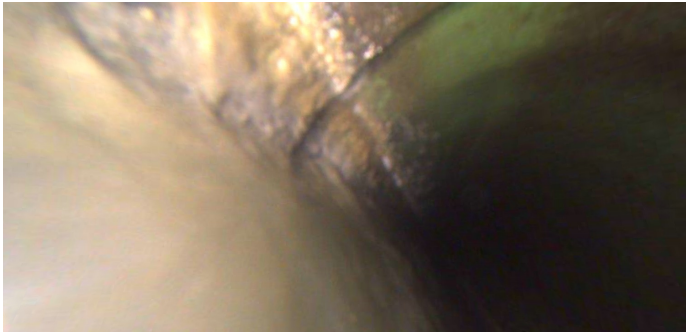
Code: **MSA**
Description: **Abandoned Survey**

Distance (ft): **42.8**
Structural Grade: **0**
O&M Grade: **0**
Clock Start/From:
Clock To:
1st Value:
2nd Value:
Value Percent:
Continuous Index:
Within 8" of Joint: **NO**
Remarks: **OVERTURNED**

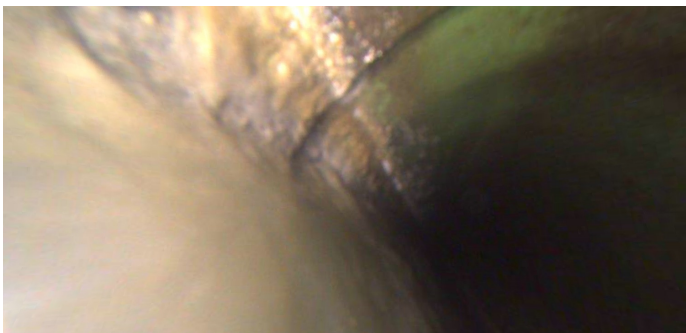
Code: **DAGS**
Description: **Deposits Attached Grease**

Distance (ft): **42.8**
Structural Grade: **0**
O&M Grade: **2**
Clock Start/From: **8**
Clock To: **4**
1st Value:
2nd Value:
Value Percent: **5.000**
Continuous Index: **F01**
Within 8" of Joint: **NO**
Remarks:
