## Profile/Photo Observation Report

Date:	<b>04/04/2018</b>	Weather:		Coding:	<b>PACP 6.0</b>
Pipe Length (ft):	<b>150.7</b>	Owner:	<b>NA</b>	Pre Clean:	<b>Not Known</b>
P.O.#:		Surveyor:	<b>Jen Costello</b>	PSR:	<b>P-708-104-103</b>
Customer:		Clean Date:	<b>01/01/1900</b>	Shape:	<b>C</b>

Street:	<b>BRACKEN PKWY</b>	Flow Control:	<b>Not Controlled</b>
City:	<b>Hobart, IN</b>	Year Renewed:	
Location:	<b>Sidewalk</b>	Tape/Media #:	
Purpose:	<b>Maintenance Related</b>	Dia/Height:	<b>12"</b>
Use:	<b>Sanitary</b>	Material:	<b>PVC</b>
Drain Area:	<b>NA</b>	Lining:	<b>Cured in Place</b>
Category:	<b>NA</b>		
Comment:	<b>Reverse setup. Debris at 120'.</b>		
Location Details:		Direction of Survey:	<b>Upstream</b>
US MH:	<b>M-708-104</b>	DS MH:	<b>M-708-103</b>
		Total Length Surveyed (ft):	<b>121.8</b>

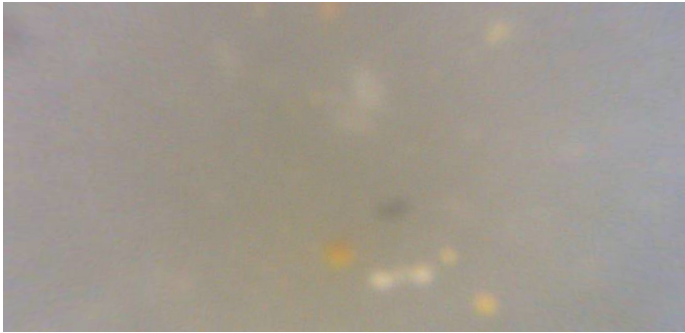
Code:	<b>MWL</b>
Description:	<b>Water Level</b>

Distance (ft):	<b>.0</b>
Structural Grade:	<b>0</b>
O&M Grade:	<b>0</b>
Clock Start/From:	
Clock To:	
1st Value:	
2nd Value:	
Value Percent:	<b>100.000</b>
Continuous Index:	
Within 8" of Joint:	<b>NO</b>
Remarks:

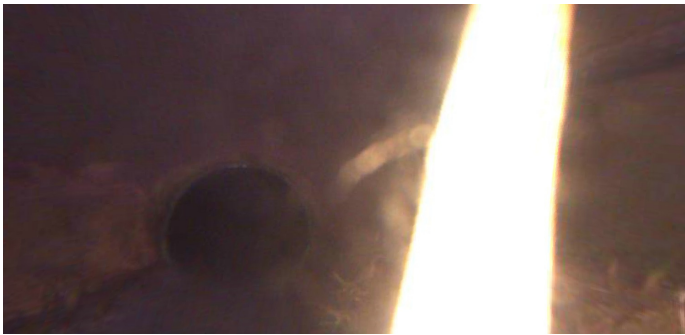
Code:	<b>MGO</b>
Description:	<b>General Observation</b>

Distance (ft):	<b>.0</b>
Structural Grade:	<b>0</b>
O&M Grade:	<b>0</b>
Clock Start/From:	
Clock To:	
1st Value:	
2nd Value:	
Value Percent:	
Continuous Index:	
Within 8" of Joint:	<b>NO</b>
Remarks:	<b>REAR CAMERA</b>

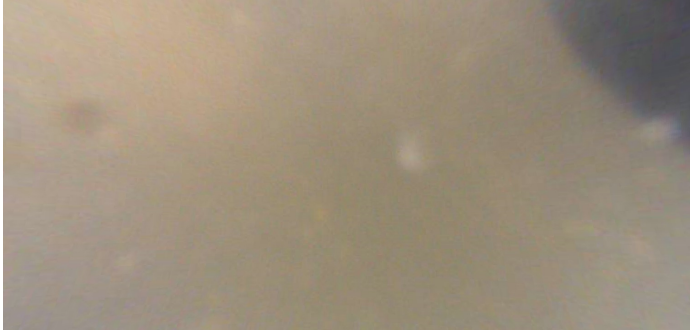
Code:	<b>MSA</b>
Description:	<b>Abandoned Survey</b>
Distance (ft):	<b>121.8</b>
Structural Grade:	<b>0</b>
O&M Grade:	<b>0</b>
Clock Start/From:	
Clock To:	
1st Value:	
2nd Value:	
Value Percent:	
Continuous Index:	
Within 8" of Joint:	<b>NO</b>
Remarks:	<b>UNDER WATER</b>
