Profile/Photo Observation Report

Street:	Bracken	Flow Control:	Not Controlled
City:	Hobart, IN	Year Renewed:	
Location:	Sidewalk	Tape/Media #:	
Purpose:	Maintenance Related	Dia/Height:	12"
Use:	Sanitary	Material:	PVC
Drain Area:	NA	Lining:	Cured in Place
Category:	NA		
Comment:	Reverse setup. Debris at 120'.

Location Details:		Direction of Survey:	Upstream
US MH:	M-708-104	DS MH:	M-708-103
		Total Length Surveyed (ft):	121.8

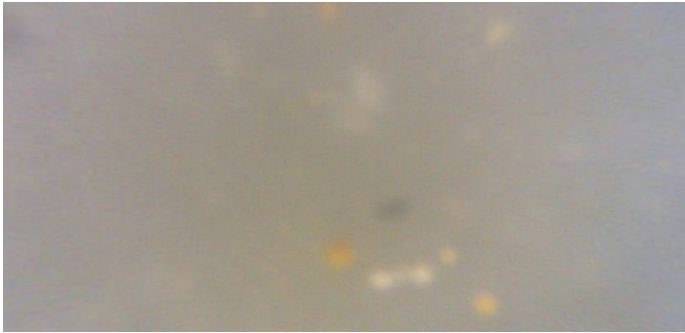
Code:	MWL
Description:	Water Level

Distance (ft):	.0
Structural Grade:	0
O&M Grade:	0
Clock Start/From:	
Clock To:	
1st Value:	
2nd Value:	
Value Percent:	100.000
Continuous Index:	
Within 8" of Joint:	NO
Remarks:

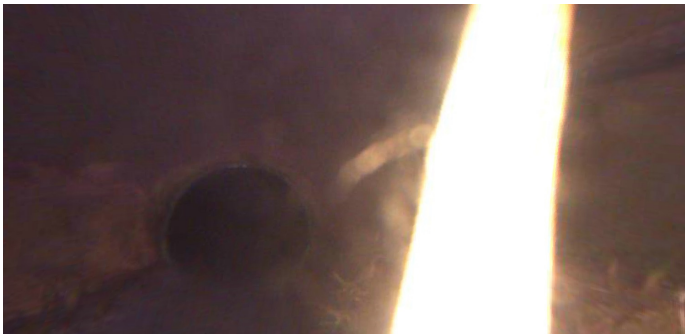
Code:	MGO
Description:	General Observation

Distance (ft):	.0
Structural Grade:	0
O&M Grade:	0
Clock Start/From:	
Clock To:	
1st Value:	
2nd Value:	
Value Percent:	
Continuous Index:	
Within 8" of Joint:	NO
Remarks:	REAR CAMERA

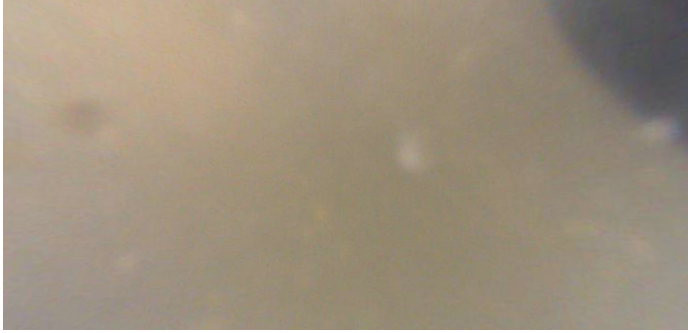
Code:	MSA
Description:	Abandoned Survey
Distance (ft):	121.8
Structural Grade:	0
O&M Grade:	0
Clock Start/From:	
Clock To:	
1st Value:	
2nd Value:	
Value Percent:	
Continuous Index:	
Within 8" of Joint:	NO
Remarks:	UNDER WATER
