## Profile/Photo Observation Report

Street:	<b>BRACKEN PKWY &amp; LAKE ST</b>	Flow Control:	<b>Not Controlled</b>
City:	<b>Hobart, IN</b>	Year Renewed:	
Location:	<b>Sidewalk</b>	Tape/Media #:	
Purpose:	<b>Maintenance Related</b>	Dia/Height:	<b>12"</b>
Use:	<b>Sanitary</b>	Material:	<b>PVC</b>
Drain Area:	<b>NA</b>	Lining:	<b>Cured in Place</b>
Category:	<b>NA</b>		
Comment:	<b>Reverse setup.</b>

Location Details:		Direction of Survey:	<b>Upstream</b>
US MH:	<b>M-708-105</b>	DS MH:	<b>M-708-104</b>
		Total Length Surveyed (ft):	<b>103.9</b>

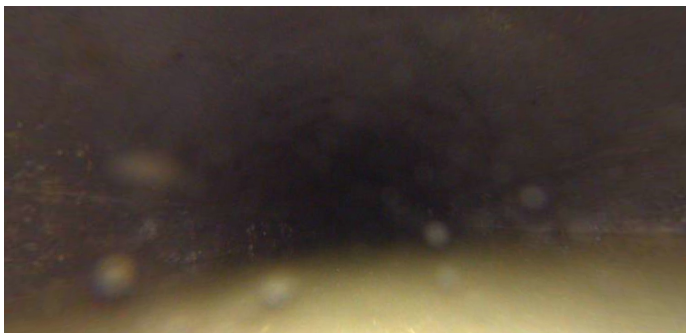
Code: **AMH**  
Description: **Manhole**

Distance (ft): **.0**  
Structural Grade: **0**  
O&M Grade: **0**  
Clock Start/From:  
Clock To:  
1st Value:  
2nd Value:  
Value Percent:  
Continuous Index:  
Within 8" of Joint: **NO**  
Remarks: **M-708-104**

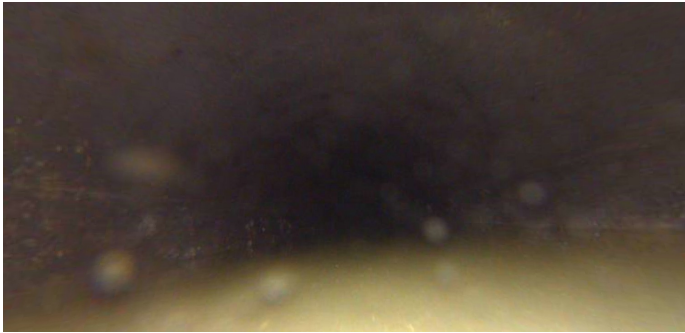
Code:	<b>MWL</b>
Description:	<b>Water Level</b>

Distance (ft):	<b>.0</b>
Structural Grade:	<b>0</b>
O&M Grade:	<b>0</b>
Clock Start/From:	
Clock To:	
1st Value:	
2nd Value:	
Value Percent:	<b>40.000</b>
Continuous Index:	
Within 8" of Joint:	<b>NO</b>
Remarks:

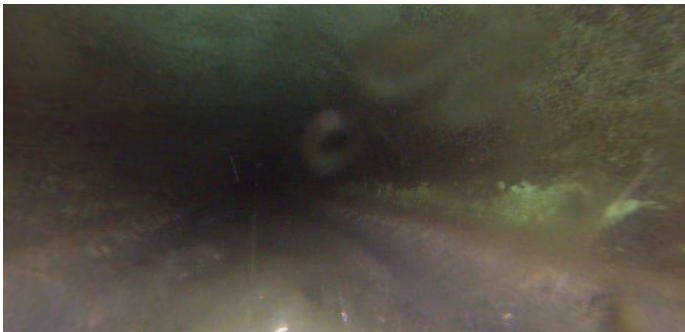
Code:	<b>MGO</b>
Description:	<b>General Observation</b>

Distance (ft):	<b>11.7</b>
Structural Grade:	<b>0</b>
O&M Grade:	<b>0</b>
Clock Start/From:	
Clock To:	
1st Value:	
2nd Value:	
Value Percent:	
Continuous Index:	
Within 8" of Joint:	<b>NO</b>
Remarks:	<b>rear camera</b>

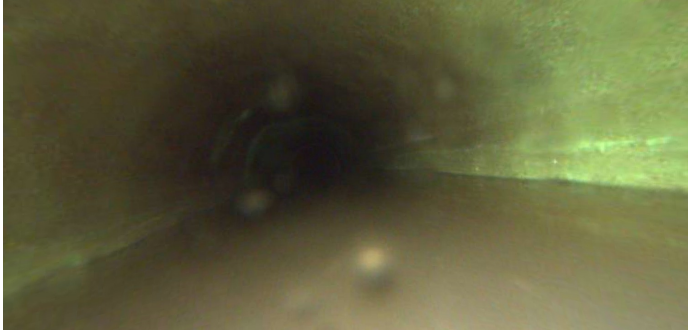
Code:	<b>MSA</b>
Description:	<b>Abandoned Survey</b>
Distance (ft):	<b>103.9</b>
Structural Grade:	<b>0</b>
O&M Grade:	<b>0</b>
Clock Start/From:	
Clock To:	
1st Value:	
2nd Value:	
Value Percent:	
Continuous Index:	
Within 8" of Joint:	<b>NO</b>
Remarks:	<b>debris under water</b>
